## Technical Service Bulletin

<b>Topic</b>	93 Charging flap without search illumination
<b>Market area</b>	United States 444 Volkswagen of America, Inc. (6444)
<b>Brand</b>	Audi
<b>Transaction No.</b>	2077496/1
<b>Level</b>	EH
<b>Status</b>	Released for publishing
<b>Release date</b>	Apr 2, 2025

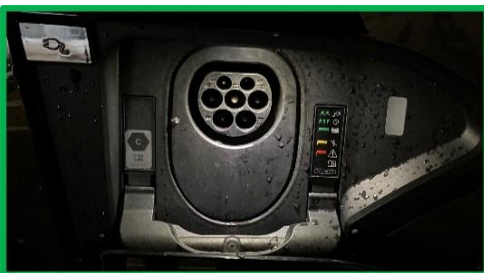
If both charging flap modules are fitted (left and right), the lighting is active, and functions as intended.

**Figure 1.** Vehicle with functioning search illumination in the charging flap module.

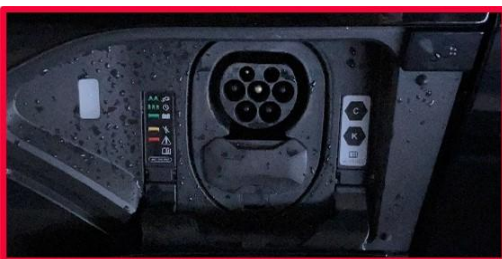
If the vehicle is only equipped with a single charging flap module, the orientation light does not work. An issue in the OBC software means that the orientation light LED is not activated when the vehicle is equipped with only one charging flap module.

**Figure 2.** Vehicle with non-functioning search illumination in the charging flap module.

Update the high-voltage battery charger -J1050- (00C6) using the SVM action code as listed in the table below, if necessary:

For stage 1: The SVM code required is **C6A015**

**Now perform a terminal 15 reset for at least 2 minutes.**

For stage 2: The SVM code required is **C6B015**
