Technical Service Bulletin

Topic	15 Engine: Cylinder head cover - oil residue Q5 (inline 4-cyl., 2.0 ltr. TFSI)
Market area	United States 444 Volkswagen of America, Inc. (6444)
Brand	Audi
Transaction No.	2072716/6
Level	EH
Status	Released for publishing
Release date	Apr 10, 2025

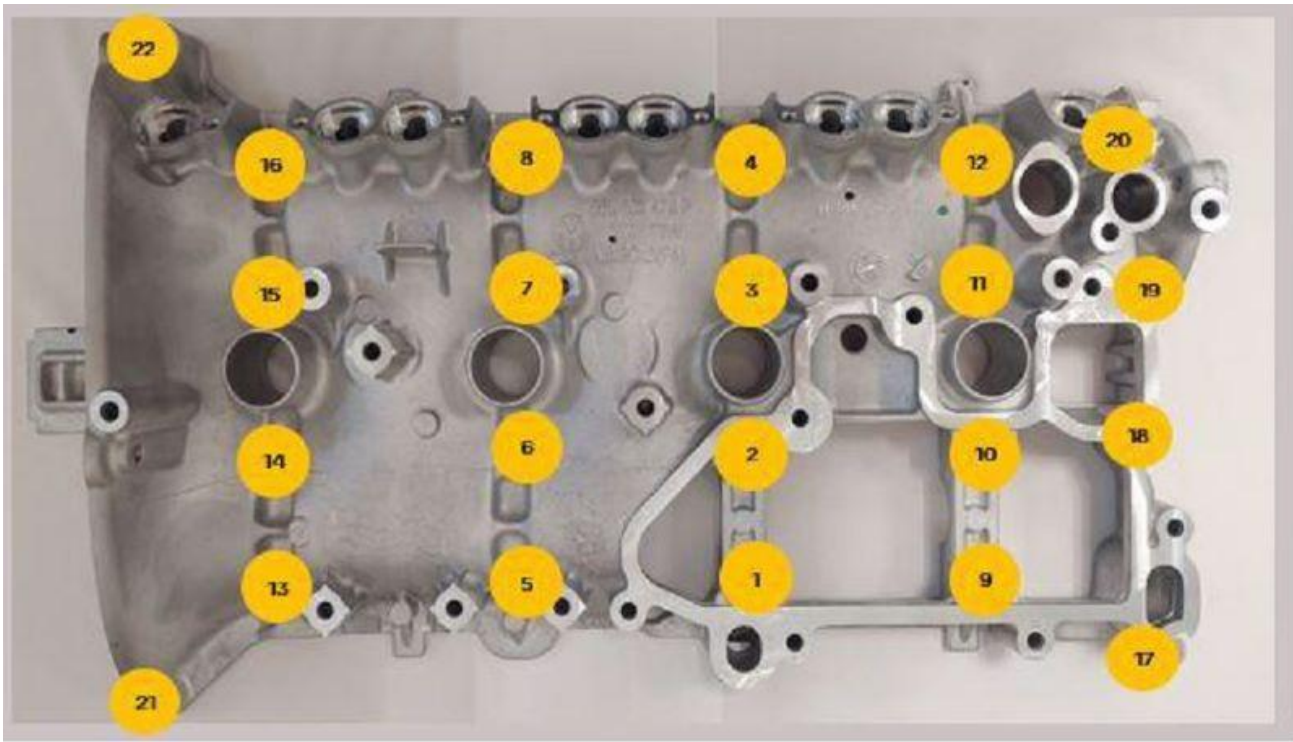
- Please check all 22-cylinder head cover bolts
- The oil separator must be removed.
- Check that the bolts are tightened to a torque of 14 Nm in the order shown in Figure 1.

Figure 1: Sequence of checking bolts

- Replace any loose bolts.
- Tighten the new bolt(s) to a torque of 8 Nm + 90°.
- If several bolts are affected, do not loosen them at the same time (i.e. several at once). Please remove, replace, and tighten the bolts one by one in order shown in Figure 1.

If the torque wrench does not click after a quarter turn (90°) when checking the bolts are tightened to 14Nm, the affected bolt must be replaced.

- **When replacing the new bolt, it must be tightened to a torque of 8 Nm + 90°. If several bolts are affected, do not loosen them at the same time (i.e. several at once). Please remove, replace, and tighten the bolts one by one in order shown in figure 1.**
- **When re-tightening the bolt(s), the maximum torque of 14 Nm must not be exceeded.**

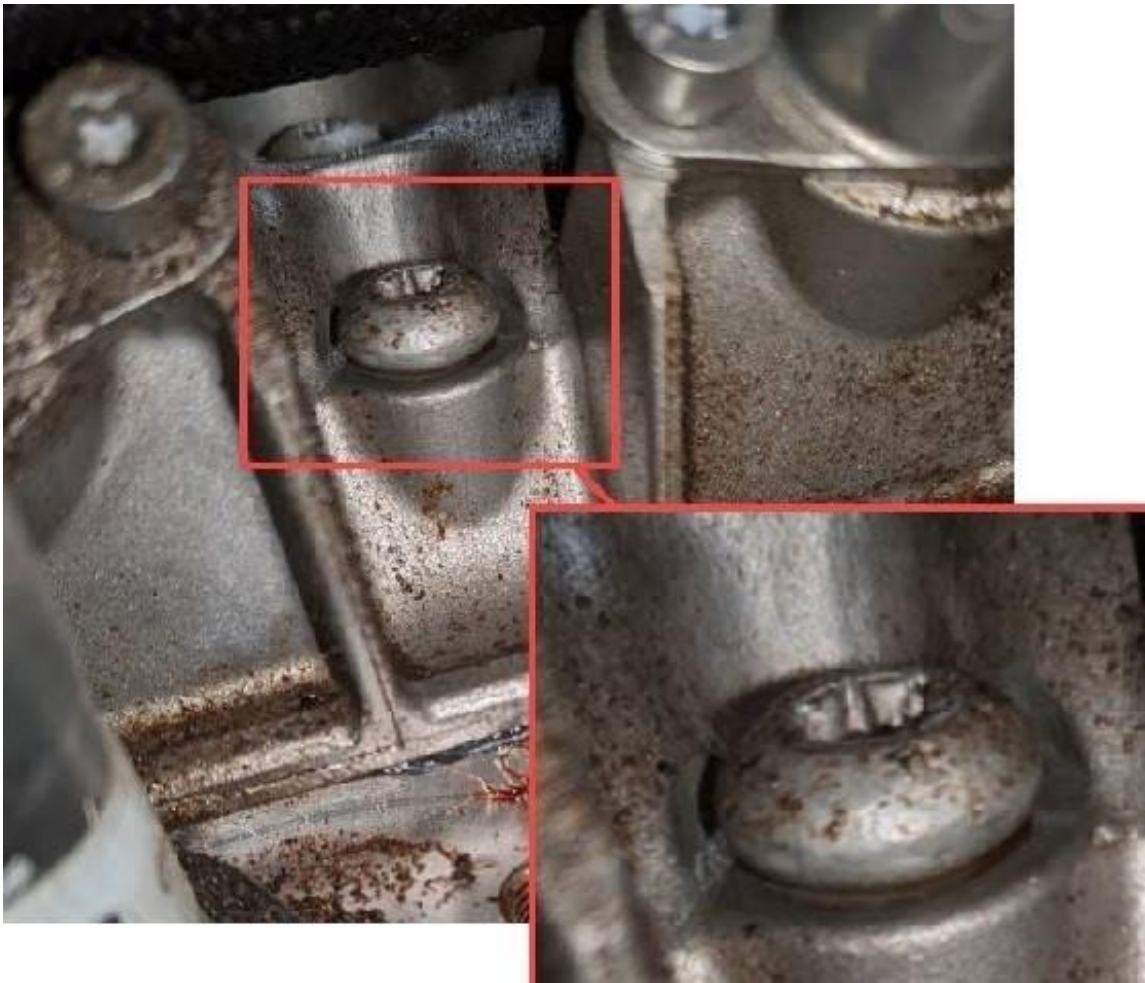
- Cylinder head cover leaking in the area around the threaded connection (on one or more bolts).

In rare cases, the cylinder head cover bolts may become loose, resulting in oil residue around the threaded connection.

Figure 2: Oil on the threaded connection.

- Please ensure that replacing the bolts remedies the leaking.
- In this case, contrary to the information in ELSA, the oil separator gasket should be reused after removing the oil separator if it is not damaged. Please only remove the gasket from the oil separator if it is damaged.
