Technical Service Bulletin

| Topic | 93 Service info: Electrics - high-voltage battery - Q4 e-tron: necessary work steps when replacing high-voltage modules |
| Transaction No. | 2077497/1 |
| Release date | Apr 9, 2025 |

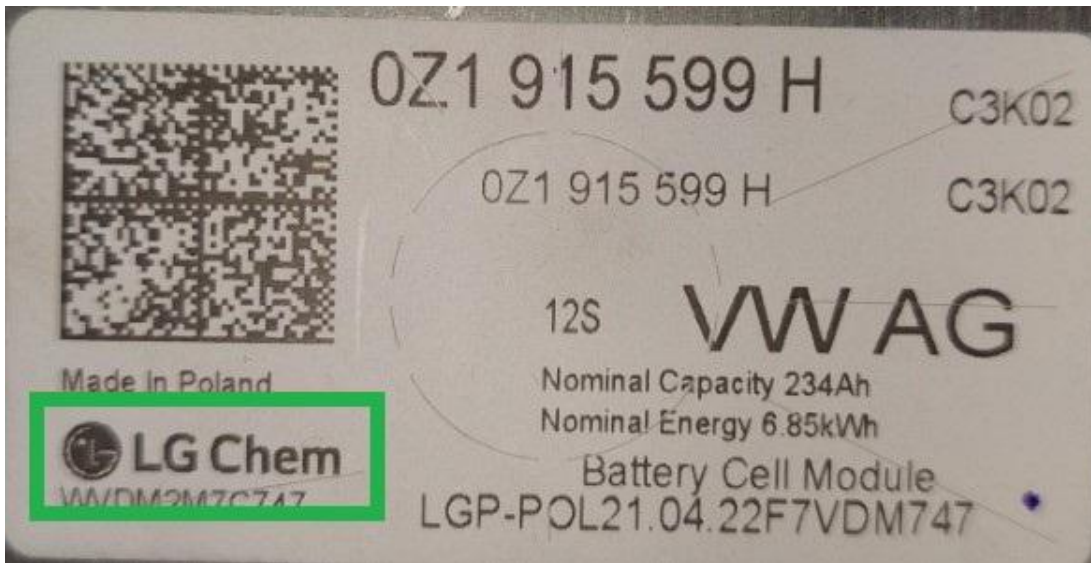
- The high-voltage module manufacturer can be found on the type plate of the high-voltage module (see Figure 1, highlighted in green).

Figure 1. Type plate on the high-voltage module from manufacturer LG Chem.
