## Technical Service Bulletin

Transaction No.: **2077506/1**

93 Q8 e-tron: option to release the AC charging connector not available in MMI

Release date: Apr 22, 2025

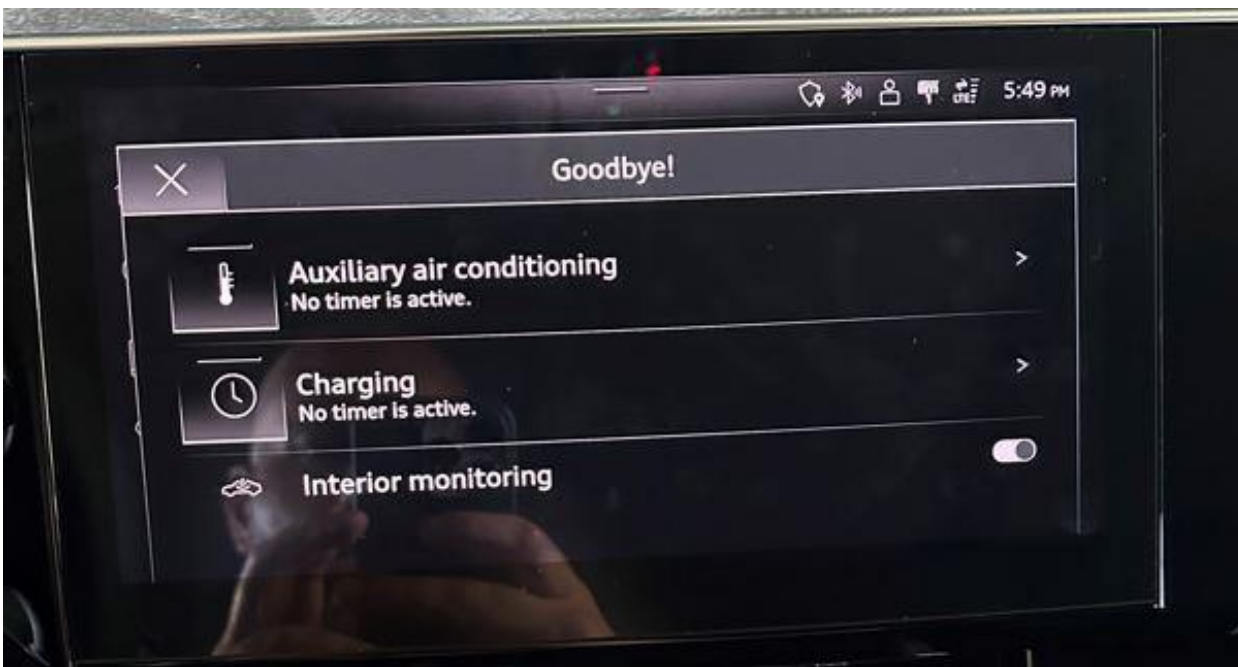
- Automatic release of the AC charging cable is not available to select in the MMI.
- No relevant event memory entries logged in diagnostic address 00C6.

**Figure 1:** Current situation - option to automatically release the charging cable at the end of an AC charging procedure is not shown in the MMI.

Software issue

Please flash the control unit for high-voltage battery charging unit (00C6) using the SVM code.

For stage 1 the SVM code required is C6A015.

For stage 2 the SVM code required is C6B015.

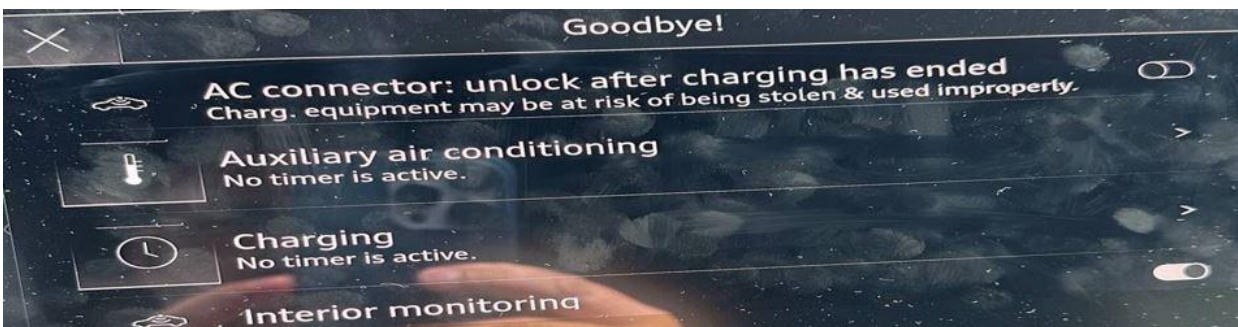
**Figure 2:** Desired situation - option to automatically release the charging cable at the end of an AC charging procedure is shown in the MMI.
