Technical Service Bulletin

Topic	93 e-tron update OBC software when replacing HV wiring harness for charging socket - NTC to PT1000 charging socket
Market area	United States 444 Volkswagen of America, Inc. (6444)
Brand	Audi
Transaction No.	2070110/5
Level	EH
Status	Released for publishing
Release date	Apr 23, 2025

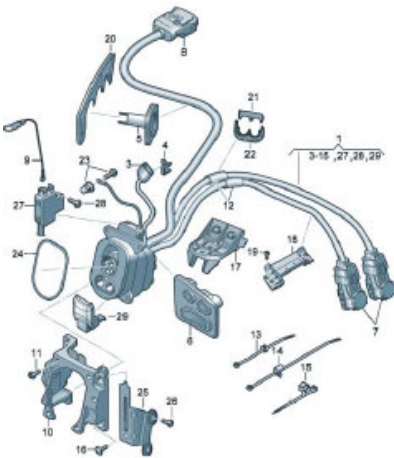
The High Voltage Wiring Harness for the charging socket UX4 or UX5 is replaced as part of any repair work (Figure 1).

Figure 1. High-voltage wiring harness for charging socket.

The charging socket was modified in production.

It is essential to check the part number of the removed original high-voltage wiring harness and of the new replacement high-voltage wiring harness.

If the high-voltage wiring harness for the charging socket is replaced as listed in Table 1.2, an SVM code will need to be performed, *and a replacement test plan performed.*
