Technical Service Bulletin

e-tron and e-tron Sportback

Transaction No.: **2063427/11**

93 HV battery charger control module cannot be started, or reports under wrong diagnostic address after being replaced

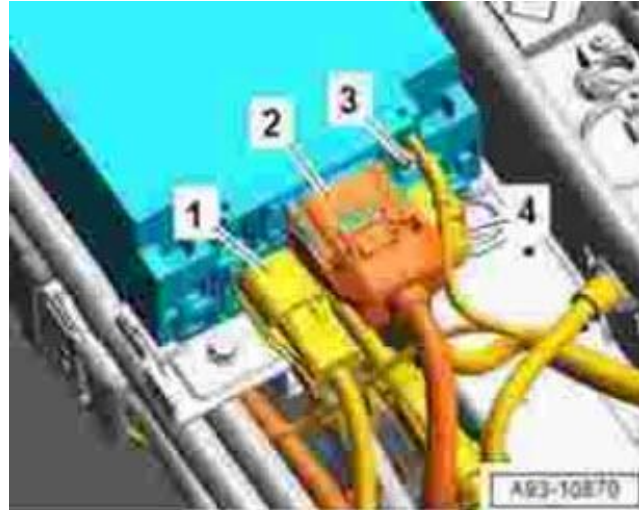
Figure 1. Labeled connections.

4. Install the battery charger and observe the connection sequence.

- First connect the electrical connectors -1- and -2- (Figure 1).
- Connect the electrical connector -4- last (Figure 1).
