# Service Bulletin

Bulletin No.: PIE0826

**Subject:** Engineering Information – (Pictures ONLY) – Center Hood Molding Loose and/or Potentially Detaching from Vehicle

Brand:	Model:	Model Year:		Breakpoint:		Engine:	Transmission:
		from	to	from	to		
GMC	HUMMER EV Pickup	2024	2025	—	—	—	—
	HUMMER EV SUV

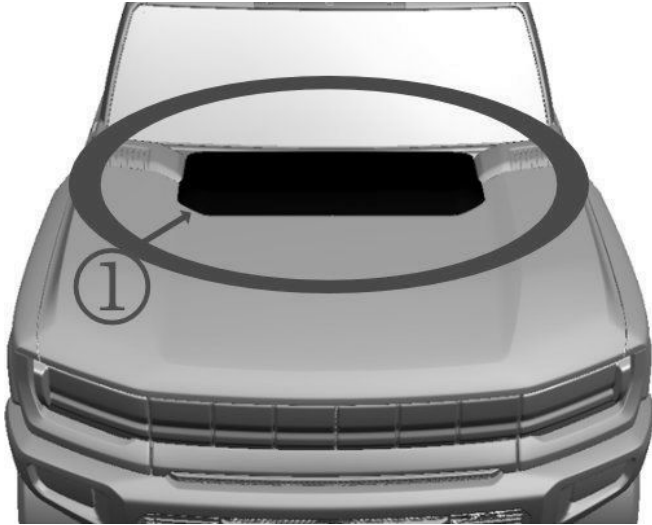
<b>Cause</b>	<p>Some customers may comment on the center hood molding (1) being loose and/or potentially detaching from the vehicle. <span style="float: right;">6880625</span></p> <p>GM Engineering is attempting to determine the root cause of the above condition. Engineering has a need to gather information on vehicles PRIOR to repair that may exhibit this condition. As a result, this information will be used to "root cause" the customer's concern and develop/validate a field fix.</p>

If you encounter a vehicle with the above concern, take clear pictures of the center hood molding and contact the engineer listed below for further instruction BEFORE replacement.
