Altec Industries, Inc. has issued a **customer satisfaction campaign** as described in the included Service Information Letter (SIL). According to our records, you own one or more units this applies to.

## LR8 Lanyard Detection System Calibration

**Units Affected:** Certain LR8 aerial devices built from January 2021 to October 2024. Verify your unit is affected by reviewing the attached list or accessing Altec Connect.

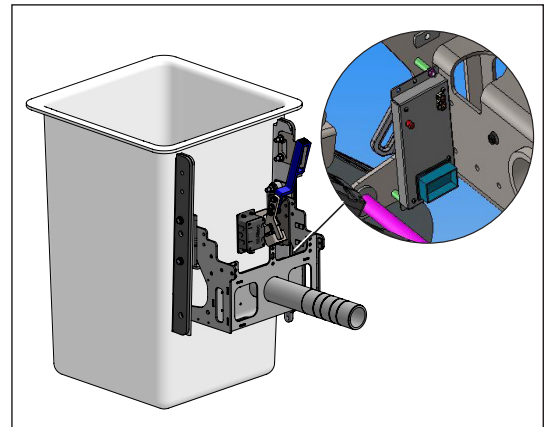
**Figure 1 — Lanyard Detection System Fiber Optic Transmitter**

**Background:** Altec has learned that the affected units could experience issues with the lanyard detection interlock system being out of adjustment due to the improper installation of the fiber optic cable on the transmitter, as well as signal interference from nearby transmission lines. These defects, stemming from early production challenges, have been resolved by implementing adjustment criteria, improving cable installation, addressing interference issues, and updating the firmware.

4. Locate the fiber optic transmitter for the lanyard detection system mounted near the upper control valve (refer to Figure 1). Inspect the electrical harness connection points for any signs of corrosion.

- a. If no corrosion is present, proceed to step 5.
  - b. If corrosion is present, attempt to clean the transmitter connector pins and/or the electrical harness connector pins.

- c. If cleaning is unsuccessful or components are damaged, order replacements for the affected component(s). Record findings in Figure 3.
    - Fiber optic transmitter: part number 990409144.

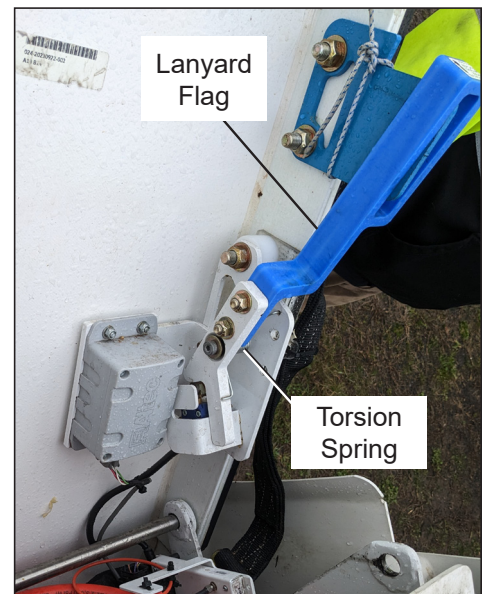
**Figure 2 — Switch Engagement Mechanism**

- Electrical (battery) harness: part number 990532616.
5. Locate the lanyard flag. Pull the lanyard flag toward the platform and release it to confirm that it springs back smoothly to its original position.

- a. If the lanyard flag does not spring back smoothly, it may be required to replace the torsion spring. Record findings in Figure 3.
    - For front mounted LR units this is part 991063815.

- For rear mounted LR units this part is 991063814.
  - b. Proceed to step 6.

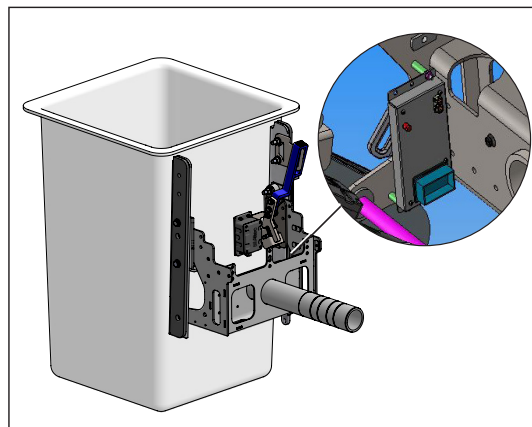
**Figura 1 — Sistema de detección de cordón con transmisor de fibra óptica**

**Antecedentes:** Altec ha descubierto que las unidades afectadas podrían experimentar problemas con el sistema de enclavamiento de detección del cordón de seguridad debido a un desajuste causado por la instalación incorrecta del cable de fibra óptica en el transmisor, así como a interferencias de señal provenientes de líneas de transmisión cercanas. Estos defectos, derivados de desafíos en la producción inicial, se han solucionado mediante la implementación de criterios de ajuste, la mejora en la instalación del cable, la resolución de problemas de interferencia y la actualización del microprograma.

4. Ubique el transmisor de fibra óptica del sistema de detección del cordón de seguridad, montado cerca de la válvula de control superior (consulte la Figura 1). Inspeccione los puntos de conexión del arnés eléctrico en busca de signos de corrosión.

- a. Si no hay corrosión, proceda al paso 5.
- b. Si hay corrosión, intente limpiar los pasadores del conector del transmisor o los pasadores del conector del arnés eléctrico.
- c. Si la limpieza no es exitosa o los componentes están dañados, ordene reemplazos para los componentes afectados. Registre los hallazgos en la Figura 3.
  - Transmisor de fibra óptica: número de parte 990409144.
  - Arnés eléctrico (de batería): número de parte 990532616.

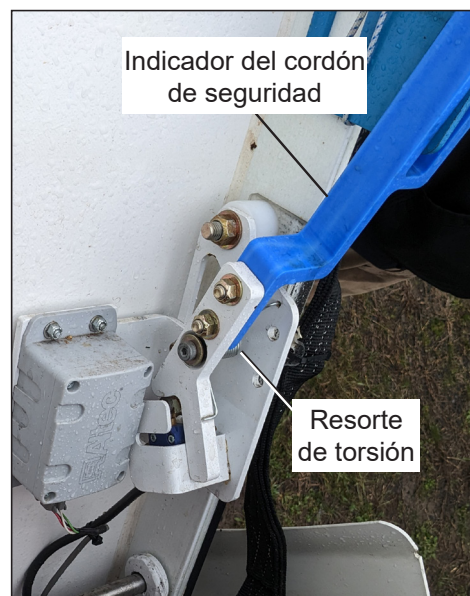
**Figura 2 — Mecanismo de acoplamiento del interruptor**

5. Ubique el indicador del cordón de seguridad. Tire del indicador del cordón de seguridad hacia la plataforma y suéltelo para confirmar que regresa suavemente a su posición original.

- a. Si el indicador del cordón de seguridad no regresa suavemente, puede ser necesario reemplazar el resorte de torsión. Registre los hallazgos en la Figura 3.
  - Para las unidades LR con montaje frontal, esta es la parte número 991063815.
  - Para las unidades LR con montaje trasero, esta es la parte número 991063814.
