## VN(4) Firewall Electrical Connectors Not Latching

Section 375

**VOLVO**

| Years | Models |
|---|---|
| 2025 | VN(4) |

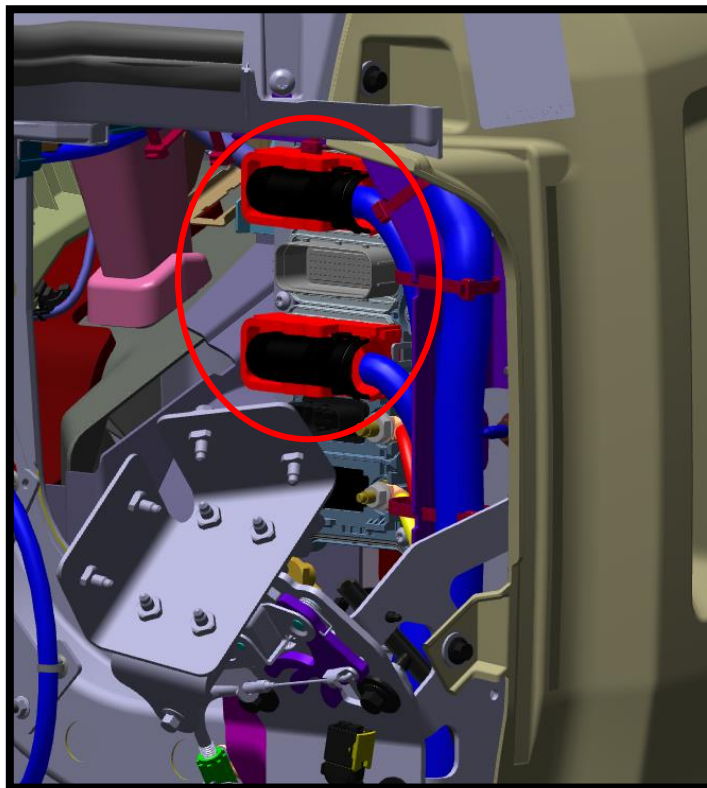
5. Follow Impact repair operation **3100-09-01-06 Low Voltage System, Decommissioning** to decommission the low voltage power system.
6. Open the hood and locate the front harness connections at the cab wall to the cab harness on the driver's side.

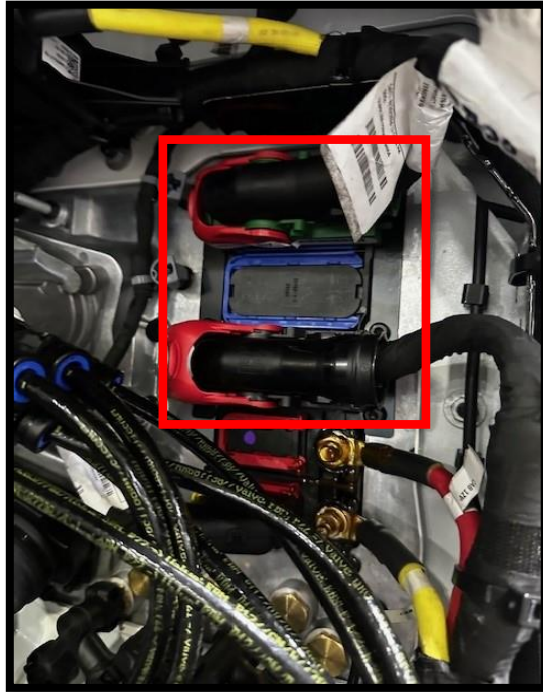
7. Disconnect the two large red cab harness connectors.

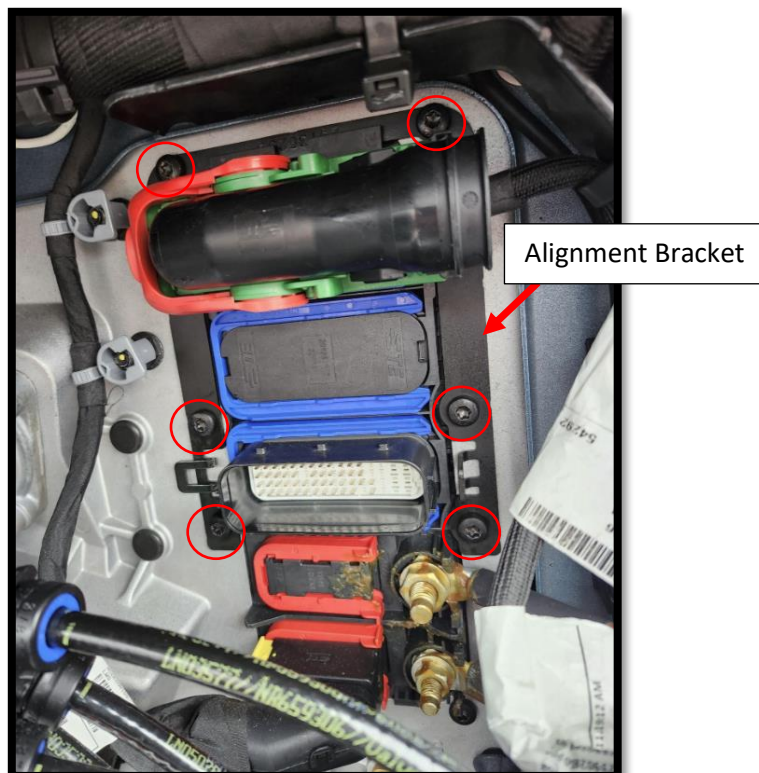
Volvo Trucks has determined that the XC201 firewall connector lock may not fully latch due to an interference with a tab on the cab hook interface bracket. The bracket is used only for assembly and serves no functional purpose post-assembly. Follow the instructions below to remove and discard the bracket.

8. Remove the six screws holding the alignment bracket (P/N: 23736239) and remove the alignment bracket.

9. Once the alignment bracket is removed, reinstall the six screws.

| Tightening torque |
|---|
| $10 \pm 1.5 \text{ Nm}$ ( $7 \pm 1 \text{ lb-ft}$ ) |
