**SERVICE ACTION**

Global Service Action  
Number: D001

Subject: <b>Automatic Pressure Maintenance Unit (APMU) Hose Clearance to Heatshield</b>	Publication No.: D001
	Model: Defender (LE)
	Model Year: 2025 - 2026
	Date of Issue: 09 April 2025
	Expiry Date: 30 April 2027

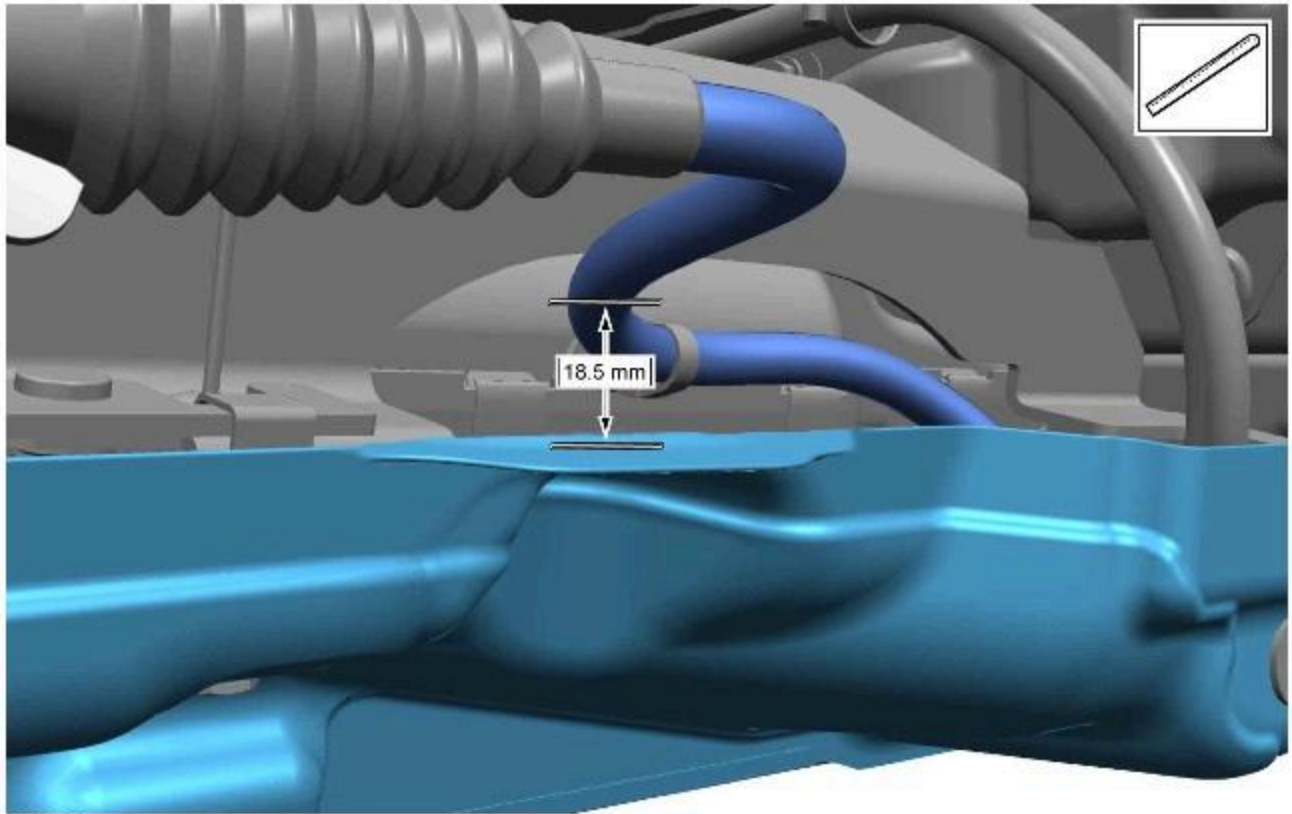
E386588

**CAUTION:**The clearance must be a **minimum** of 18.5 mm.

Using a suitable method, measure the clearance of the heatshield to the [APMU](#) hose.

- If the heatshield to [APMU](#) hose clearance is **18.5 mm or greater**, continue to step 4.
- If the heatshield to [APMU](#) hose clearance is **less than 18.5 mm**, continue to step 3.
