## EPICD (DC/DC) FAULT U3008-13 CONNECTOR C31VR/WR

### Range Rover

- 22-25MY Range Rover
- 23-25MY RR Sport

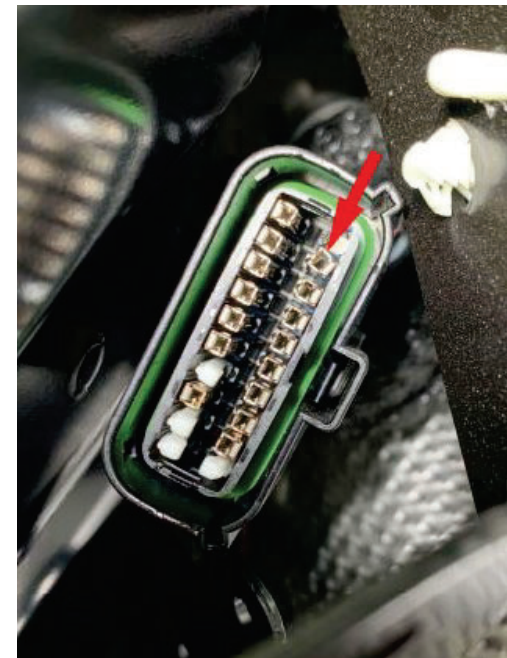
- DTC may be caused by damage to #9 circuit running through connector C31VR/WR.
- Loose or damaged Pin/Terminals for this ground circuit have been found requiring repair to restore circuit function.

- Reference **SSM76303** and complete steps to repair the connector as necessary.
- Raise EPQR and provide photo of any fault identified with the C31VR/WR connector for review.
