Technical Service Bulletin

CC-25-70-01

MODEL: 2025 Karma Revero

TITLE: Hood bump stop adjustment

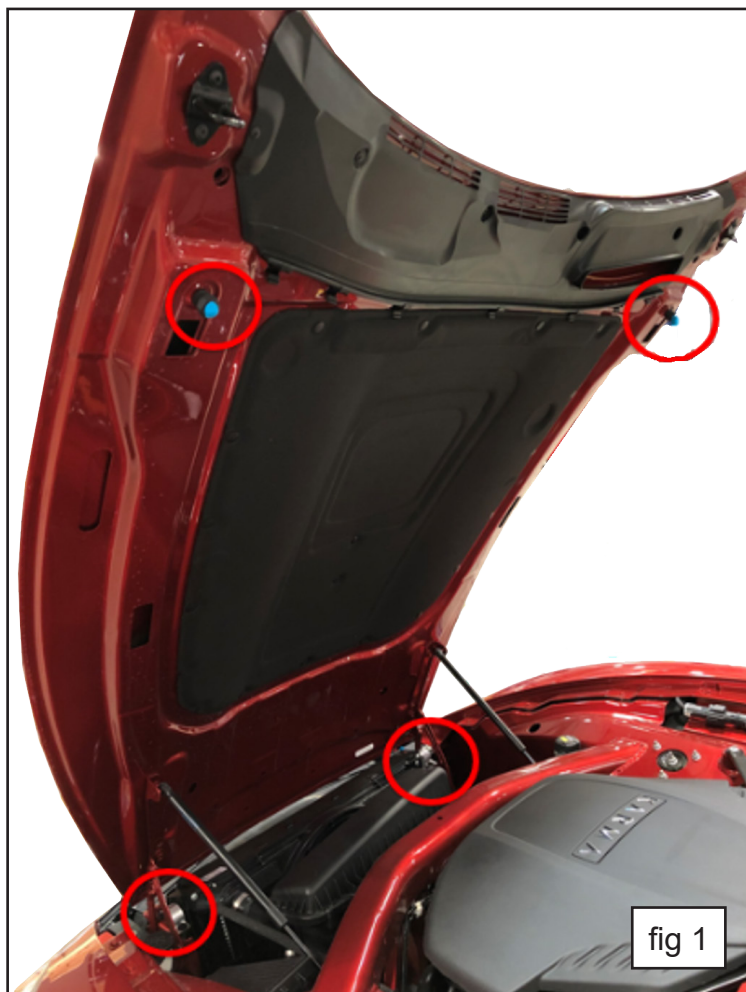
PURPOSE: Remedy for possible wind noise complaint and visible hood flutter while driving

The Vehicle hood may require adjusting the bump stop depth and hinge set screws to remedy and prevent any complaint and prevent fluttering or noise. (fig 1). These fasteners need to have positive contact with the mating interface. It may involve several rounds of trials to reach an acceptable result. Using some modeling clay (such as "play dough") as pressure/contact indicator place it on the surface of the bump stop and set screw. Hinge Set Screws and Bump Stops are set with a little free travel. Plan to adjust and monitor when flutter occurs, to aid in adjusting using clay, or butyl, to see the "squish" and contact area of the hood and related closing stops.
