**Title:** 6090/6091 Connector Damage

**Applies To:** IC Bus® Electric CE Series, International® eMV™ Series

This document will guide the user through identifying a possible damaged 6090/6091 connector due to improper harness routing/clipping.

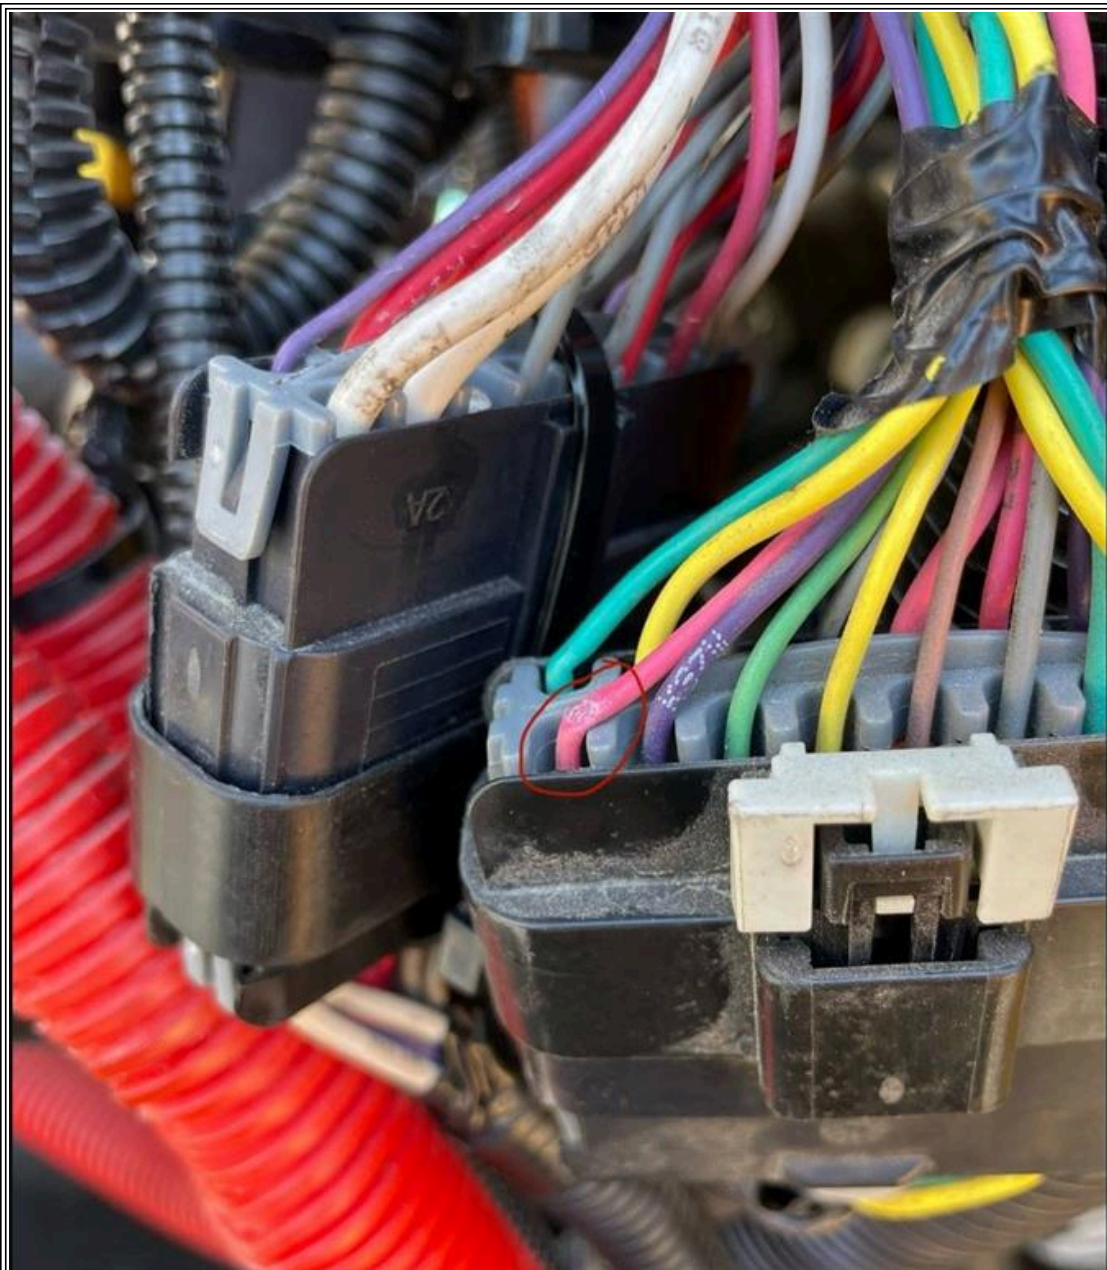
**Figure 1: Wire Tension**

**After repairing connector, terminals or wiring; to prevent re-occurrence cut clipping points to allow slack to the 6090/6091. Resecure as needed.**

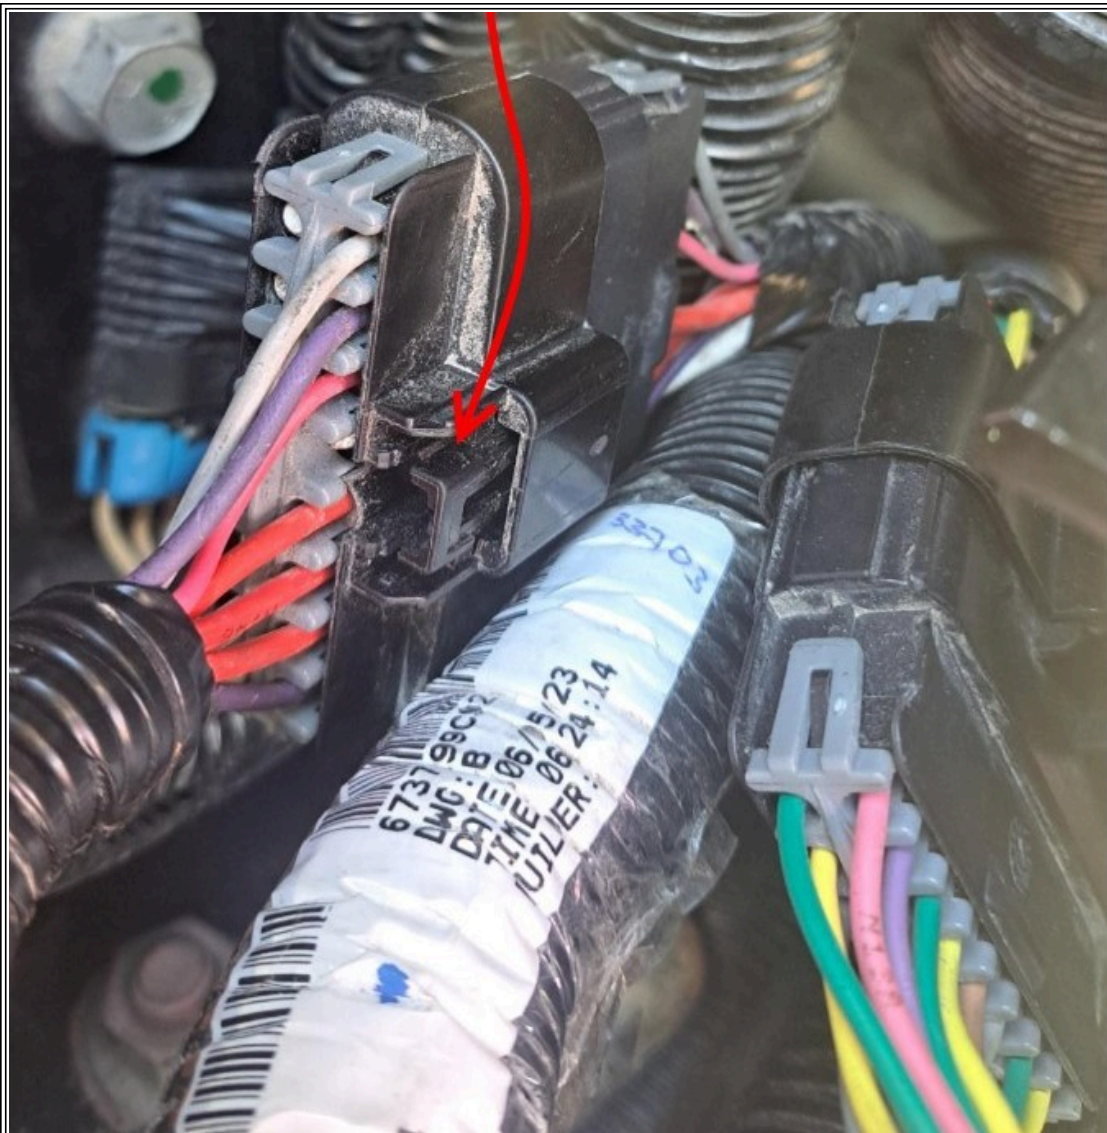
Figure 2: Missing Lock - Connector Pulled Apart

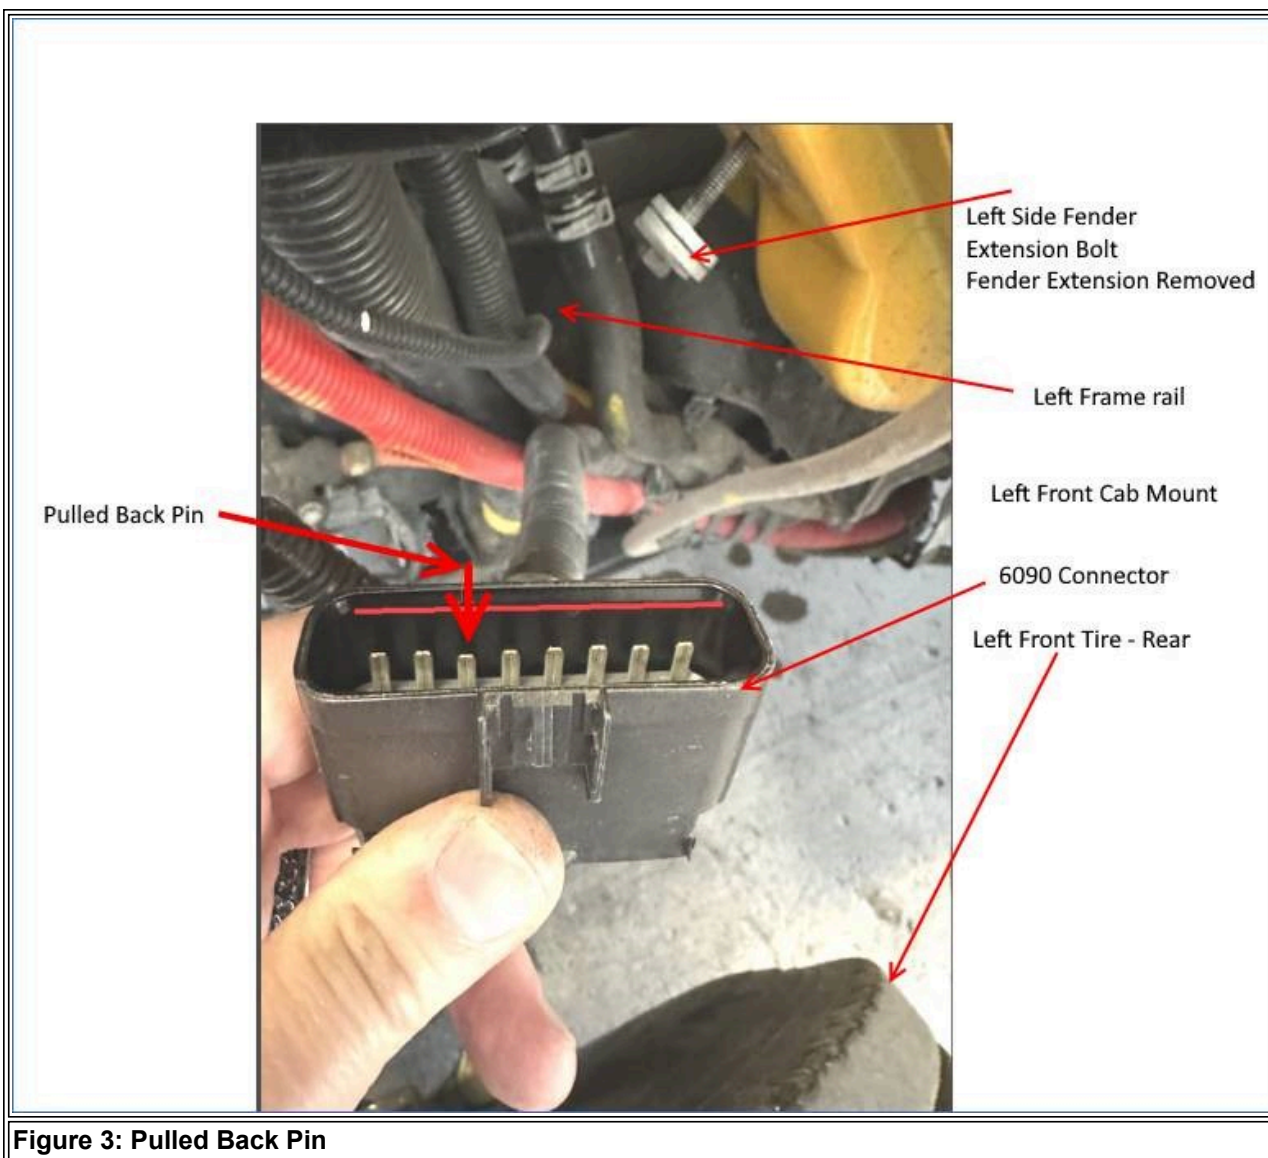
Figure 3: Pulled Back Pin
