Countries: Document ID: IK2200165
Availability: ISIS, FleetISIS, NotSIR Revision: 0
Major System: BUS BODY Created: 4/7/2025
Current Language: English Last Modified: 4/16/2025
Other Languages: NONE Author: Aaron Aguilera
Viewed: 20

Title: Next Gen Bus Incorrect Cluster Lens for Allison Mode Switch

Applies To: Next Gen Bus

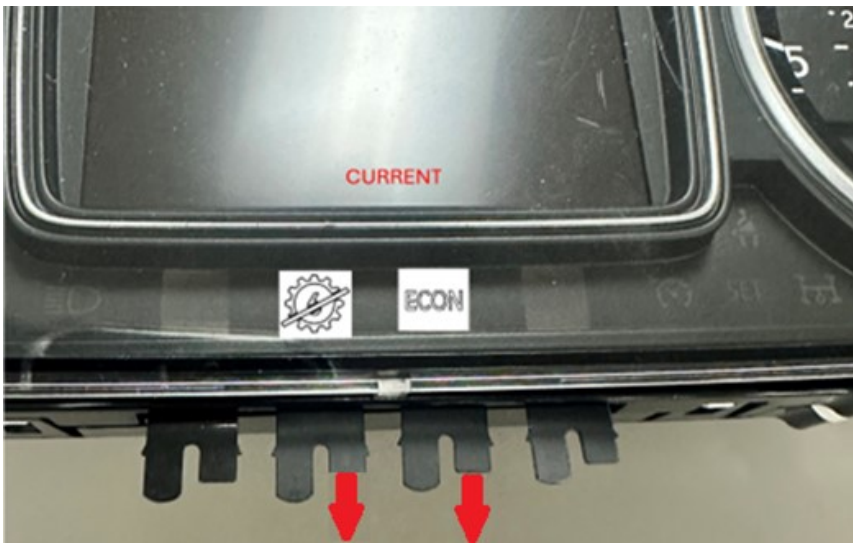
This document will guide the user through correcting mismatched indicator light lenses for vehicles found with the ECON and 6th gear disabled indicators incorrectly illuminating.

The customer can visually observe Allison Switch Mode illuminating 6th Gear Disable.

6. With the gauge cluster removed, locate the warning lamp lenses on the bottom of the cluster. Pull on the tab to remove the lens for position 2 and 3.
