**Document ID:** IK1201505

**Title:** S13 Integrated Powertrain Known Leaks

**Applies To:** S13 Integrated Powertrain

This article is to walk through and assist the technician in diagnosing and repairing some of the known leaks around the **S13 Integrated Powertrain**.

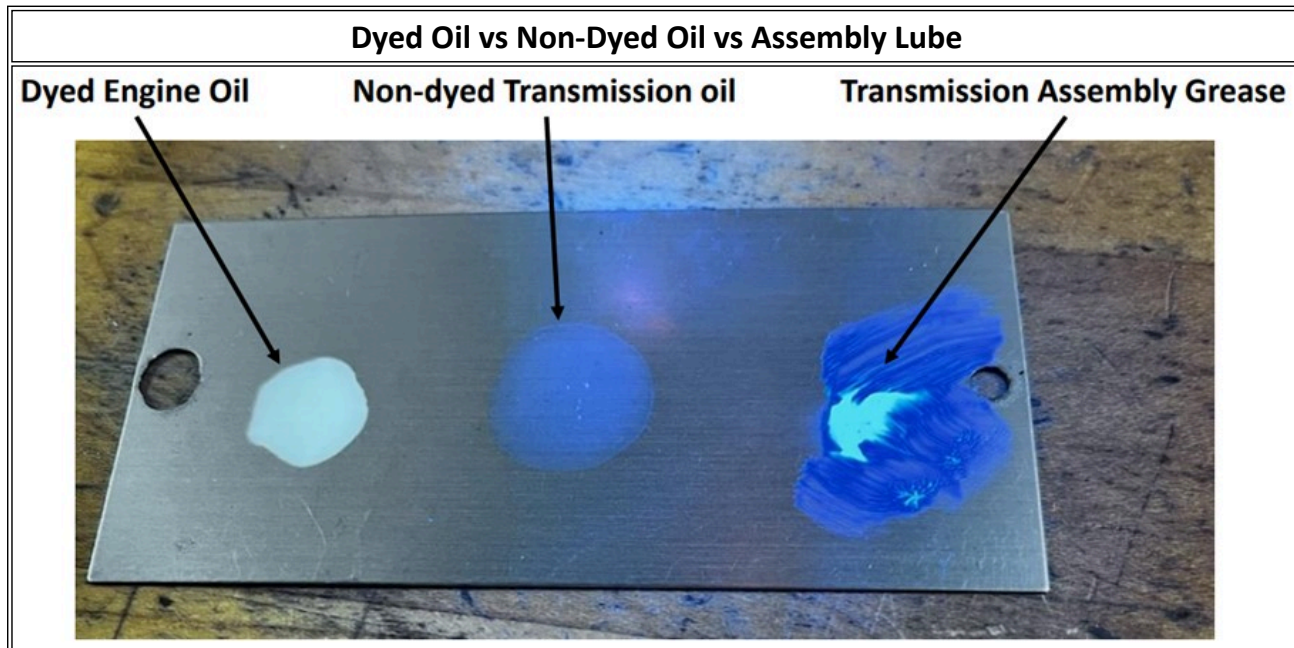
- **Assembly Lube and Fuel:** These can also glow under UV light. Be cautious when identifying the type of fluid. If in doubt, clean the area and monitor for the dye to reappear.
- **UV Light Tips:** If the dye is hard to see, do not add more dye. Instead, try using a different UV light, as each UV light has different wavelengths that react better or worse to various dyes
- Below is an image showing different glow reactions of fluids under UV light.

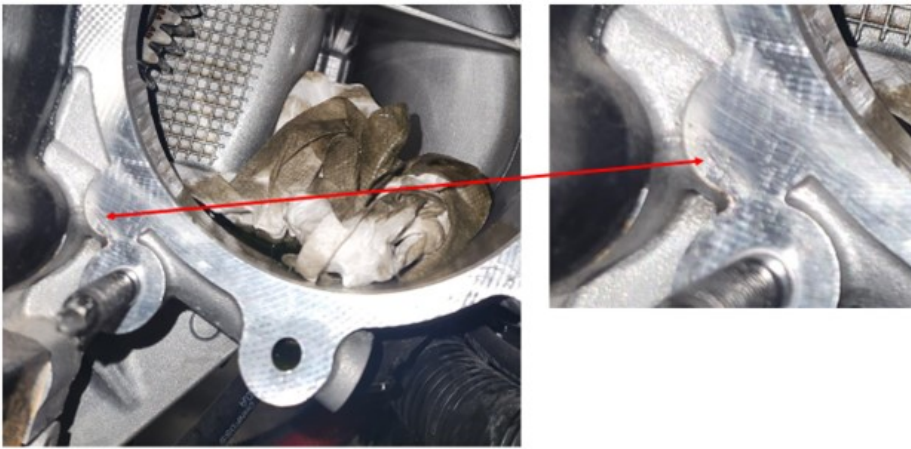
**Figure 1 - Gear Housing Boss Leak**

**Observation:** This will present itself as a leak at the bottom of the gear housing, right under the air compressor mounting, and could be easily mistaken for an air compressor gasket leak. Please reference the pictures below to assist in identifying if the leak is present at the gear housing boss section. **Keep in mind** that oil can travel down and may originate higher in the area. If oil is observed at the gear housing to block joint by the

**NOTE:** Below Figure 1, the air compressor is removed to assist in showing the area in question; the compressor does not need to be removed to inspect for the boss leak.

**Repair Direction:** If the specific leak is observed as depicted in the examples above, please follow [IK1201501 - S13 Gear Housing Leak \(By The Air Compressor\)](#).

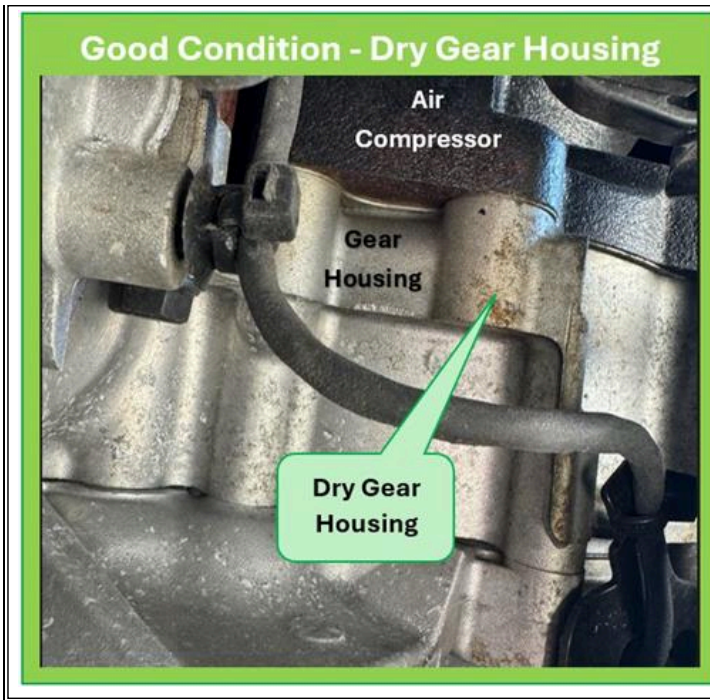
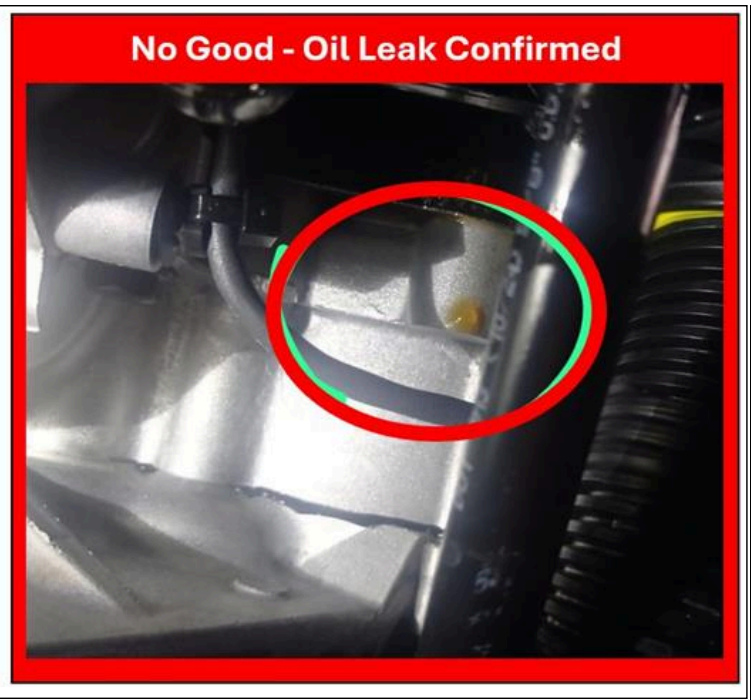
**Figure 1 - Air Compressor Mounting**

**Observation:** Oil drips may form right under the air compressor mounting. Additionally, drips could start trailing back towards the gear housing and forming at the bottom of the gear housing. Reference the image below. **Keep in mind** that oil can travel down. Ensure there is no oil following the gear housing to block joint alongside the air compressor (reference [1.7 Gear Housing Joint Between Air Compressor and HP Fuel Pump](#)) or originating from the machined boss area (reference [1.1 Rear Gear Housing Boss Leak Near Air Compressor](#)).

1. Remove the air compressor and discard the gasket.
2. Inspect the lower mounting studs if any oil appears to be leaking past the threads of the stud - if so, remove the stud, clean the threads, apply blue loctite and reinstall the stud (torque to 10Nm).
3. Install new gasket, torque the 4 nuts to 45Nm in two stages (1st stage torque all to 10Nm, 2nd stage torque all to 45Nm) following the pattern shown in the image below (Air Compressor Mounting - Figure 2).

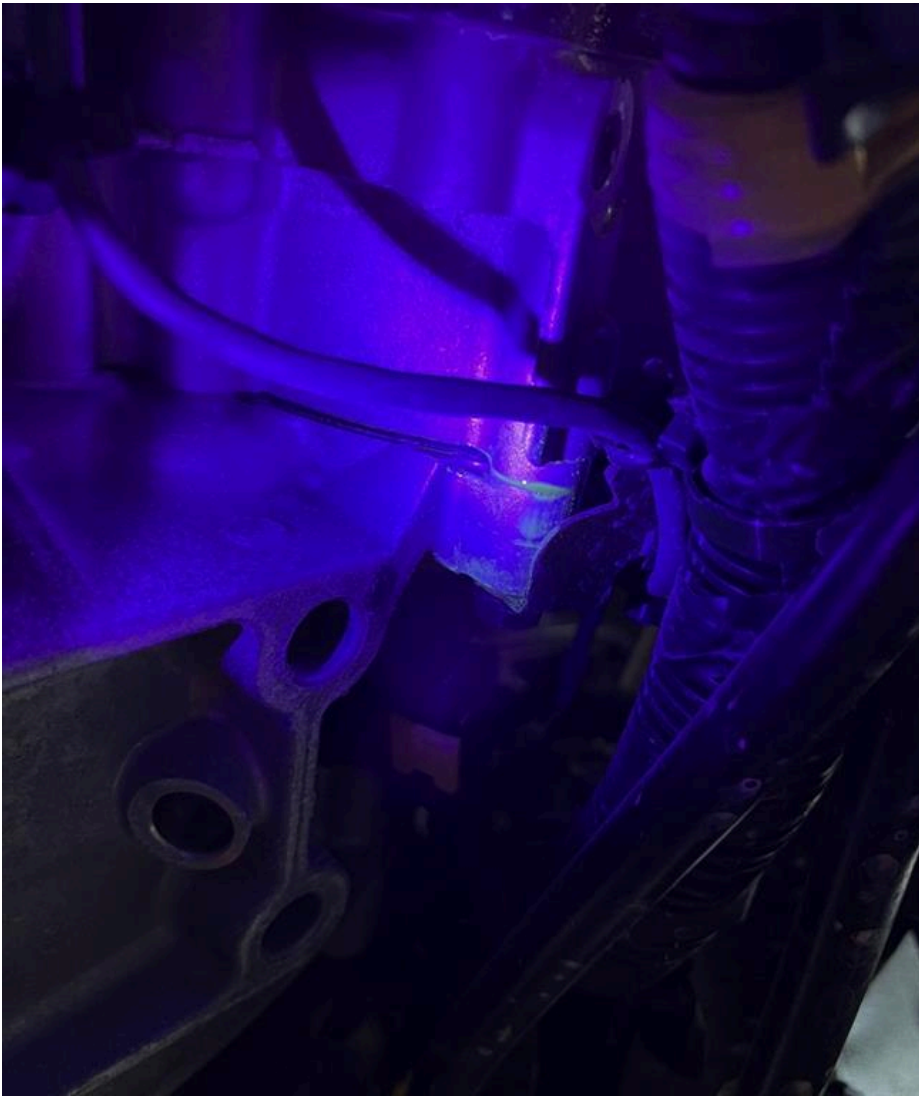
**Figure 1 - Flywheel Housing Leak**

**Observation:** The leak is typically noticed on the driver side, bottom of the engine. The oil will leak down the seam between the flywheel housing and the gear housing, collecting on the lower bolt (right by the harness support bracket). Reference the image below (Flywheel Housing Leak - Figure 1).

**Repair Direction:** Follow the procedure in the manual to remove and reseal the flywheel housing.

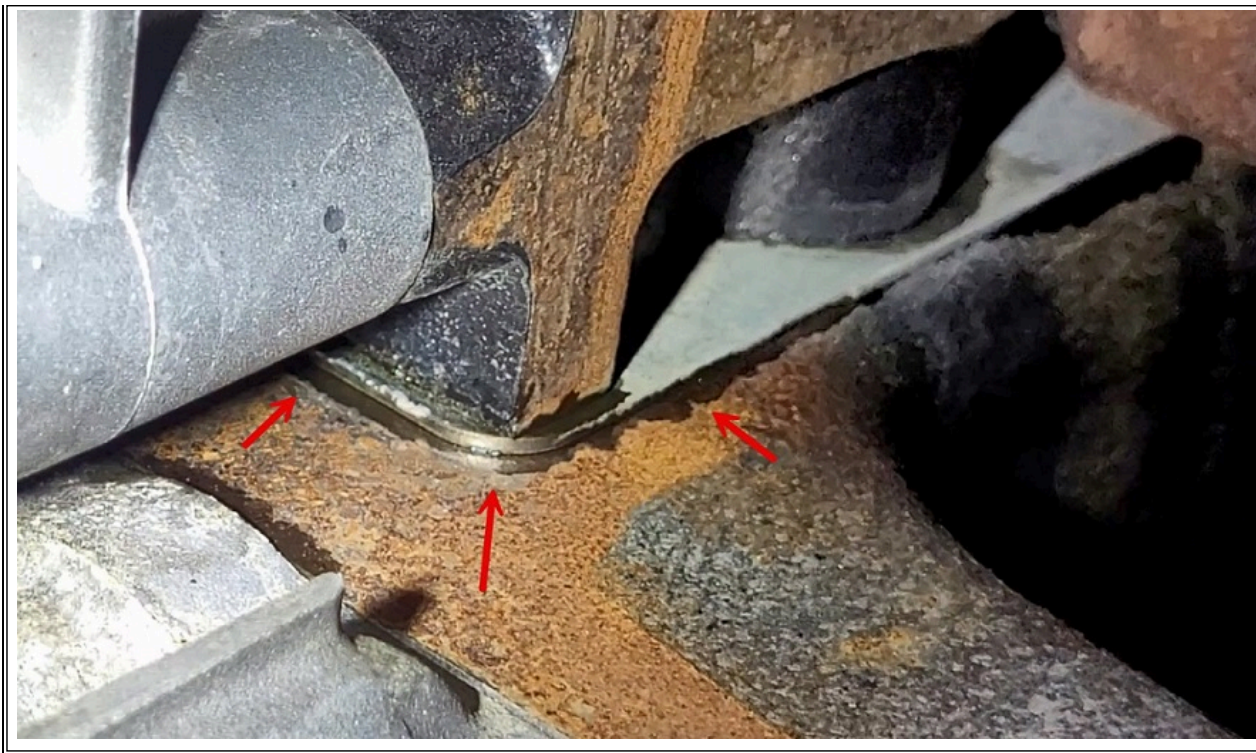
**Figure 1 - Cylinder Head Gasket Oil Leak**

**Observation:** Oil collects and wets the cylinder head block deck, following the outline of the gasket, commonly on the passenger/exhaust side of the engine. To avoid confusing it with a coolant leak, use a UV light to verify the type of fluid. Reference the picture below (Cylinder Head Gasket Oil Leak - Figure 1).

**Repair Direction:** If the leak is observed at the head gasket area, please take clear pictures identifying the source of the leak and open a technical support case file for the latest repair direction, provide the pictures in the case

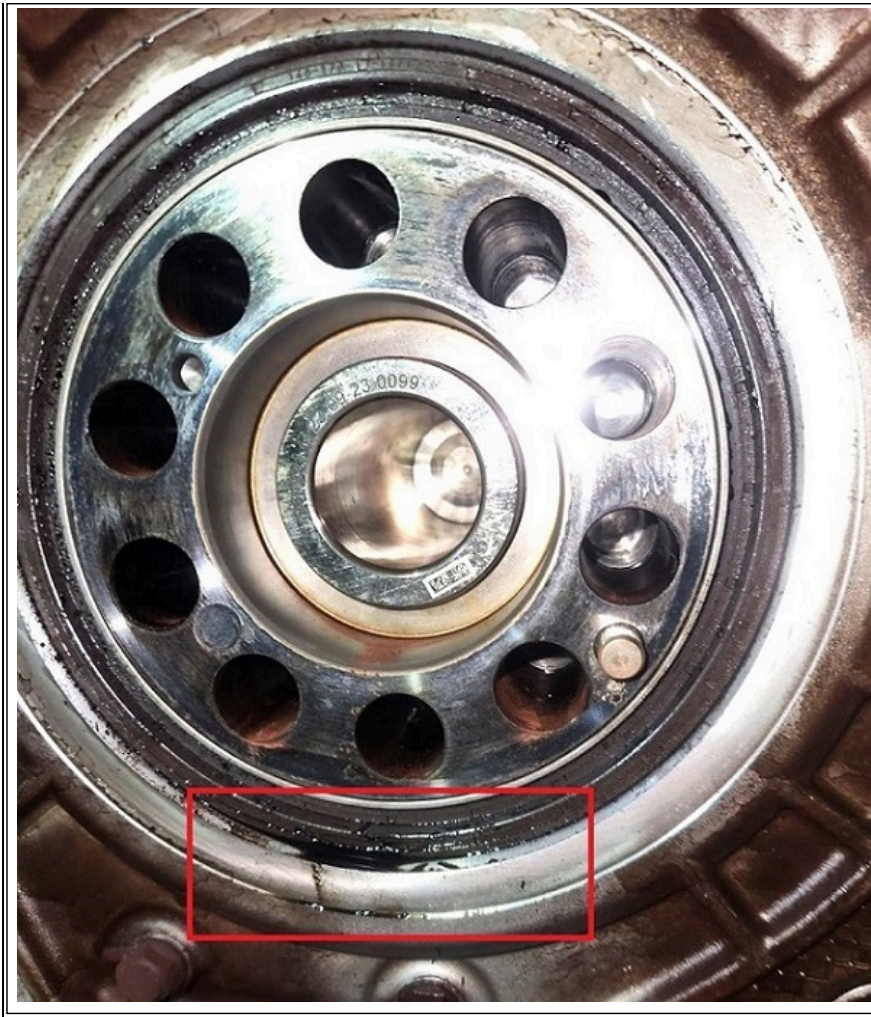
**Figure 1 - Rear Main Seal Leak**

**Observation:** Oil is observed seeping out through the clutch inspection port. When the plug is removed, some accumulated oil can be seen on the plug if the leak is severe. Additionally, since the clutch spins at high speeds, the air turbulence may coat the entire area with oil, making it difficult to determine the source of the leak.

After transmission removal, check the rear main crankshaft seal; oil will be pooling at the bottom of the seal as shown in the Figure below. Inspect the flywheel bolts removed to ensure the threads of the bolts are dry. If the flywheel bolt threads are wet, proceed to the next section in this article (**1.6 Rear Main Crank Gear Bolt Holes**).

**Repair Direction:** Follow the procedure in the manual to remove and reseal the Rear Main Crankshaft Seal.

- If the clutch is contaminated with oil, the clutch disc and cover will have to be replaced as well

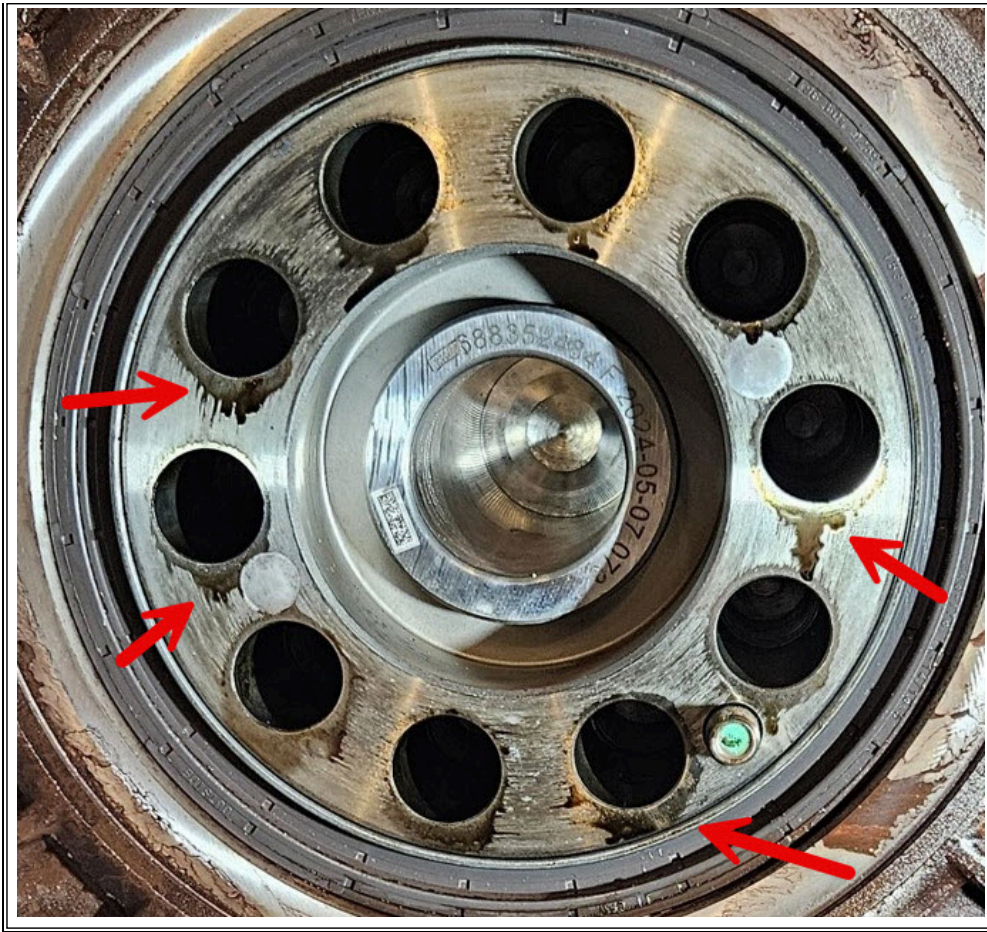
**Figure 1 - Crankshaft Gear Bolt Hole Leak**

When the flywheel crankshaft gear bolts are removed, wetness on the threads will be observed. Additionally, when looking at the bolt holes, oil can be seen inside, and some oil residue might be trailing directly aligned with the removed bolt heads on the face of the crankshaft gear. Reference figures 1, 2, and 3 below.

**Repair Direction:** If the leak is observed at the crankshaft gear bolt holes, please take pictures showing wetness in the bolt holes to the best of the ability and open a technical support case file for the latest repair direction, provide the pictures in the case

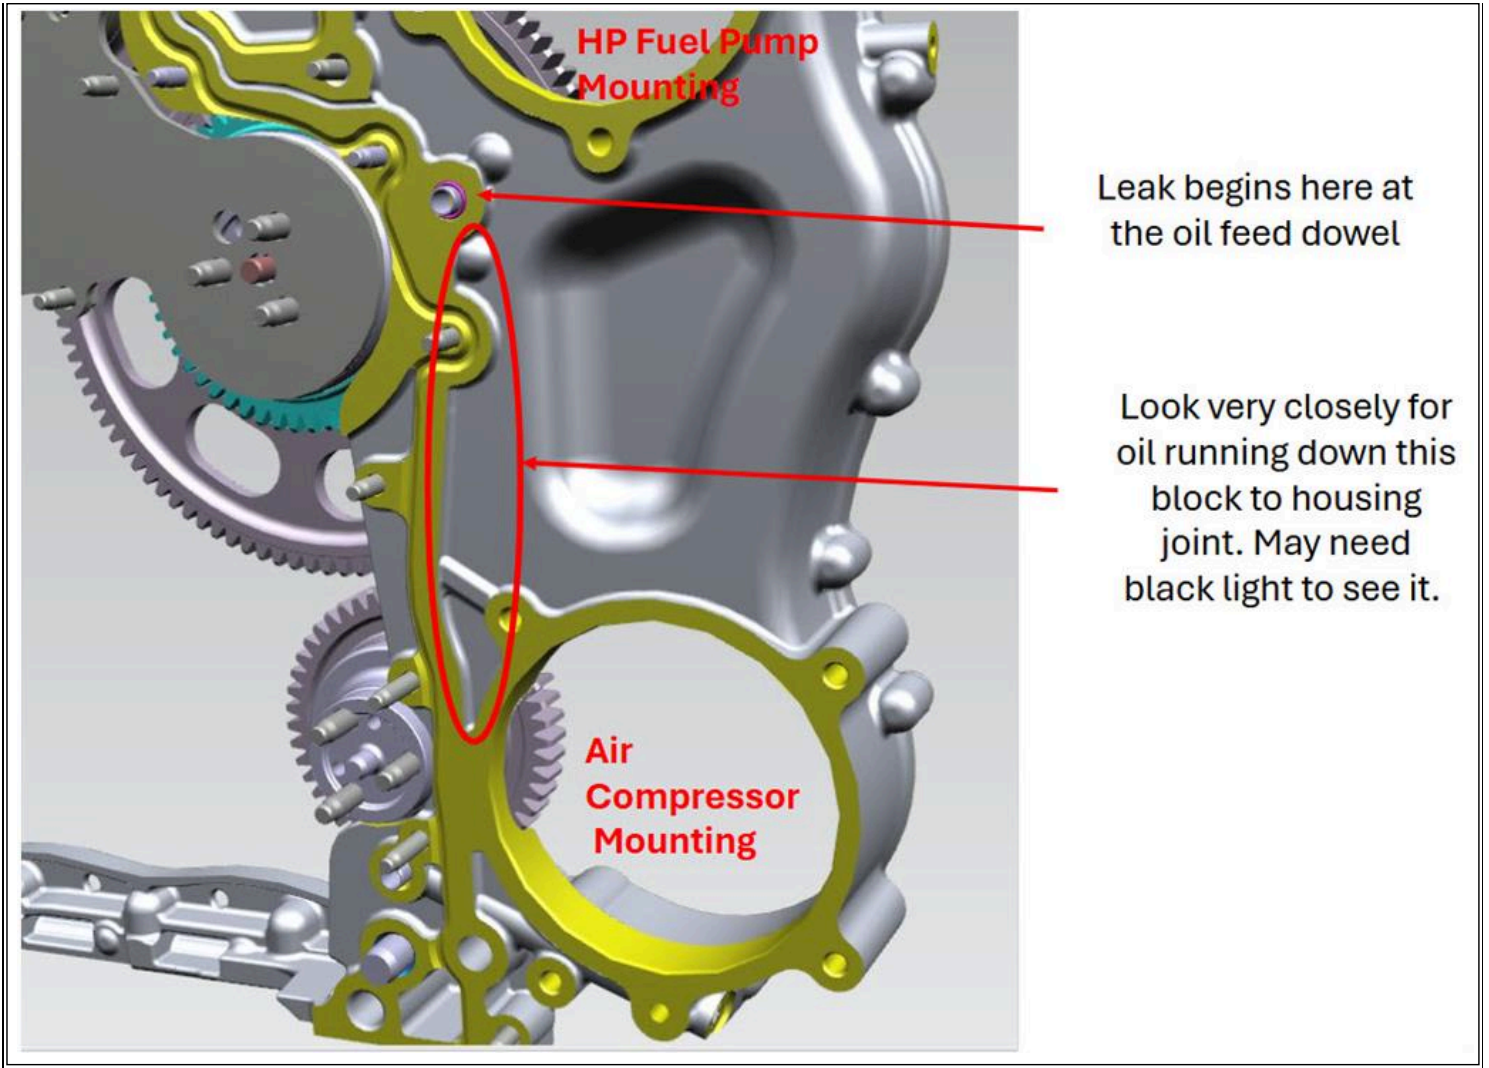
**Figure 1 - Gear Housing Joint Between Air Compressor and HP Fuel Pump**

**Observation:** An oil leak would be observed near the bottom of the gear housing, near or under the compressor, following the joint seam between the gear housing and the block. Using a UV light, focus on the joint seam behind and above the air compressor but below the high-pressure fuel pump. Reference figure 1 below. This might require a borescope camera with UV light to see the leak clearly.

**Repair Direction:** If this specific leak is observed between the air compressor and the HP fuel pump at the gear housing to block joint, please take pictures identifying the source of the leak (borescope may be needed) and open a technical support case file for the latest repair direction, attach pictures to the case

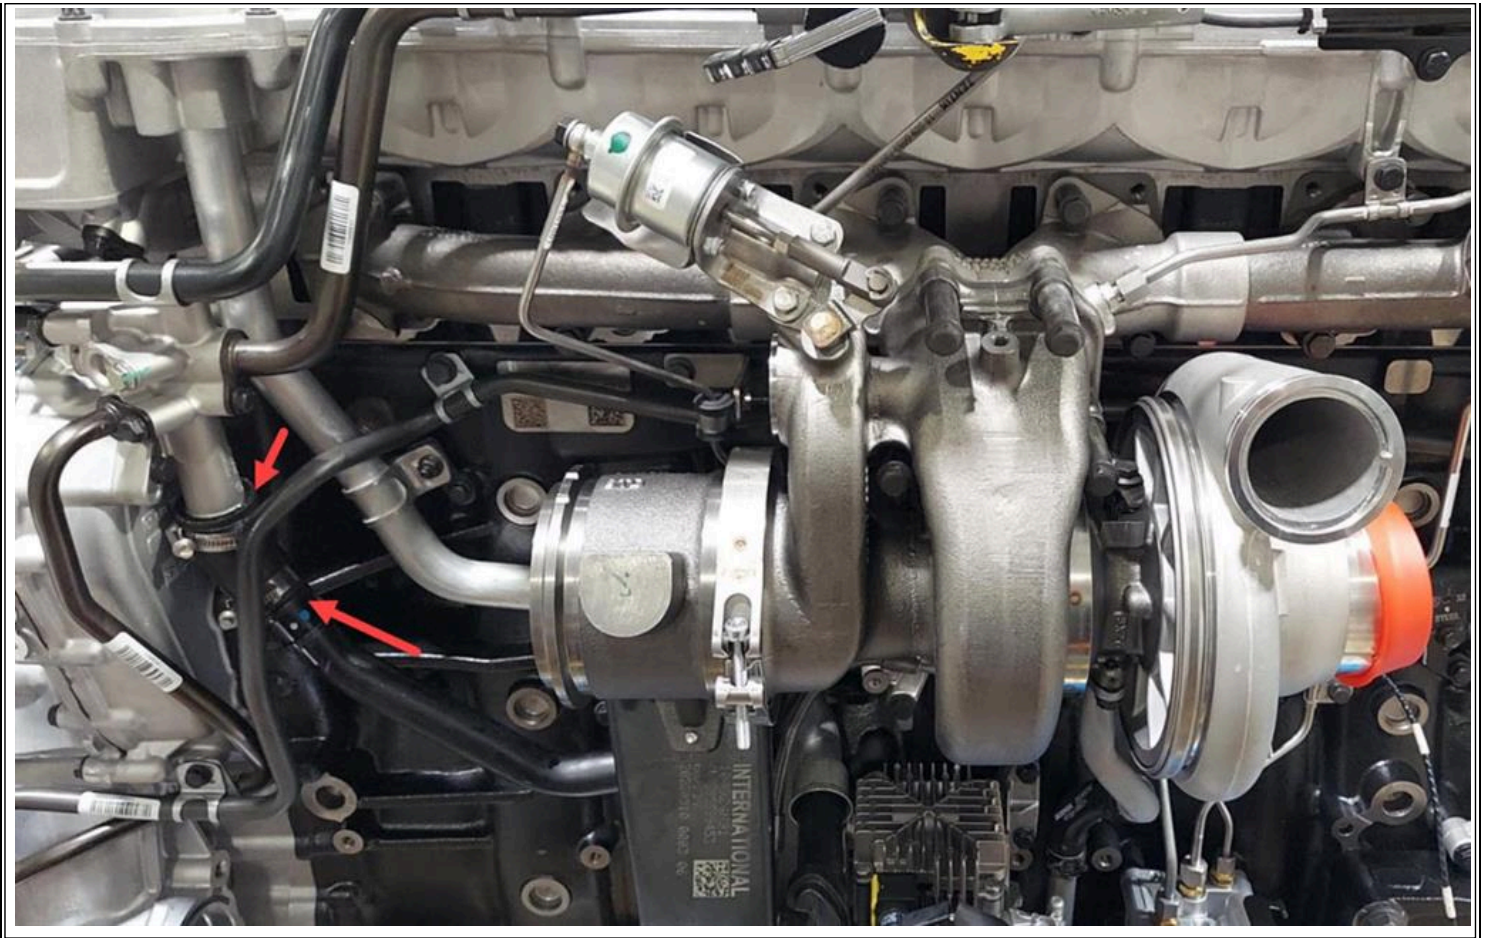
**Figure 1 - Coolant Leak Behind the Turbo**

**Observation:** The complaint and observation would be a coolant leak and coolant drips on the passenger side towards the rear of the engine. The coolant leak originates at one of the two clamps (upper and/or lower) at the rear coolant rubber tube leading to the thermostat housing. Please reference figures 1 and 2 below for the location of the leak.

**Repair Direction:** If the leak is observed behind the turbo at the rubber boot in either the upper or lower clamp, follow [IK1201507 - S13 Leaks at the Coolant Return Pipe Hose Clamps](#)

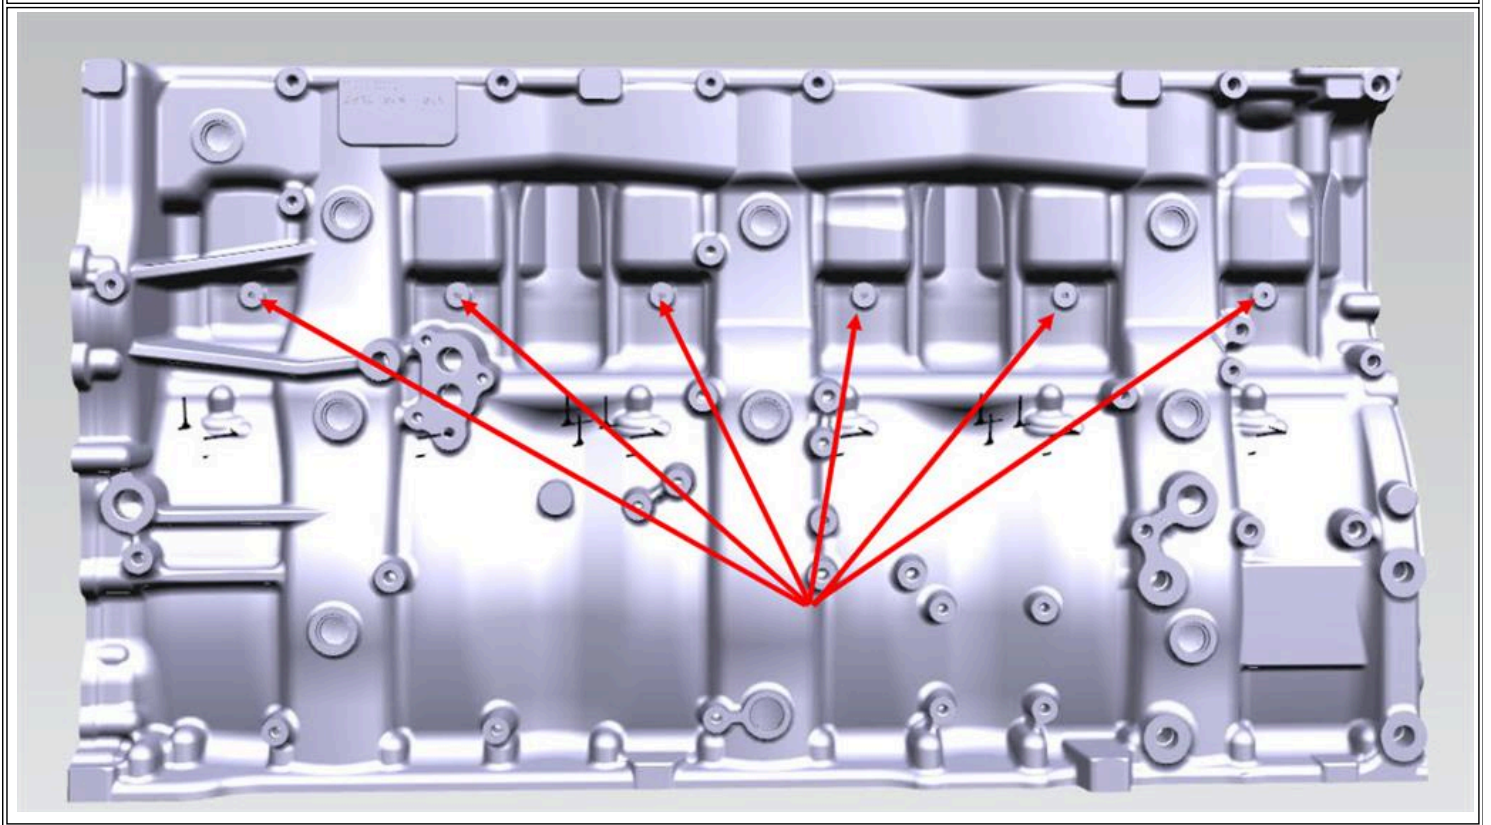
**Figure 1 - Weep Hole Locations**

**Observation:** The complaint would be losing coolant and possible coolant staining on the passenger side of the block, right below the weep holes. The weep holes are located at about mid-height of the engine, with a single weep hole per cylinder (reference figure 1 for weep hole locations). This leak indicates a leak past a cylinder liner O-ring. Reference figure 2 below to help identify the weep hole leak.

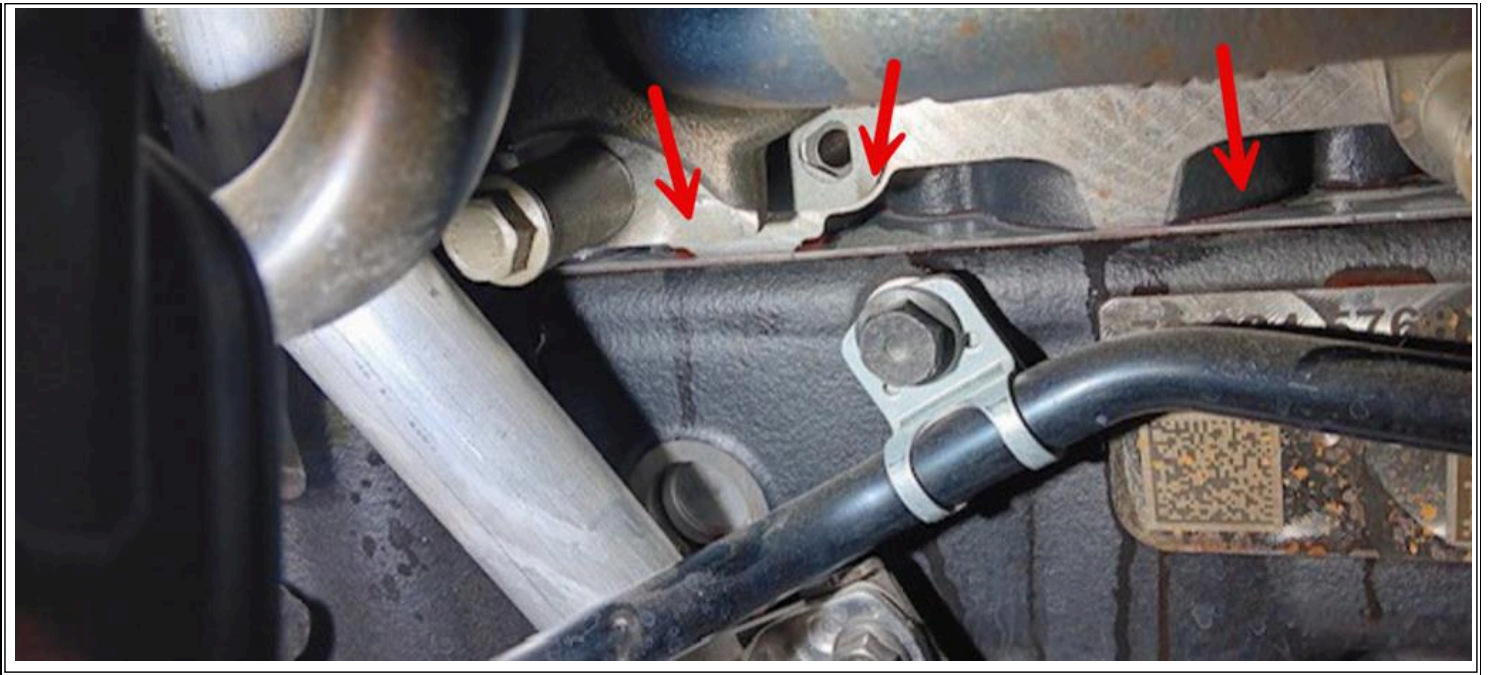
**Figure 1 - Coolant Leak at the Cylinder Head**

**Observation:** The complaint would be losing coolant, with trails and coolant staining commonly on the passenger side of the engine block, right below the cylinder head deck. Reference figures 1 and 2 below for leak examples.

**Repair Direction:** If the coolant leak at the cylinder head is observed, please take pictures identifying the source of the leak and start technical support case file for the latest repair direction, attach pictures to the case

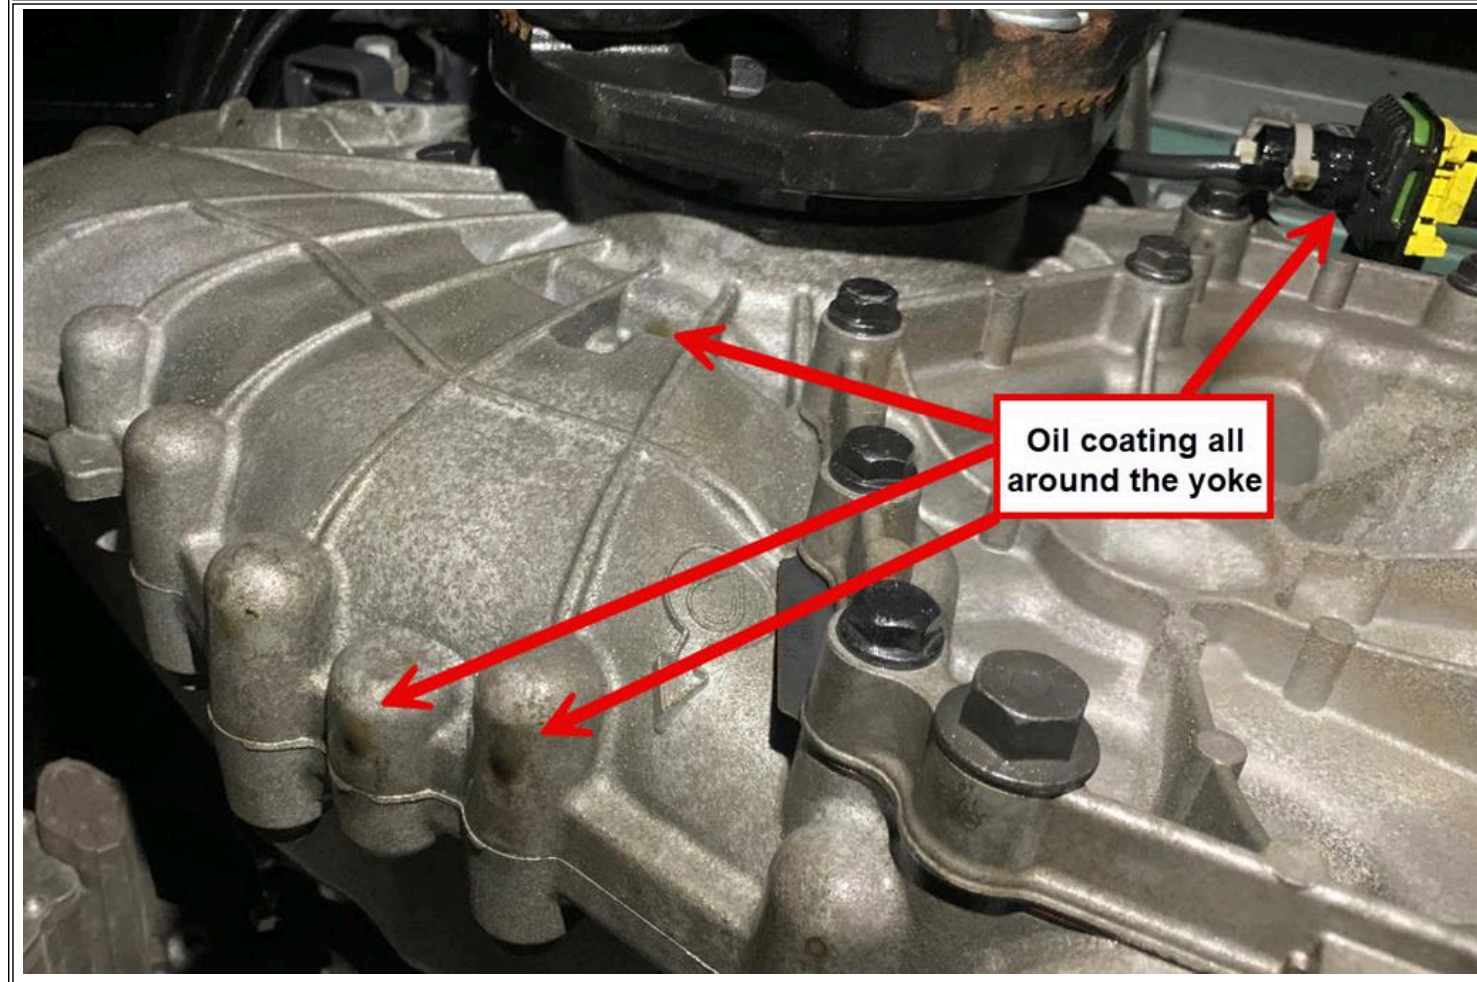
Figure 1 - Rear Output Yoke Leak

**Observation:** The complaint would be a leak at the rear of the transmission along side of possible fault code being present and light on the dash. Leak would originate at the rear output of the transmission indicating the rear output seal leaking, and as the yoke spins, it will throw oil around in the circular motion covering components below and above with oil making everything seem oily and damp (reference figures 1 and 2).

- If the vehicle only has a output seal leak without fault codes, excessive play, or any metal noticed, go to: S13 Integrated Powertrain Manual --> 13 - Transmission --> Automated Manual Transmission --> International T14 Transmission --> Component Replacement Procedures --> Output Flange and Output Flange Seal Removal / Output Flange and Output Flange Seal Installation
- If fault 191-2 is present, excessive play on the output is noticed, and metal is found on the output speed sensor, please take pictures of the metal found, proceed with opening a technical support case file for the latest repair directions, and attach pictures to the case

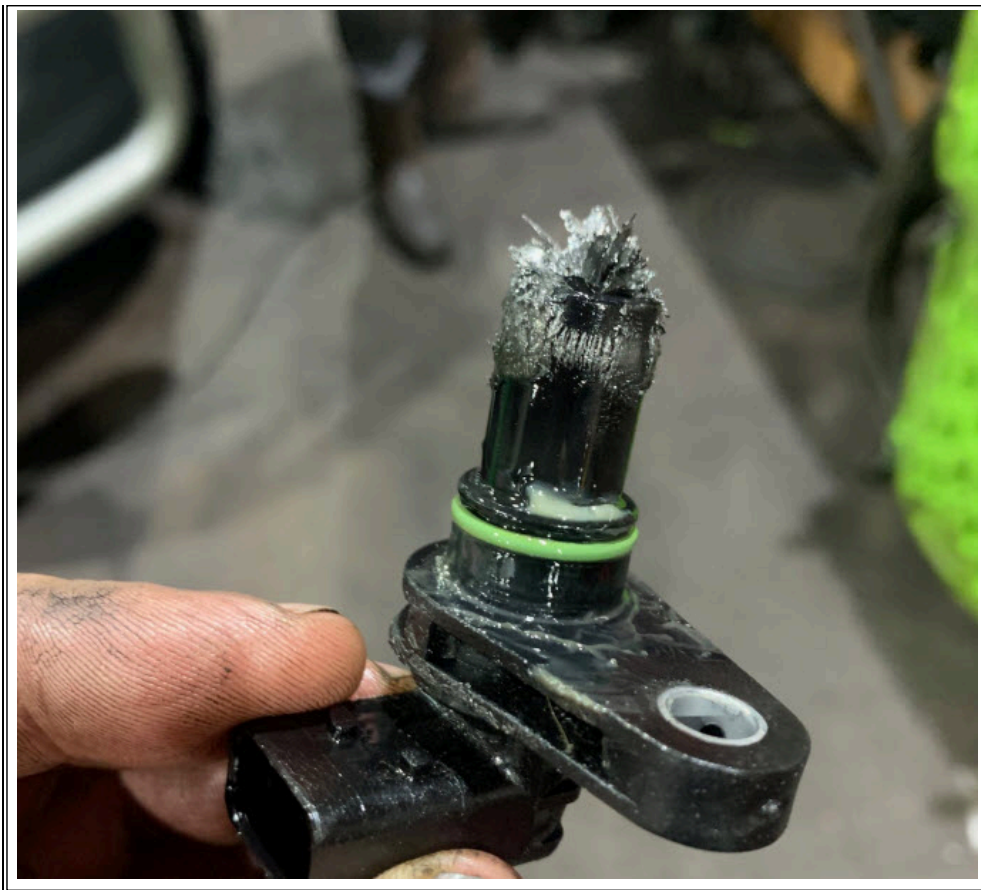
Figure 3 - Output Speed Sensor Metal Debris

**NOTE:** If the vehicle has logged SPN 191 FMI 2 fault code, check the output yoke for play, pull the output speed sensor for inspection and check if there is any metal noticed on the tip of the sensor (reference figure 3 below)

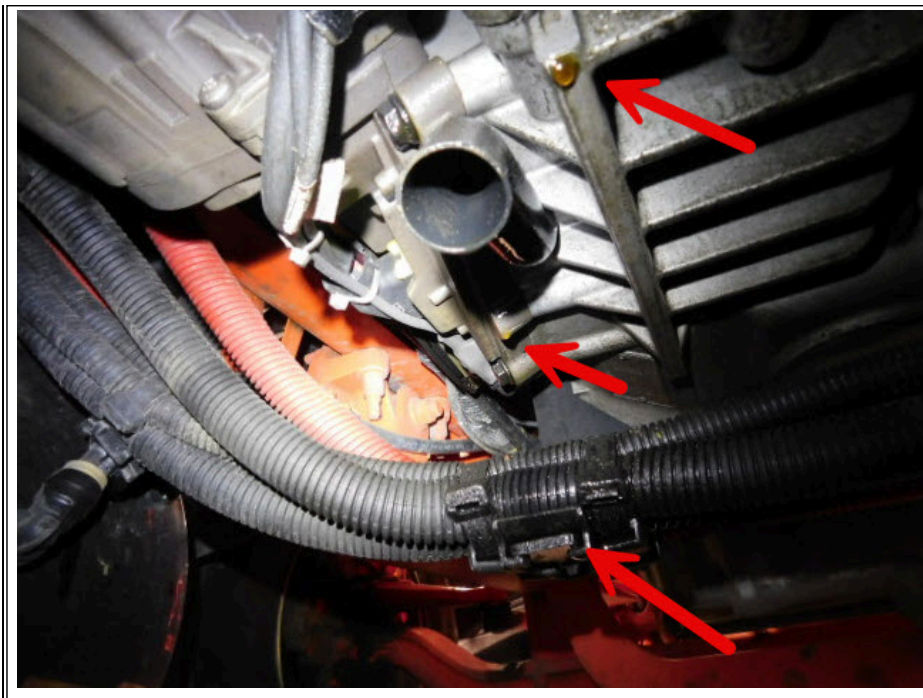
**Figure 1 - Oil Leak at the ECA**

**Observation:** Vehicle would have visible leak under the transmission originating from the driver side. Oil may be seen running down the ECA (Electronic Clutch Actuator) and collecting at the bottom of the transmission. Refer to figures 1 and 2.

- Gather as clear pictures as possible showing the leak.
- Remove the fill plug and note down the oil level if it seems low.
- Remove the ECA and inspect for wetness at the pointed galley in Figure 3 - ECA Removed, take any pictures that may showing the leak/wetness.
- If wetness is observed, remove the main valve body assembly, inspect the condition of the green O-Ring as called out in Figure 4 - Main Valve Body Removed. If the o-ring is found damaged or missing, replace it and reassemble the transmission following Service procedure outlined in the manual. Reference the following NOTE below

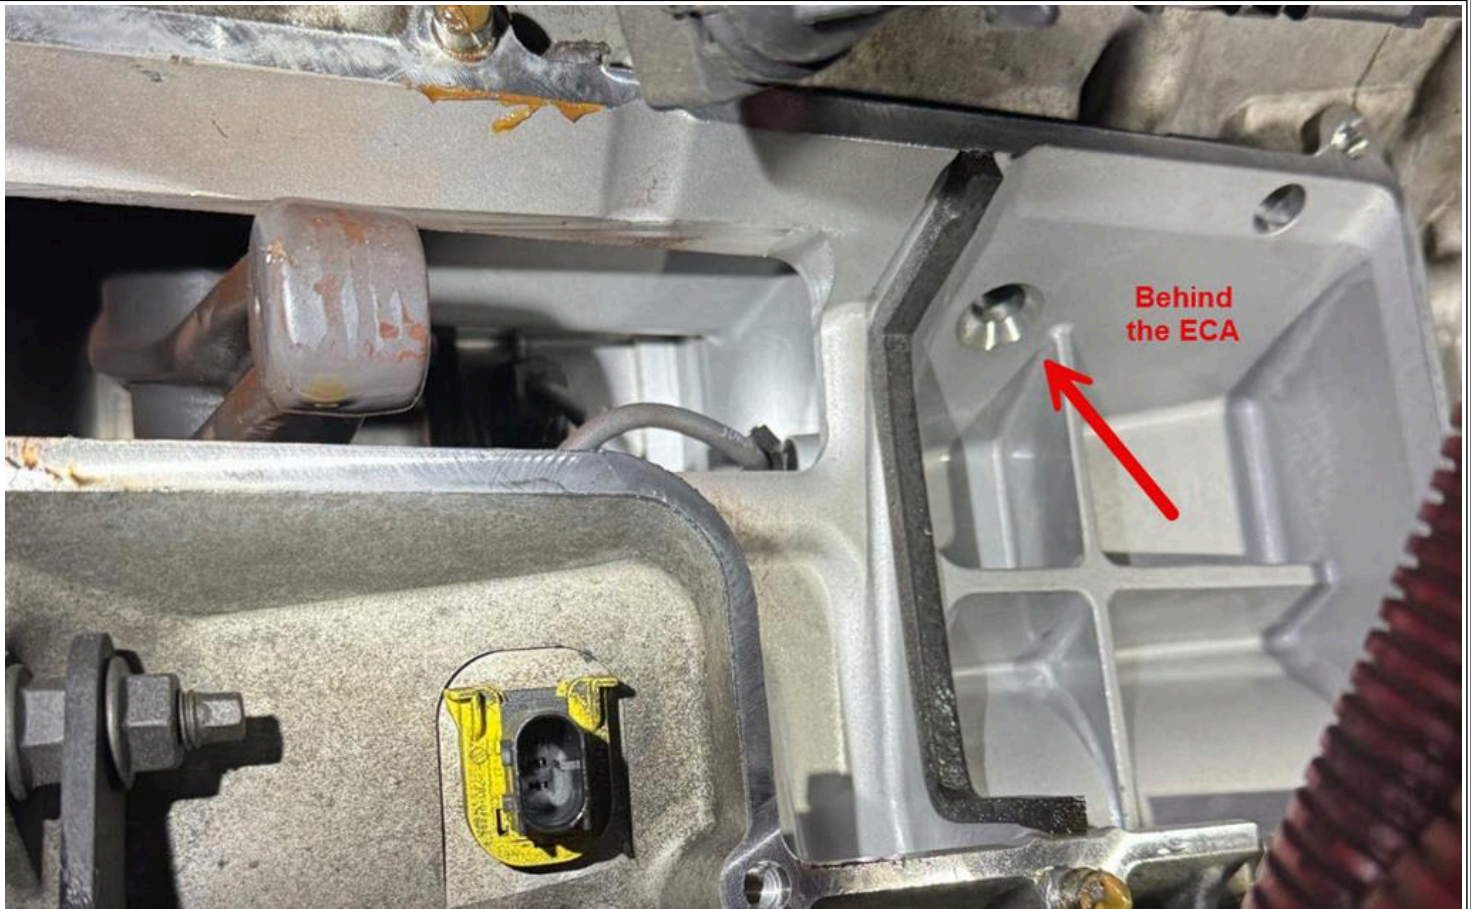
**Figure 3 - ECA Removed**

**NOTE:** There will be oil present in the housing behind the main valve body assembly, this is normal. System is designed for shift rails to pass slight amount of oil so they self lubricate, oil that collects in the housing then flows back into the sump through one of the drilled passages. The galley with the green o-ring called out in Figure 4 is the same galley behind the ECA as called out in Figure 3. If the green

**o-ring is left out, not installed properly, or gets pinched due to slippage during installation process, the collected oil will run down into the ECA area and this will result in an external transmission leak.**

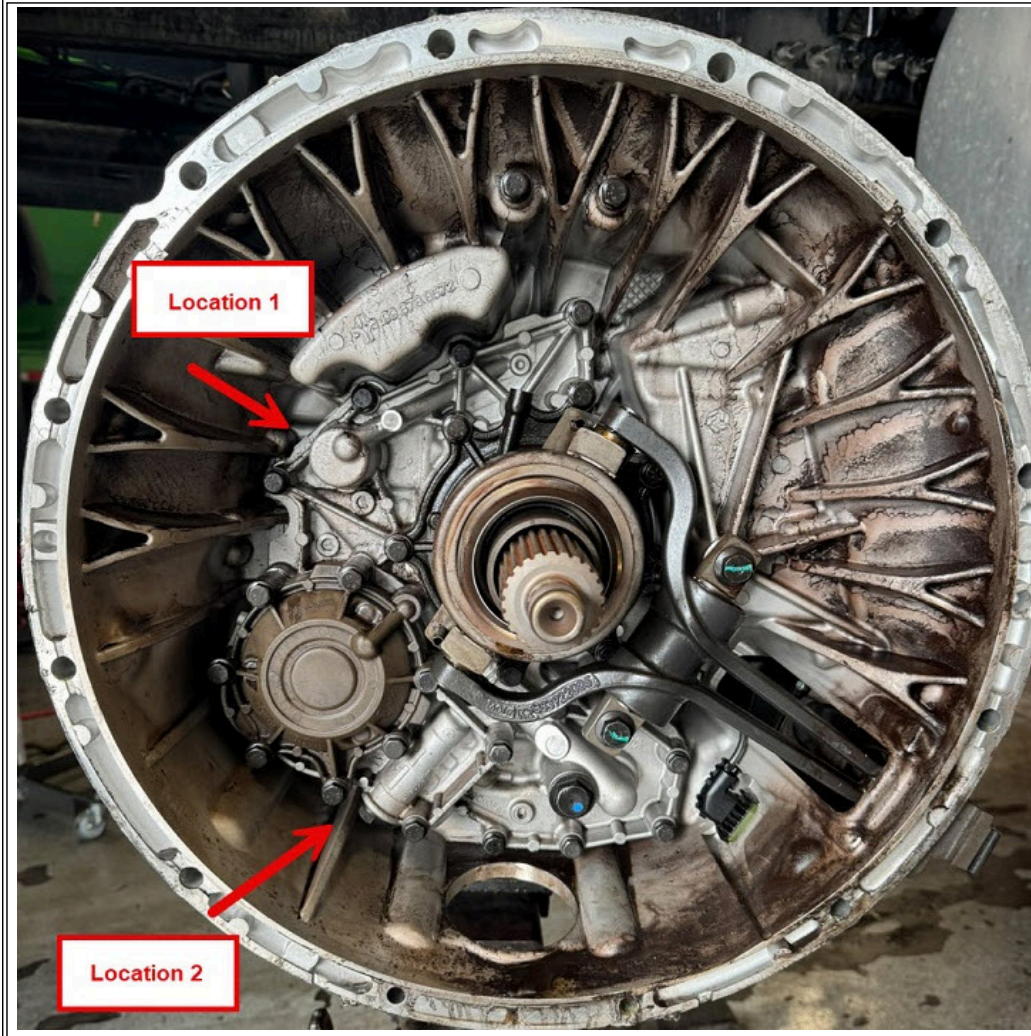
Figure 1 - Possible Leak Locations Behind the Front Cover

Once it is confirmed that the oil is transmission oil, the transmission will need to be removed for further inspection. Oil is commonly observed in one of the 2 locations shown in figures 1 and 2. This leak would be coming from behind the front cover as it mates to the transmission case

**Repair Direction:** If the leak is observed behind the transmission front cover where it mates to the transmission case, please take pictures trying to identify the source to the best of the ability and open a technical support case for the latest repair directions, attach pictures to the case

**NOTE:** If the clutch is contaminated with oil, clutch disc and cover will have to be replaced as well.

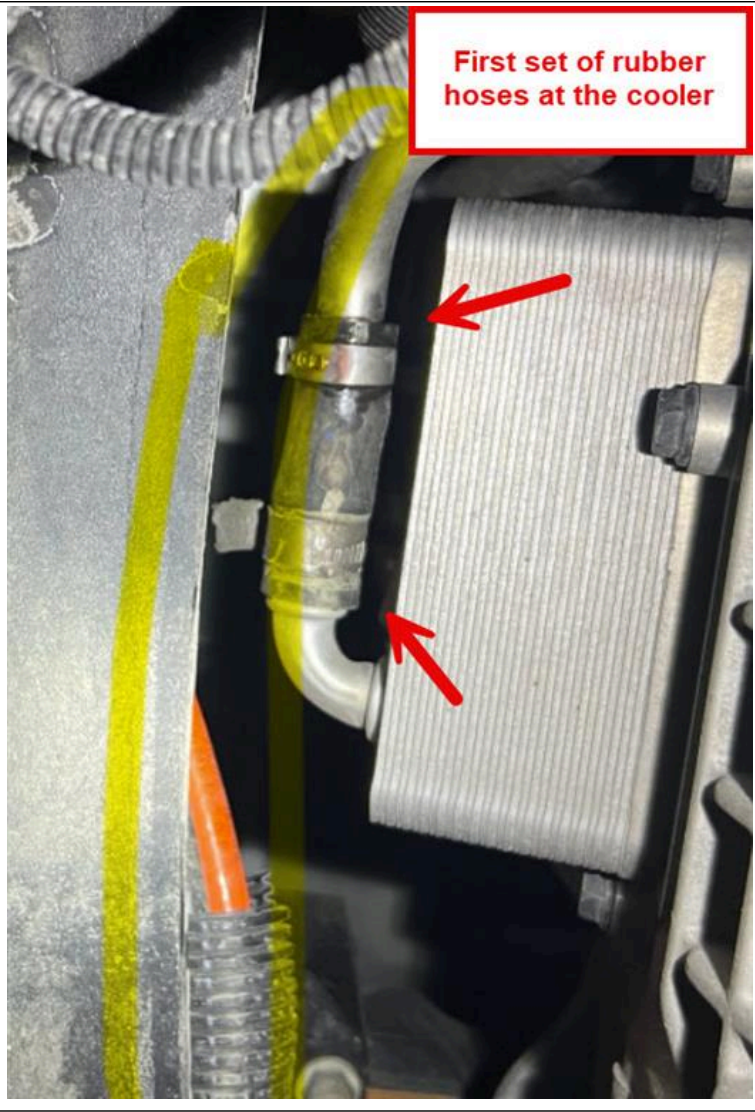
**Figure 1 - Transmission Cooler Hose Leak**

**Observation:** Complaint and observation: Coolant loss and an observed leak on the passenger side of the transmission. Coolant could be seen seeping through at the joints of rubber coolant hoses and at the hard lines near the transmission cooler area. There are two sections of rubber hose on the supply side of the cooler and two sections of rubber hose on the return side of the cooler, making a total of four rubber hoses that could leak at the joints. Refer to figures 1, 2, and 3.

**Repair Direction:** If the leak is observed at any of the rubber hose joints near the transmission cooler, please reference to IKnow article [IK1300194 - S13/T14 Transmission Cooler Pipe or Clamp Leak Troubleshooting and Repairs](#).
