**WRCO - Checking Right-Hand Intake Manifold on Turbocharger Replacing if Necessary (Workshop Campaign)**

Model Year: **As of 2020 up to 2022**

Model Line: **911 Turbo/ Turbo S (992)**

Concerns: **Right-hand intake manifold on turbocharger**

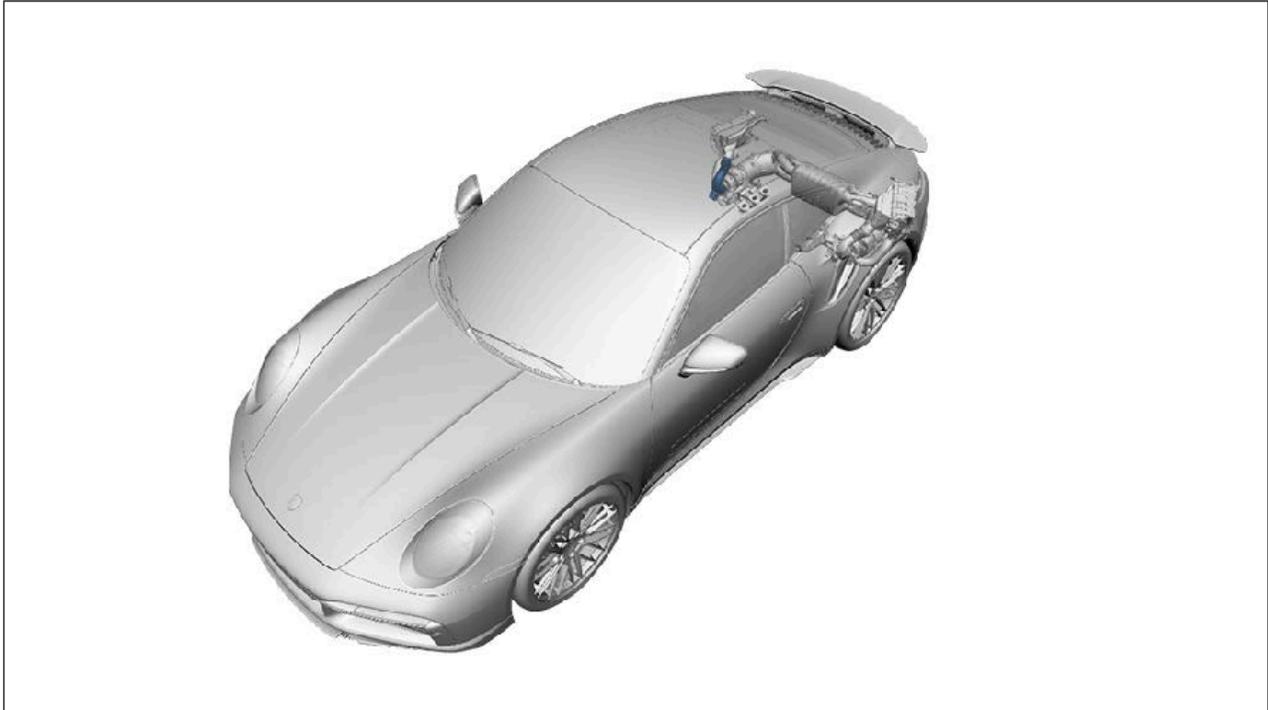
*Installation position of right-hand intake manifold on turbocharger*

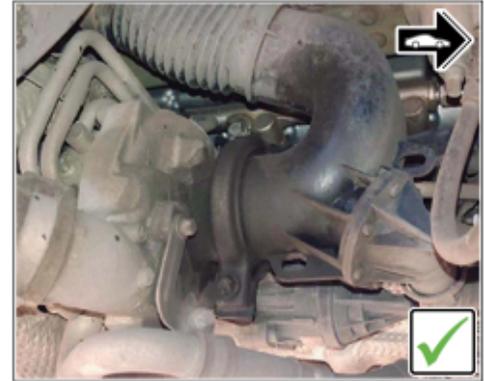
"Sweating" or slightly oil-moist contamination in the area of the turbocharger or intake manifold does not constitute a defect and does not entitle the right turbocharger intake manifold to be replaced.  
⇒ *Right-hand intake manifold on turbocharger - OK*

*Right-hand intake manifold on turbocharger - OK*

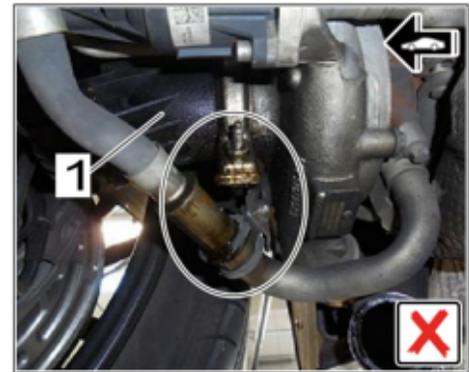
- 2 Check whether oil **droplets** are present on the right turbocharger intake manifold on the right ⇒ *Right-hand intake manifold on turbocharger - not OK -1-* and on the turbocharger housing.

*Right-hand intake manifold on turbocharger - not OK*

Assessment		Action
(✓)	Only oil sweating is visible on the turbocharger intake manifold and turbocharger housing, but <b>no oil droplets</b> .	<b>The right-hand intake manifold on the turbocharger is OK.</b> Continue with Step 3.
(x)	Oil <b>droplet</b> formation can be seen on the turbocharger intake manifold and/or turbocharger housing.	<b>The right-hand intake manifold on the turbocharger is leaking and must be replaced.</b> Continue with ⇒ <i>Technical Information '4X00IN replacing right-hand intake manifold on turbocharger'</i> .

- Work Procedure: 1 Replace the right-hand intake manifold on the turbocharger.  
 For instructions, see:  
 ⇒ *Workshop Manual '212419 Removing and installing intake manifold'*
- 2 Lower the vehicle and remove it from the lifting platform.
- 3 Enter the campaign in the Warranty and Maintenance logbook.
