Field campaign

Topic	Incorrect wheel bolt cap kits (SC25/06)
Market area	Bentley: worldwide (2WBE),China 796 VW Import Comp. Ltd (Vico), Beijing (6796)
Brand	Bentley
Transaction No.	2077217/1
Campaign number	ED36
Note	
Type	
US code

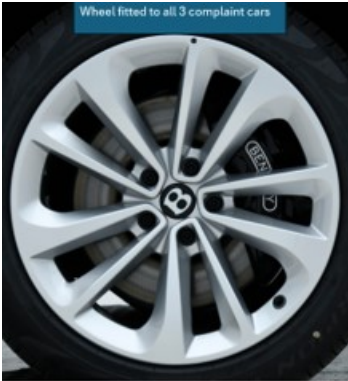
On all affected vehicles the wheel bolt cover cap kit supplied in the dealer kit bag for specific BY636 25MY vehicles (wheel style dependant) do not fit the wheel bolts.

Testing found that the cap kit 8w0.600.026.E was unsuitable and the caps do not fit on to the bolt.

Figure 1 – 21" Twin 5 spoke (PR Code: C9N)

To fix this Bentley has reverted to current cap kit 36A.600.026.B.

Replacement of wheel bolt caps.

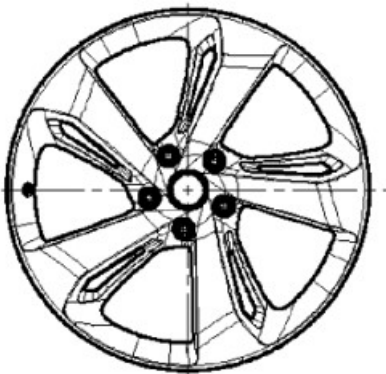
Figure 2 – 22" 5 spoke (PR Code (U03/U04/62B)

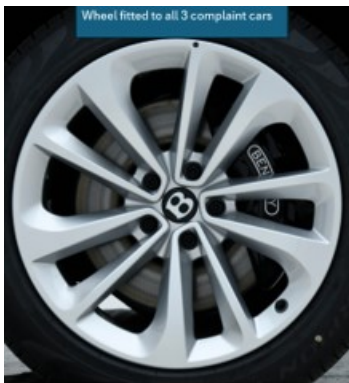
On all affected vehicles the wheel bolt cover cap kit supplied in the dealer kit bag for specific BY636 25MY vehicles (wheel style dependant) do not fit the wheel bolts.

Testing found that the cap kit 8w0.600.026.E was unsuitable and the caps do not fit on to the bolt.

Figure 1 – 21" Twin 5 spoke (PR Code: C9N)

To fix this Bentley has reverted to current cap kit 36A.600.026.B.

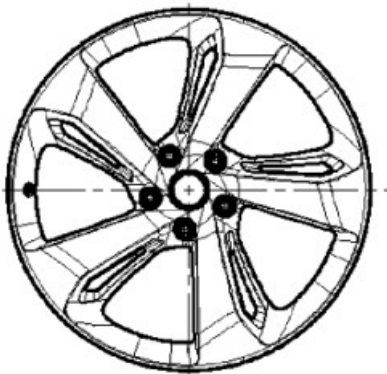
Figure 2 – 22" 5 spoke (PR Code (U03/U04/62B)
