**Oil Leakage in the Area of the Upper Part of the Oil Pan and Crankcase: Checking Return Seal on Upper Part of Oil Pan and Replacing if necessary (91/24)**

Vehicle Type: **718 Cayman GTS 4.0 (982) / 718 Boxster GTS 4.0 (982) / 25 years Boxster (982) / 718 Spyder (982) / 718 Cayman GT4 (982)**

Concerns: **Oil pan return seal**

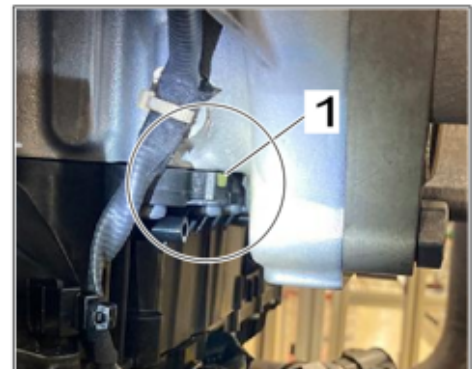
*Oil leakage area*

Cause: **Oil traces are detected on the oil pan on the side of the engine transmission flange.**

The leak is located in the area of the sealing point between the upper part of the engine oil pan and crankcase ⇒ *Oil leakage area -Circle-*, on green return seal ⇒ *Oil leakage area -1-* in the "window section" of the upper part of the oil pan.

Action: Check the return seal in the area of the "window section" and replace it with a **new component status** if applicable.

**Replacing the upper part of the oil pan, including the moulded seal, is not expedient** because this complaint involves a defect in the return seal in the area of the "window section" of the oil pan and not a defect in the oil pan itself.

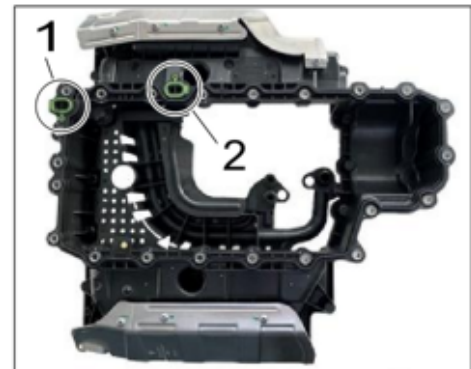
*Affected seals*

The previous component status of the return seal in green must no longer be used here.

- 3 Replace previous return seals ⇒ *Affected seals -1 and 2-* on the upper part of the oil pan with **new, black return seals with a new component status**.  
For procedure, see: ⇒ *Workshop Manual '175019 Removing and installing oil pan (upper part)'*
