Oil Leakage in the Area of the Upper Part of the Oil Pan and Crankcase: Checking Return Seal on Upper Part of Oil Pan and Replacing if necessary (91/24)

Vehicle Type: **911 Carrera (992) / 911 Carrera S (992) / 911 Sport (992) / 911 Carrera GTS (992) / 911 Carrera T (992) / 911 Carrera 4 (992) / 911 Carrera 4S (992) / 911 Carrera 4 GTS (992) / 911 Targa 4 (992) / 911 Targa 4S (992) / 911 Targa 4 GTS / 911 Turbo (992) / 911 Turbo S (992) / 911 Dakar (992)**

Model Year: **As of 2020 up to 2024**

Concerns: **Oil pan return seal**

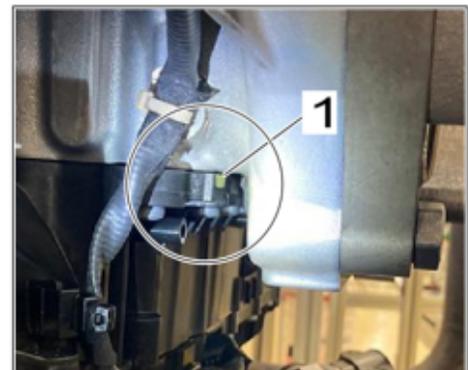
Oil leakage area

Cause: **Oil traces are detected on the oil pan on the side of the engine transmission flange.**

The leak is located in the area of the sealing point between the upper part of the engine oil pan and crankcase ⇒ *Oil leakage area -Circle-*, on green return seal ⇒ *Oil leakage area -1-* in the "window section" of the upper part of the oil pan.

Action: Check the return seal in the area of the "window section" and replace it with a **new component status** if applicable.

Replacing the upper part of the oil pan, including the moulded seal, is not expedient because this complaint involves a defect in the return seal in the area of the "window section" of the oil pan and not a defect in the oil pan itself.

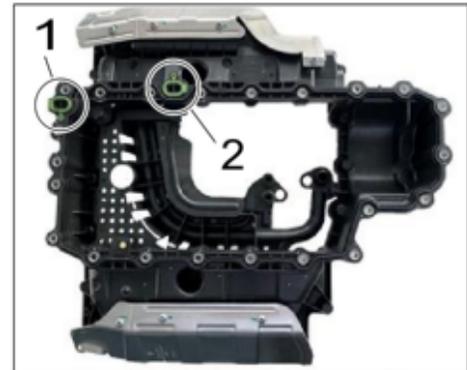
Affected seals

The previous component status of the return seal in green must no longer be used here.

- 3 Replace previous return seals ⇒ *Affected seals -1 and 2-* on the upper part of the oil pan with **new, black return seals with a new component status**.
For procedure, see: ⇒ *Workshop Manual '175019 Removing and installing oil pan (upper part)'*
