STAR ONLINE PUBLICATION

Case Number: S2523000039

Symptom/Vehicle Issue: Steering Column Difficult To Adjust Up Or Down.

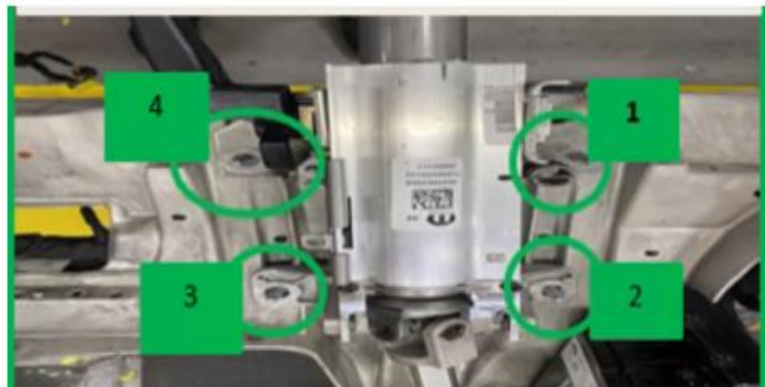
Fig 1.

Customer Complaint/Technician Observation: Steering column binding or difficult to move during up down adjustment. Requires excessive effort.

1. Loosen the 4 nuts of the column assembly.
2. Tighten the 4 nuts following the sequence (Fig 1): 1-rearward passenger side, 2-forward passenger sider, 3-rearward outer side, 4-forward. Torque mounting nut 27 Nm.
