992 – Instrument Cluster Navigation Arrow Off-Center

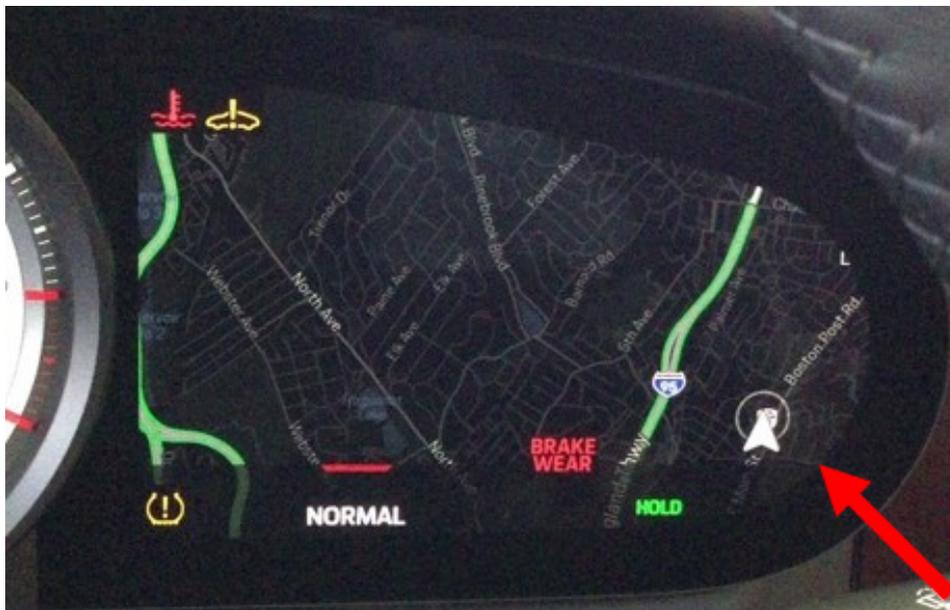
Customer complains of the navigation arrow in the instrument cluster not being centered.

Figure 1 - Navigation Arrow Off-Center

Due to the lower resolution of the instrument cluster display for the 992, the navigation display becomes unproportional. This leads to the image becoming oversized and the navigation arrow off centered.

Refer to ***TI 65/23 Various Fault Patterns for Porsche Communication Management (PCM)*** to update the PCM to SW 3885.
