## Field campaign

<b>Topic</b>	Software Update   BiL 5.3.1 v1 to v2   Flying Spur   25MY (SC25/11)
<b>Market area</b>	Bentley: worldwide (2WBE),China 796 VW Import Comp. Ltd (Vico), Beijing (6796)
<b>Brand</b>	Bentley
<b>Transaction No.</b>	2077583/2
<b>Campaign number</b>	ED42
<b>Note</b>	
<b>Type</b>	
<b>US code</b>

### 25MY Flying Spur

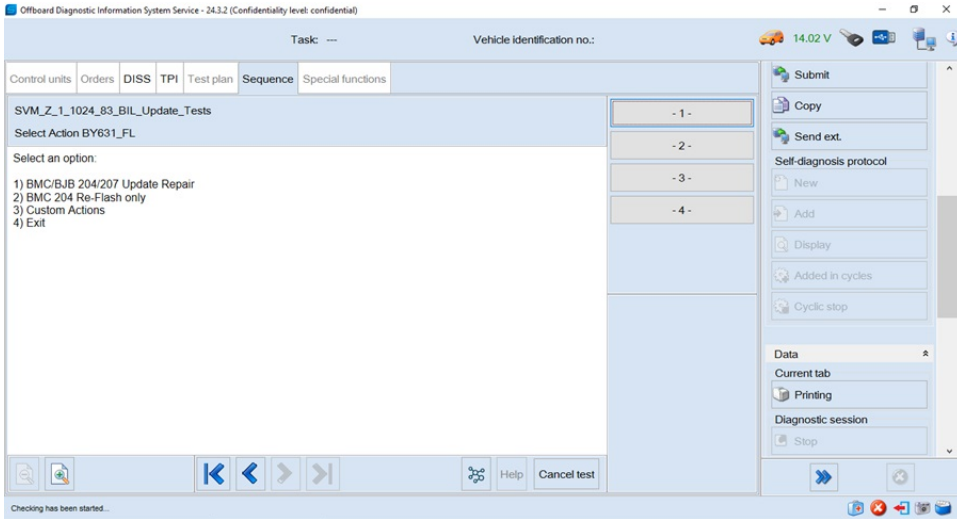
4. Select ‘1) BMC/BJB 204/207 Update Repair’ and follow the on-screen instructions.
  - When the tester attempts to flash ‘008C - Battery regulation control module’ you may receive a message informing you that the pre-conditions have not been met. Select ‘done/continue’.
  - On the following screen (shown below) select option 2 to attempt to flash the ECU – this should allow the ‘008C - Battery regulation control module’ to flash successfully.

- If the flash fails, perform the below actions.

1. Exit the test.

2. Allow the car to sleep for 5 minutes.

- Turn off the ignition.
- Remove all equipment from the car (Diagnostic tester/dongle, battery charger, keys).
- Close all doors, windows, bonnet and boot lid.
- Lock the vehicle to perform a CAN-BUS sleep (wait 5 minutes).

3. Clear DTCs from '008C - Battery regulation control module'.

3a. To do this, right click on control unit 008C, click Guided Functions and then click 'Clear Fault Memory'.

4. Return to 'Special functions' and run the test plan 'SVM – Pre 372BIL5201 Hotfix Routines'.

5. Within this test plan, select option 2 and run until completion.

6. Once the test has been completed, right click on control unit 008C and select guided functions. Then, read ECU Identification and ensure that the 06D0 (Battery Junction Box) appears as a subsystem within the read identification test plan.

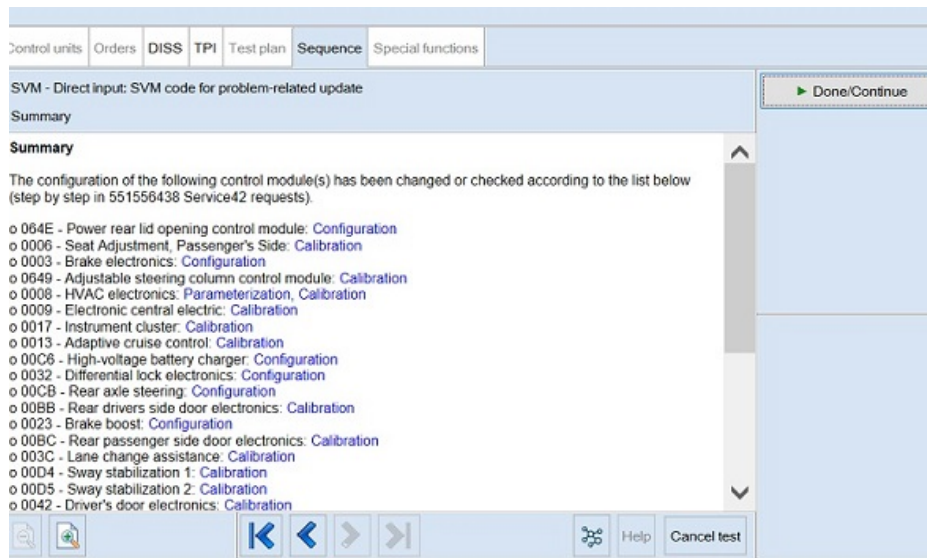
Fig 3

3. On the next screen, ensure that the SVM code displayed is correct.
4. You will be shown the communication type. **This MUST be set to "DoIP"**.
  - a. If "DoIP" is not selected, select option 3 until the communication type is set to "DoIP".
5. After ensuring DoIP is selected, and a suitable battery charger is connected, select Option 1 – "Yes".
  - a. From here, all control modules will be interrogated and the SVM action will take place.
6. Ensure that the diagnostic device remains connected for the duration of the update.
7. Follow all on-screen prompts until the program ends.
  - a. If you have a prompt stating there is no communication established with 00CC, select done/continue.
8. Follow the on-screen instructions to completion.
9. If you are presented with this screen (Fig 3) at the end of the update, the update was successful. Please continue to step 11.

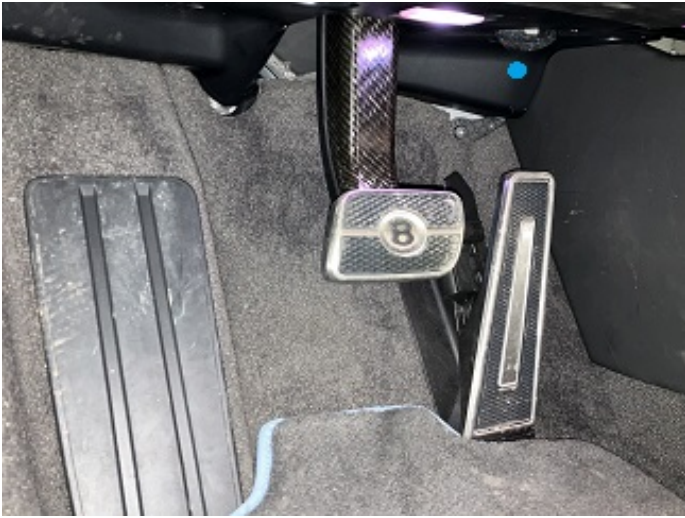
You must also add a blue paint mark as per the picture below.
