Field campaign

Topic	Software Update BiL 5.3.1 v1 to v2 Flying Spur 25MY (SC25/11)
Market area	Bentley: worldwide (2WBE),China 796 VW Import Comp. Ltd (Vico), Beijing (6796)
Brand	Bentley
Transaction No.	2077583/1
Campaign number	ED42
Note	
Type	
US code

25MY Flying Spur

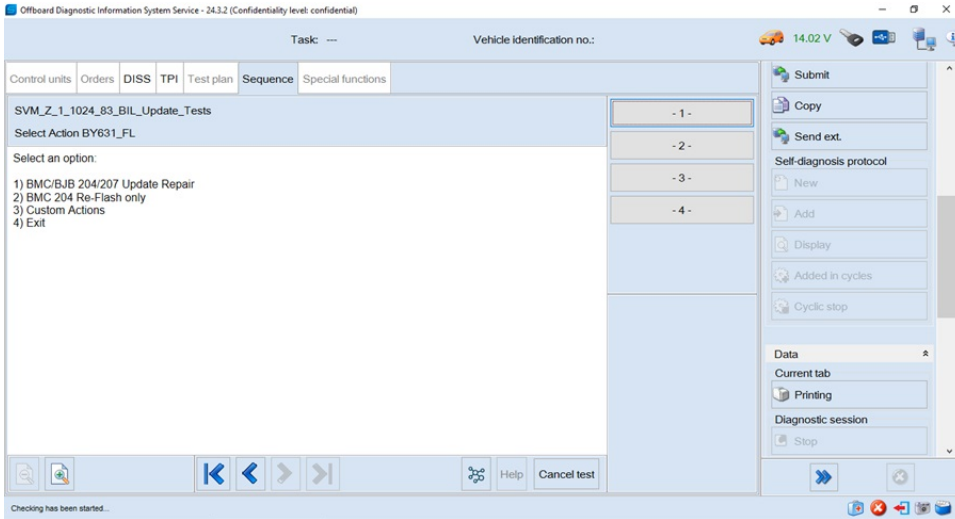
4. Select ‘1) BMC/BJB 204/207 Update Repair’ and follow the on-screen instructions.
 - When the tester attempts to flash ‘008C - Battery regulation control module’ you may receive a message informing you that the pre-conditions have not been met. Select ‘done/continue’.
 - On the following screen (shown below) select option 2 to attempt to flash the ECU – this should allow the ‘008C - Battery regulation control module’ to flash successfully.

- If the flash fails, perform the below actions.

1. Exit the test.

2. Allow the car to sleep for 5 minutes.

- Turn off the ignition.
- Remove all equipment from the car (Diagnostic tester/dongle, battery charger, keys).
- Close all doors, windows, bonnet and boot lid.
- Lock the vehicle to perform a CAN-BUS sleep (wait 5 minutes).

3. Clear DTCs from '008C - Battery regulation control module'.

3a. To do this, right click on control unit 008C, click Guided Functions and then click 'Clear Fault Memory'.

4. Return to 'Special functions' and run the test plan 'SVM – Pre 372BIL5201 Hotfix Routines'.

5. Within this test plan, select option 2 and run until completion.

6. Once the test has been completed, right click on control unit 008C and select guided functions. Then, read ECU Identification and ensure that the 06D0 (Battery Junction Box) appears as a subsystem within the read identification test plan.

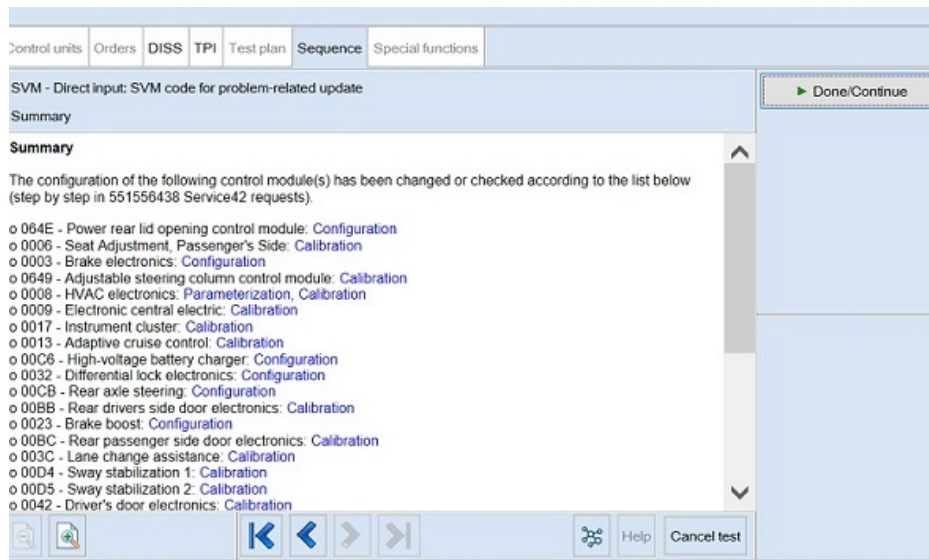
Fig 3

3. On the next screen, ensure that the SVM code displayed is correct.
4. You will be shown the communication type. **This MUST be set to "DoIP"**.
 - a. If "DoIP" is not selected, select option 3 until the communication type is set to "DoIP".
5. After ensuring DoIP is selected, and a suitable battery charger is connected, select Option 1 – "Yes".
 - a. From here, all control modules will be interrogated and the SVM action will take place.
6. Ensure that the diagnostic device remains connected for the duration of the update.
7. Follow all on-screen prompts until the program ends.
 - a. If you have a prompt stating there is no communication established with 00CC, select done/continue.
8. Follow the on-screen instructions to completion.
9. If you are presented with this screen (Fig 3) at the end of the update, the update was successful. Please continue to step 11.

10. If you encounter any errors during the update, please raise a FULL TECHNICAL DISS query.
 - a. Customer Statement: "ED42 Support"
 - b. Workshop Findings: Give a summary of the error encountered and ensure that the latest Guided Fault Finding log is submitted online.

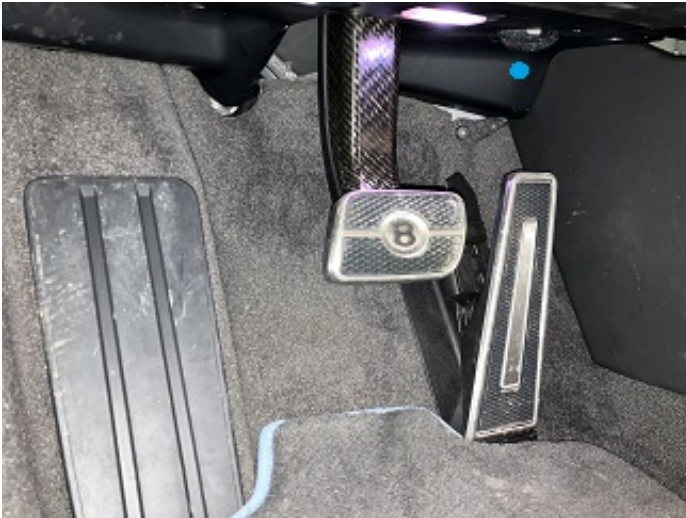
You must also add a blue paint mark as per the picture below.
