Service Bulletin

Bulletin No.: 18-NA-069

Subject: Poor Engine Performance in Extremely Cold Weather Conditions for LFV Engines, Charge Air Cooler Icing - Malfunction Indicator Lamp (MIL) Illuminated - DTC P0299, P0234, P2227 and/or P00C7 Set

Brand:	Model:	Model Year:		VIN:		Engine:	Transmission:
		from	to	from	to		
Chevrolet	Malibu	2016	2025	—	—	1.5L (LFV)	—

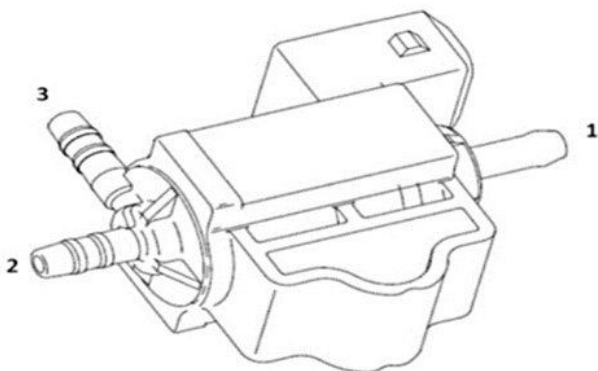
6055068

Note: Check port #2 to assure the spring gets lifted off the seat. This will be determined by the compressed air not dead heading when applied to port #2. When applying air to this port, a small amount of air should be observed at port #3 and even less air will be noticed at port #1. If this does not happen, the TCV plunger may have

hardened deposits from hot operating conditions which will impede TCV plunger movement, and the TCV should be replaced.

4. Using clean shop air regulated to 80-100 PSI, blow through all three ports (1, 2 & 3) for 5 seconds each.
⇒ Repeat step 4 twice.

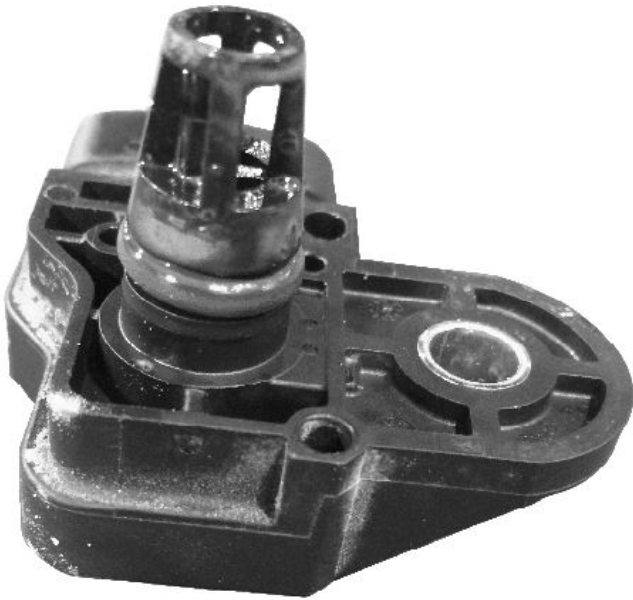
4910683

Important: Due to the sensitivity of the sensor, **Do Not** use any chemical cleaners including water and **Do Not** use compressed air to remove contaminates.

2. Inspect the sensor of any contaminates.
