# Service Bulletin

Bulletin No.: 23-NA-151

**Subject: Hybrid/EV Battery Stability, High Priority DTCs, Potential Loss of Isolation, Vehicle Handling and Battery Pack Return Shipping Requirements**

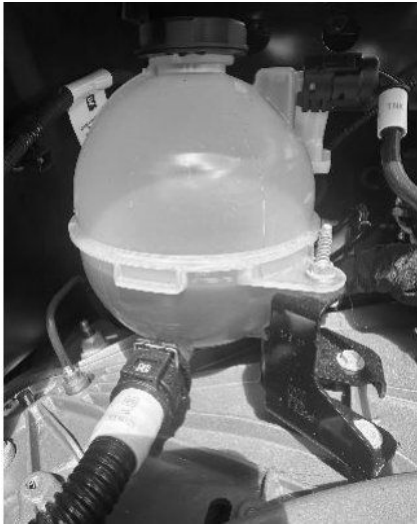
4. Visually inspect the coolant level in the high-voltage battery surge tank (Fig 1 and 2) and document via photo. Inform TAC if coolant has previously been added.

<p><b>Figure 1 (Coolant Level - Passed)</b></p>

**Danger: DO NOT add coolant without first confirming the Lithium-Ion Hybrid/EV Battery Pack internal coolant passage can maintain proper vacuum and pressure. Adding coolant to the coolant system with an internal lithium-ion Hybrid/EV Battery Pack coolant leak may result in Fire, which could result in vehicle or component damage, and cause severe body injury or death.**

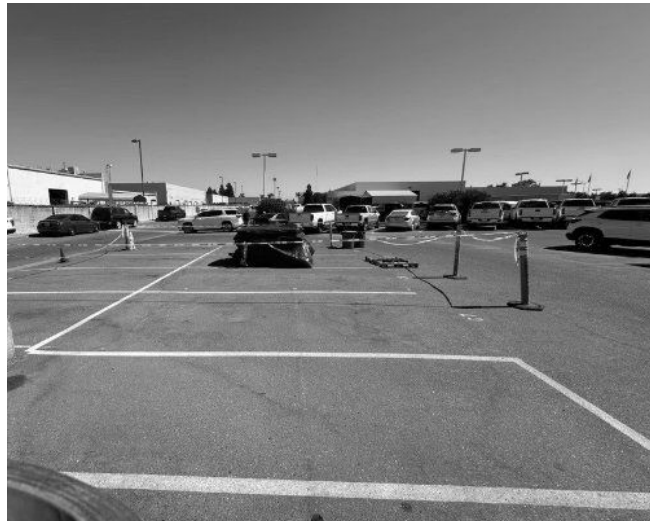
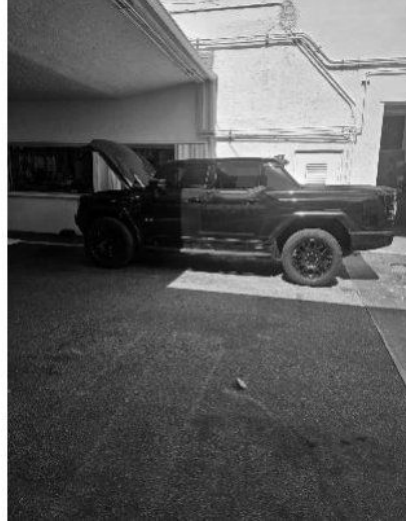
- 8. Move the vehicle to a stable location outdoors: isolated and away from buildings, vehicles, and foot traffic while waiting direction to diagnose/repair. Recommended distance is 50 feet (15M). Document isolated location via photo (Fig 4 and 5). Refer to 'Neutral Service Mode' in electronic transmission range select service information if required.
- 9. Start a TAC case and upload all photos and your GDS2 session log per Document ID: 6385557 / PIP4902 and reference this bulletin. Additionally, provide any previous diagnosis work performed based on the DTC(s) set or inability to collect the data.

**Figure 4 (Vehicle and Battery Pack Isolation – Passed)**

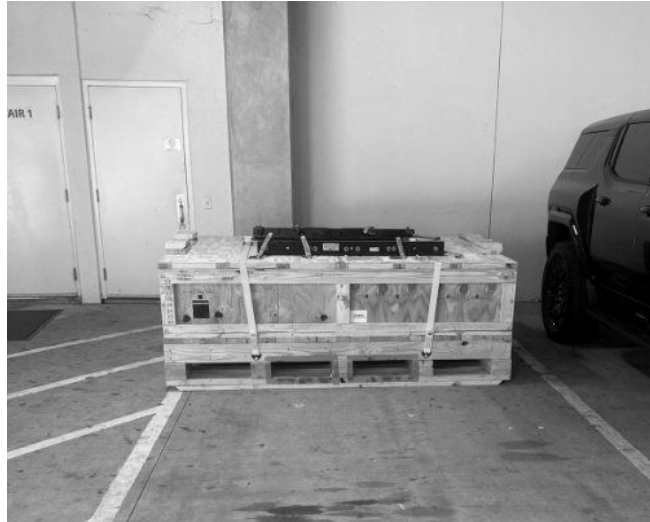
**Figure 5 (Vehicle and Battery Pack Isolation – Failed)**

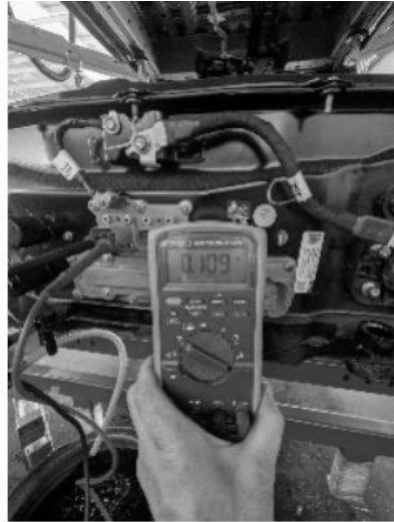
- 10.2. Check for High Voltage at the Hybrid/Electric Vehicle Battery Pack X1 through X7 (as equipped) by following High Voltage Disabling – High Voltage Disable Confirmation Table – A4 Hybrid/EV Battery Pack in Service Information (Fig 6 and 7).

**Figure 6 (High Voltage Disable  
Result < 3V)  
Passed**

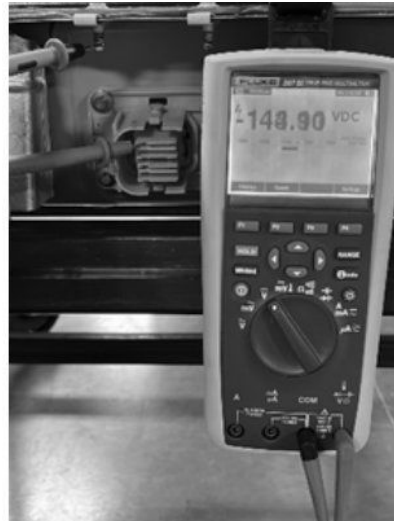
**Note:** If more than 3V is found, continue but contact TAC immediately upon completion.

**Figure 7 (High Voltage Disable  
Result > 3V)  
Failed**

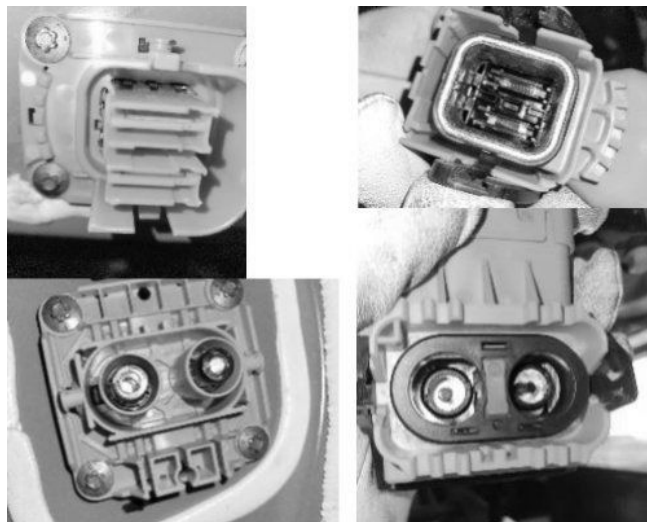
- 10. Following SI Procedure for high voltage battery removal, Hybrid/Electric Vehicle Battery Pack Removal, and Installation:
  - 10.1. Inspect the High Voltage Connectors at the High Voltage Battery for corrosion, moisture, and/or soot. Take clear, close-up photos of the vehicle side HV connectors and High Voltage Battery connection headers. Review Fig 8-10 for examples of light and heavy soot and the photo clarity required. Attach photos to TAC Case.

**Figure 8 (Battery Pack Connectors  
- Passed)**

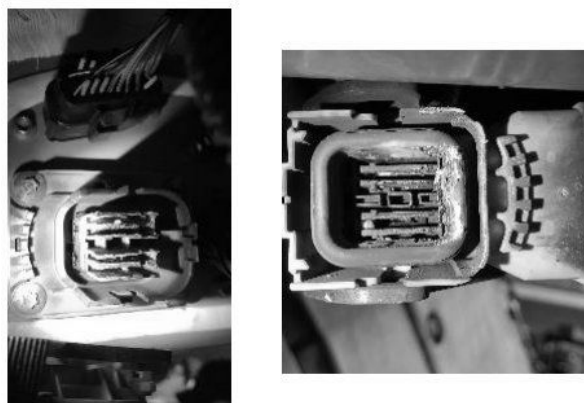
**Figure 9 Battery Pack Connectors  
- Failed w/Heavy Soot)**

**Note:** If soot, corrosion or moisture is observed, continue but contact TAC immediately upon completion.

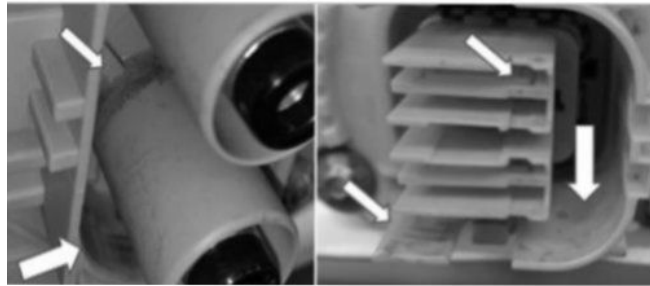
**Figure 10 (Battery Pack Connectors – Failed w/Light Soot)**

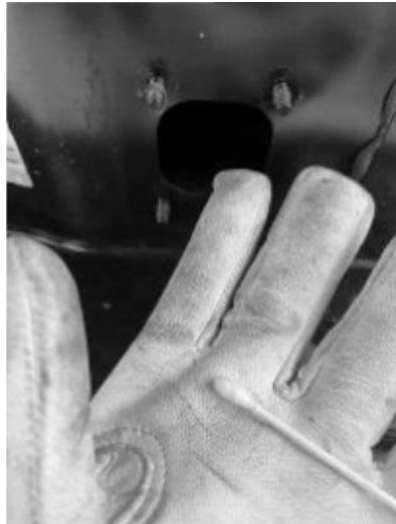
- 10.3. Remove the High Voltage Battery Pressure Equalizer Vent and Battery Inspection plug (if equipped) (Fig 11 and 12). The equalizer vents have 4 fasteners, never remove the vent valves that fasten with 2 fasteners. Using a cotton swab or paper towel to swab inside the enclosure for moisture/coolant and/or soot. Take photos and attach to TAC case.

**Figure 11 (Battery Pack Swab Test – Passed)**

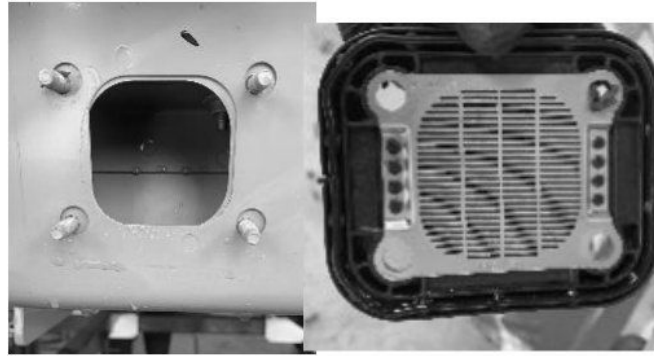
Figure 12 (Battery Pack Swab Test - Failed)

**Note:** If fluid/soot is observed, continue but contact TAC immediately upon completion.

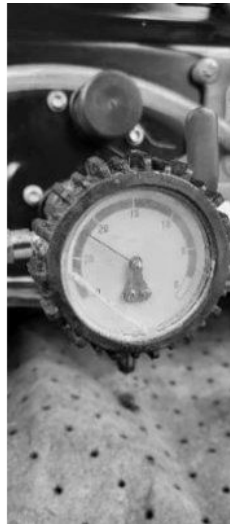
- 10.5. Vacuum test the High Voltage Battery coolant circuit for leaks. See Hybrid Battery Pack Coolant Passage Leak Test (Fig 13 and 14). Attach photos to the TAC case.

**Figure 13 (Coolant Passage Vacuum Leak Test – Passed)**

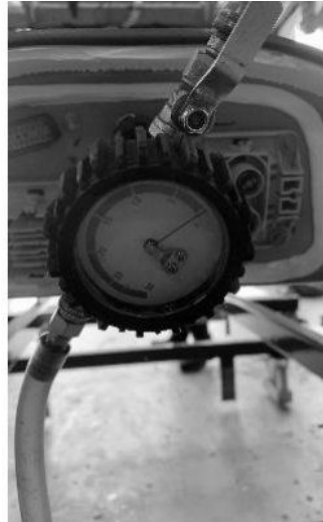
**Figure 14 (Coolant Passage Vacuum Leak Test – Failed)**

**Note:** If the High Voltage Battery coolant circuit does not hold vacuum, continue but contact TAC immediately upon completion.

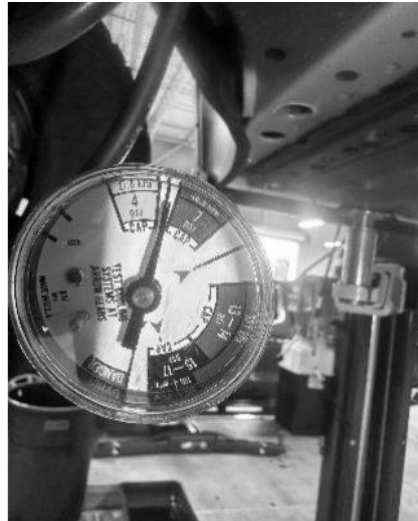
- 10.6. Pressure test the High Voltage Battery coolant circuit for leaks (Only complete if passes vacuum test). See Hybrid Battery Pack Coolant Passage Leak Test (Fig 15 and 16). Attach photos to the TAC case.

**Figure 15 (Coolant Passage Pressure Leak Test – Passed)**

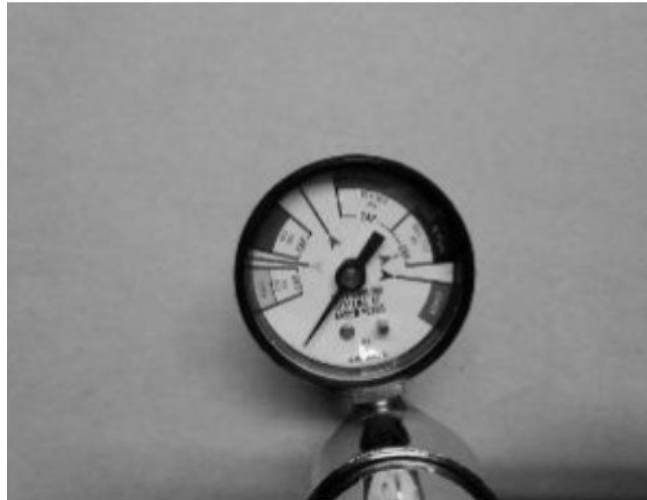
Figure 16 (Coolant Passage Pressure Leak Test – Failed)

**Note:** If the High Voltage Battery coolant circuit does not hold pressure, continue but contact TAC immediately upon completion.
