Working on High-Voltage Battery: Additional Photo Documentation Required when Removing the High-Voltage Battery (194/24)

Model Line: **Taycan (Y1A / Y1B / Y1C)**

Concerns: **High-voltage battery**

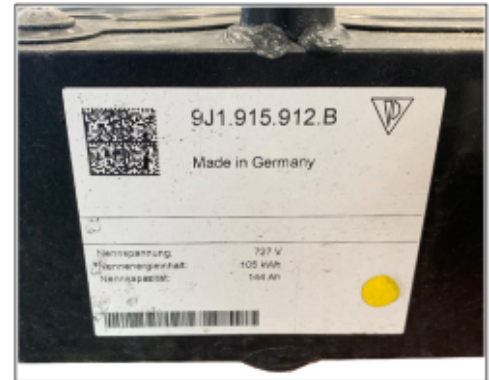
High-voltage battery rating plate

- 1 Photograph the high-voltage battery rating plate.

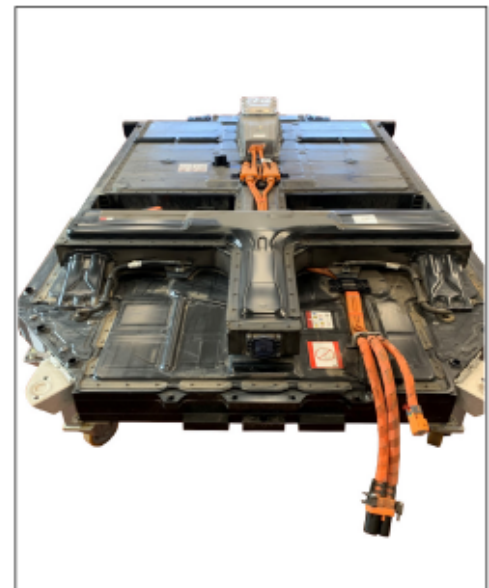
General overview of rear high-voltage battery

- 2 Photograph the high-voltage battery in the following views.

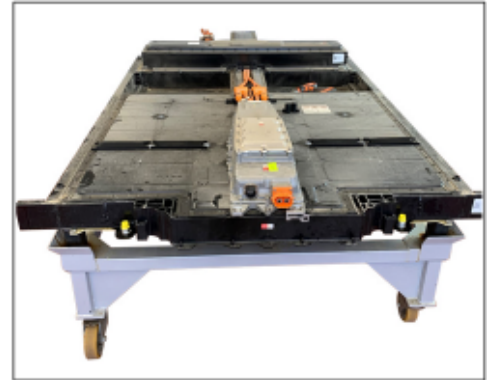
General overall overview of front high-voltage battery

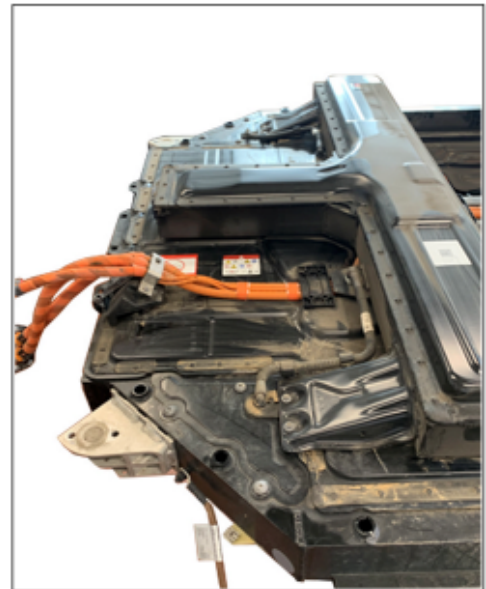
Overview of frame corner (sample representation at rear right frame corner)

- 3 Photograph the frame at **all four corners** in the following views.

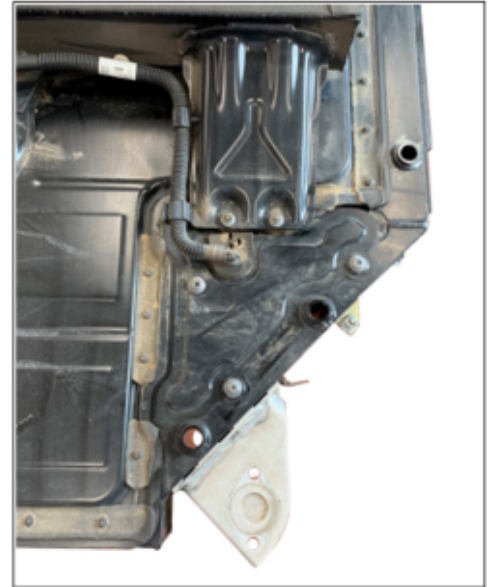
Top view of frame corner (sample representation at rear right frame corner)

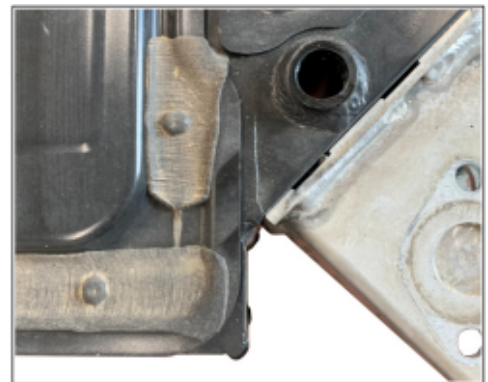
Top view of weld seams (sample representation at rear right frame corner)

- 4 Photograph weld seams at **all four frame corners** in the following views.

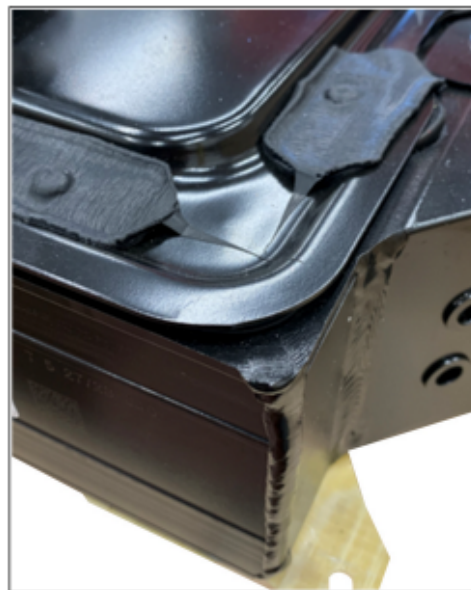
Detailed view of welded seams (sample representation at rear right frame corner)

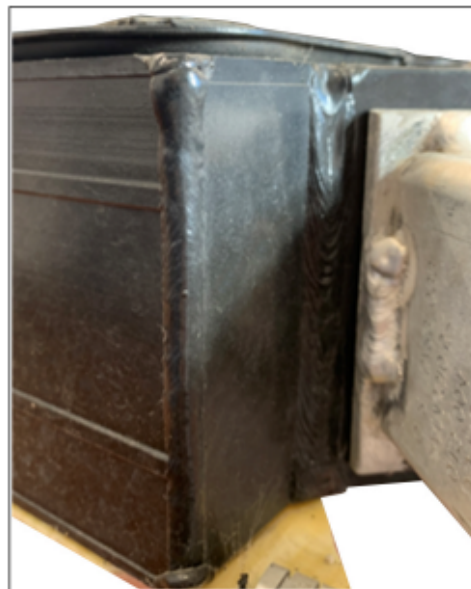
Side view of weld seams (sample representation at rear right frame corner)

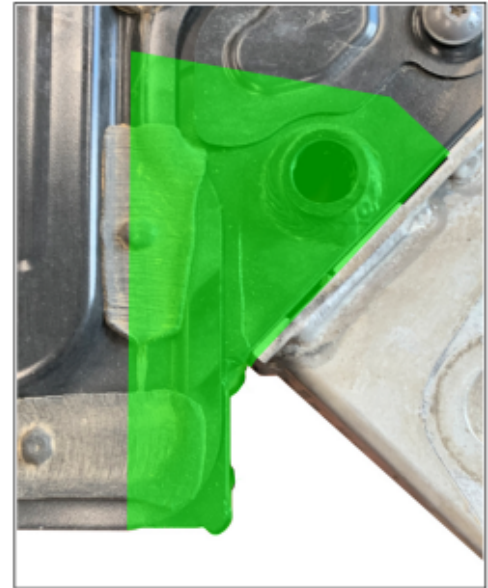
Top view of cleaned weld seams (representation of cleaned surface in green)

- 5 Clean the high-voltage battery with a cleaning cloth and isopropanol at **all four frame corners** and photograph it in the following views.

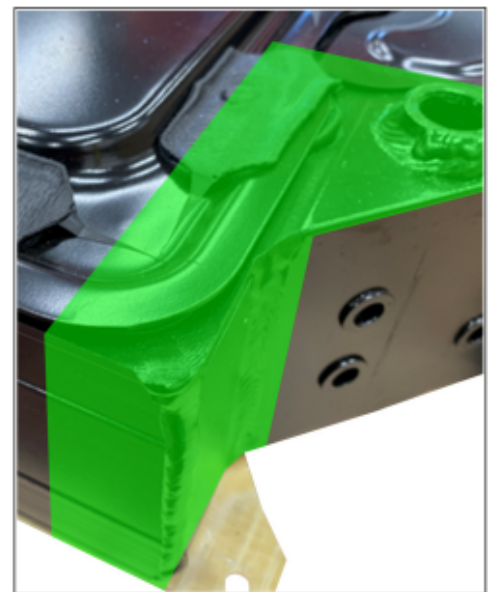
Detailed view of cleaned weld seams (representation of cleaned area in green)

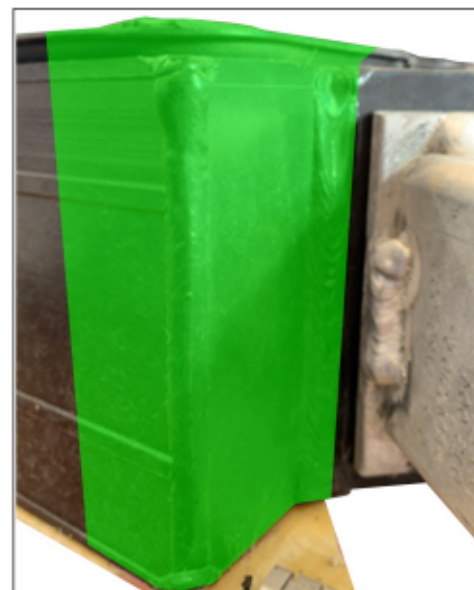
Side view of cleaned weld seams (representation of cleaned surface in green)
