Working on High-Voltage Battery: Additional Photo Documentation Required when Removing the High-Voltage Battery (194/24)

Model Line: **Taycan (Y1A / Y1B / Y1C)**

Concerns: **High-voltage battery**

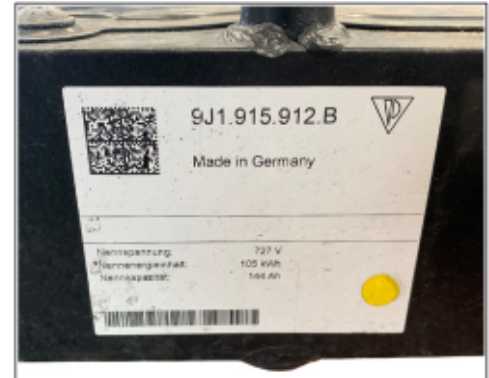
High-voltage battery rating plate

- 1 Photograph the high-voltage battery rating plate.

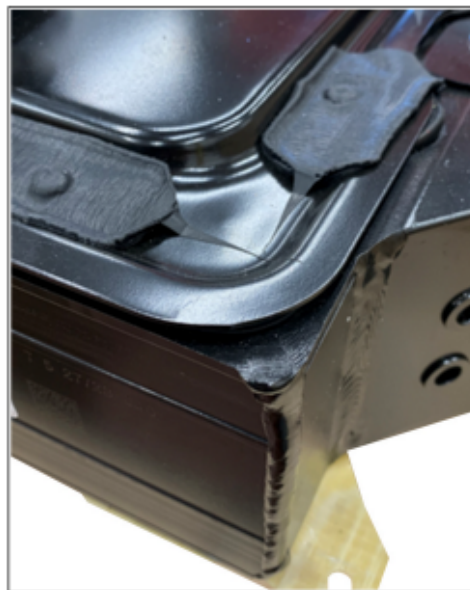
Detailed view of welded seams (sample representation at rear right frame corner)

- 4 Photograph weld seams at **all four frame corners** in the following views.

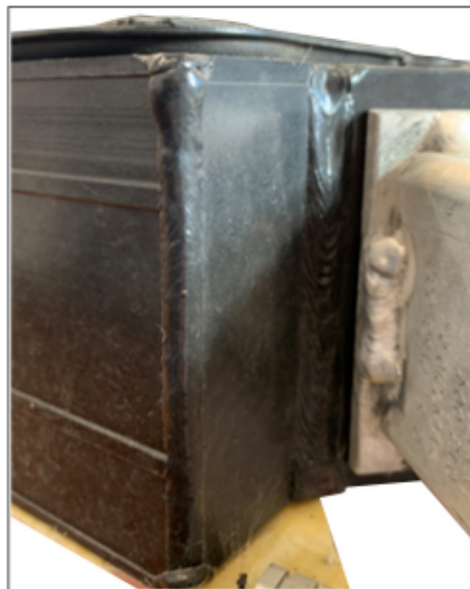
Side view of weld seams (sample representation at rear right frame corner)

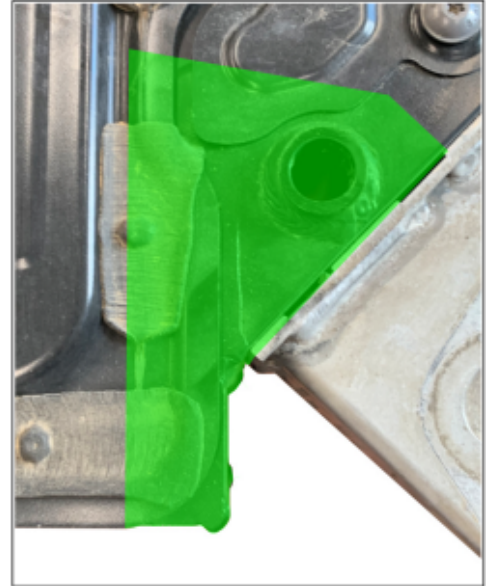
Top view of cleaned weld seams (representation of cleaned surface in green)

- 5 Clean the high-voltage battery with a cleaning cloth and isopropanol at **all four frame corners** and photograph it in the following views.

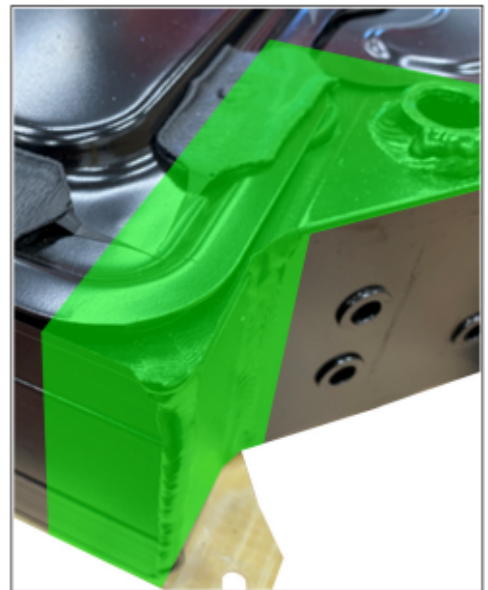
Detailed view of cleaned weld seams (representation of cleaned area in green)

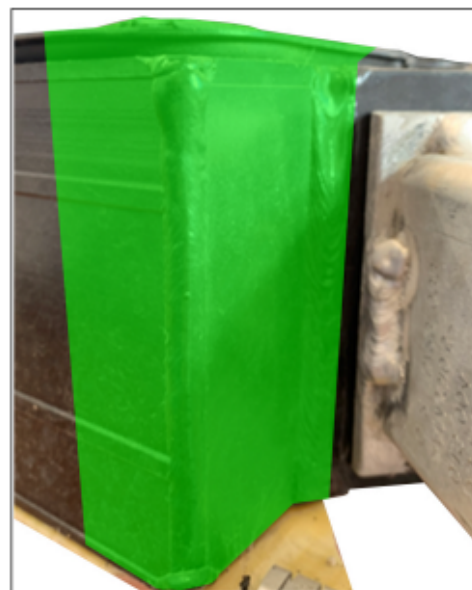
Side view of cleaned weld seams (representation of cleaned surface in green)
