**Charging of the High-Voltage Battery Not Possible or Faulty, Error Messages After Charging:  
Re-Program High-Voltage Charger (OBC) Control Unit (95/22)**

Revision: This bulletin replaces bulletin ATI Group 2 2202.1, dated April 29, 2022.

Model Year: **2021**

Concerns: **Control unit for high-voltage charger (OBC)**

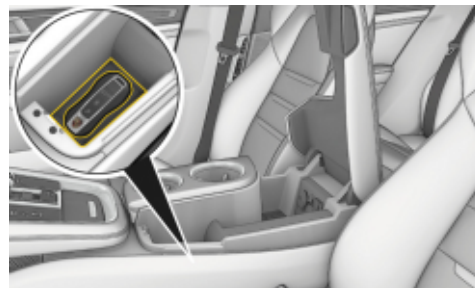
*Emergency start tray*

- Work Procedure: 1 Place the driver's key with the back facing down into the front left storage compartment in the center console (emergency start tray) to guarantee a continuous radio link between the vehicle and the driver's key ⇒ *Emergency start tray*.
- 2 Carry out general preliminary work for control unit programming as described in ⇒ *Workshop Manual '9X00IN Basic instructions and procedure for control unit programming - section on "Preliminary work"*.
