**Technical Service Bulletin (TSB)**  
**Flash: Motor Control Processor B (MCP B) Updates 11A1**

<b>REFERENCE:</b>	<b>TSB:</b> 08-013-25 REV. C <b>GROUP:</b> 08 - Electrical	<b>Date:</b>	April 30, 2025	<b>REVISION:</b>	08-013-25 REV. B
<b>VEHICLES AFFECTED:</b>	<b>2024 (KM) Jeep Wagoneer S</b> This bulletin applies to vehicles equipped with 400V G2500 FR/RR Elec Drive Motors (Sales Code ELD).			<b>MARKET APPLICABILITY:</b>	
				<input checked="" type="checkbox"/> NA	<input checked="" type="checkbox"/> MEA
				<input checked="" type="checkbox"/> SA	<input checked="" type="checkbox"/> IAP
				<input checked="" type="checkbox"/> EE	<input checked="" type="checkbox"/> CH
<b>CUSTOMER SYMPTOM:</b>	<p>Customers may experience a Malfunction Indicator Lamp (MIL) illumination and the vehicle may exhibit/set the following Diagnostic Trouble Code (DTC):</p> <ul style="list-style-type: none"> <li>• P1626-00 - Park Pawl Motor Stuck.</li> </ul> <p>Customers may also comment on one or more of the following:</p> <ul style="list-style-type: none"> <li>• Wrench lamp on in the Instrument Panel Cluster (IPC).</li> <li>• Not able to move the shifter out of Park.</li> <li>• Vehicle has reduced power.</l

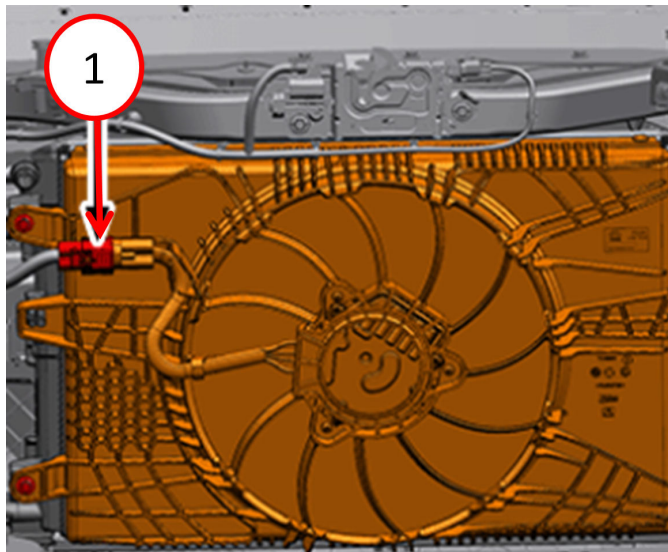
**Fig. 1**  
Cooling Fan Assembly

1 - Wire Harness To Disconnect/Connect

4. Disconnect the cooling fan wire harness connector [Fig. 1](#).

22. Connect the cooling fan wire harness connector [Fig. 1](#).
