**WSD5 – Check Coolant Expansion Tank Cap and Replace if necessary (Workshop Campaign)**

Model Line: **911 (992)**

Model Year: **As of 2024 up to 2026**

Concerns: **Coolant expansion cap**

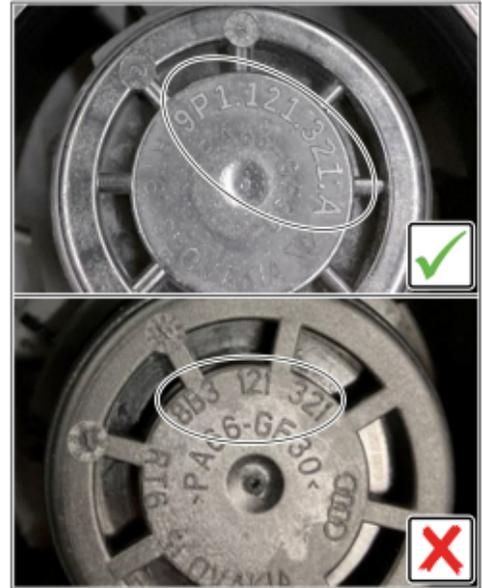
Check coolant expansion tank cap

Assessment		Action
(✓)	The <b>part number "9P1.121.321.A"</b> is applied to the coolant expansion tank cap.	Coolant expansion tank cap is <b>ok</b> . Then continue with Step 3. [Warranty processing: Scope 1]
(✗)	The <b>part number "8B3 121 321"</b> is applied to the coolant expansion tank cap.	Coolant expansion tank cap is <b>not OK</b> . <b>Replace coolant expansion tank cap.</b> Then continue with Step 3. [Warranty processing: Scope 2]
