CONDENSATION ON INSTRUMENT PACKS AND HEADLAMPS

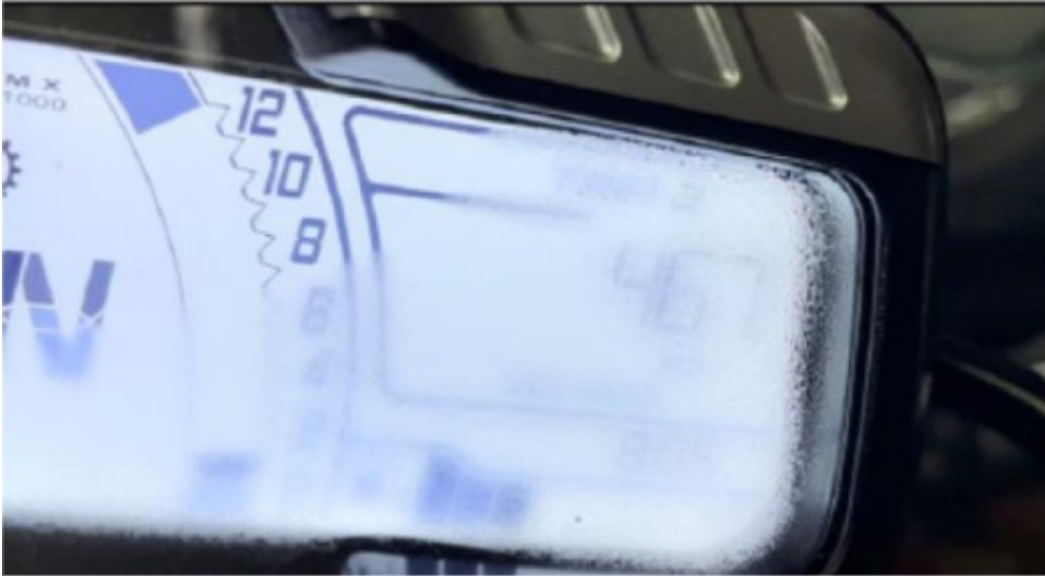
Example instrument pack:

Condensation is normal and expected with electrical components of this type. As they generate heat during use, ventilation is necessary for cooling and airflow. This allows moisture in the air to enter and condense on surfaces, especially in cool or damp conditions.

Condensation typically clears within about 15 minutes as the component warms up and the air circulates, but the time taken will vary depending on the component and conditions and could be longer.

This condensation is **not** indicative of a defect and does not require repair. **Warranty claims for condensation of this type will be rejected.** Should any customer report this as a concern, please

inform them of the above and that no repairs are required.
