REFERENCE:	TSB: 08-129-25 REV. A GROUP: 08 - Electrical	Date:	April 30, 2025	REVISION:	08-129-25
VEHICLES AFFECTED:	2024 (KM) Jeep Wagoneer S This bulletin applies to vehicles equipped with 400V G2500 FR/RR Elec Drive Motors (Sales Code ELD).	MARKET APPLICABILITY:			
		<input checked="" type="checkbox"/> NA <input checked="" type="checkbox"/> MEA <input checked="" type="checkbox"/> SA <input checked="" type="checkbox"/> IAP <input checked="" type="checkbox"/> EE <input checked="" type="checkbox"/> CH			
CUSTOMER SYMPTOM:	Customers may comment on one or more of the following: <ul style="list-style-type: none"> • 12 volt battery lamp on the Instrument Panel Cluster (IPC) illuminated due to depleted 12 volt battery. • Unable to charge at High Voltage Charging station at Level-1, Level-2 or DC Fast Charge. 				
CAUSE:	IDCM software update

This bulletin supersedes Technical Service Bulletin (TSB) 08-129-25, date of issue April 29, 2025, which should be removed from your files. All revisions are highlighted with ****asterisks**** and include an updated LOP.

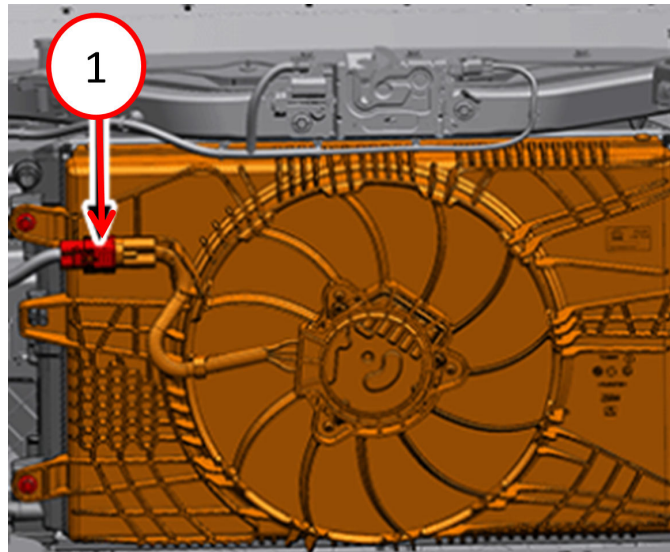
Fig. 1
Cooling Fan Assembly

NOTE: The cooling fan must be disconnected to prevent it from powering on, which may interrupt/ abort the flash process.

1 - Wire Harness To Disconnect/Connect

4. Disconnect the cooling fan wire harness connector [Fig. 1](#).

22. Connect the cooling fan wire harness connector [Fig. 1](#).
23. Install the front storage bin. Refer to the detailed service procedures available in DealerCONNECT/ ServiceLibrary under: Service Info> 23 - Body / Exterior / Bin, Storage / Installation.
