Technical Service Bulletin (TSB)
Smartphone As A Key (SPAAK) Module Damaged

REFERENCE:	TSB: 08-140-25 GROUP: 08 - Electrical	Date:	May 1, 2025	REVISION:	—
VEHICLES AFFECTED:	2025 (DT) RAM 1500 Pickup This bulletin applies to vehicles built on or after June 30, 2024 (MDH 0630XX) and on and before October 23, 2024 (MDH 1023XX) equipped with the Smartphone As A Key Capable Module (Sales Code GX6) and Mopar Lockable Console Storage (Sales Code CNA).	MARKET APPLICABILITY:			
		<input checked="" type="checkbox"/> NA		<input type="checkbox"/> MEA	
		<input type="checkbox"/> SA		<input type="checkbox"/> IAP	
		<input type="checkbox"/> EE		<input type="checkbox"/> CH	
CUSTOMER SYMPTOM:	Customers may experience the following: <ul style="list-style-type: none"> Smartphone as key capable is not working. 				
CAUSE:	Damaged SPAAK/Digital Key Control Module (DKCM)

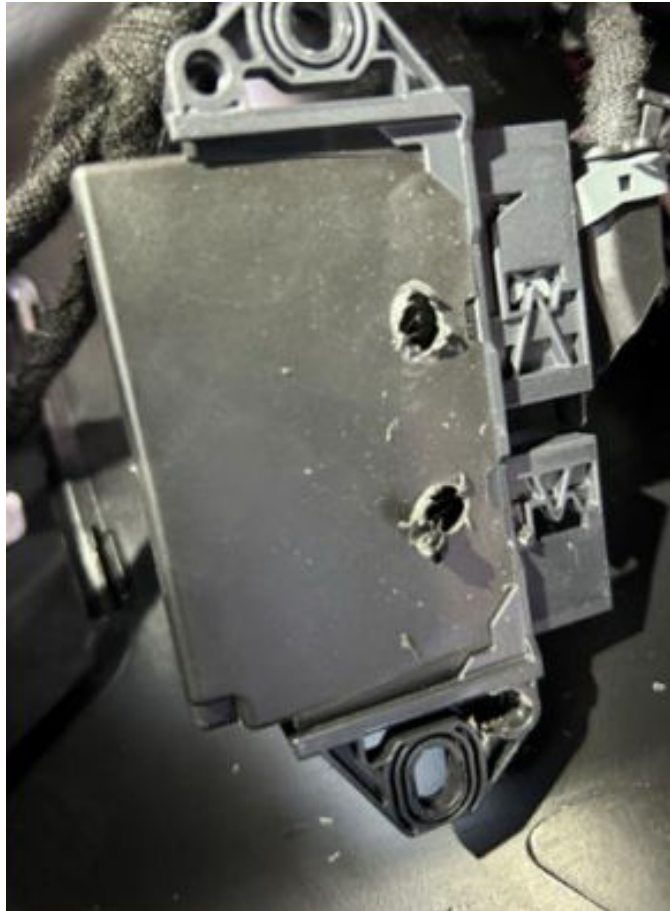
1. Remove the SPAAK module. Refer to the detailed service procedures listed in DealerCONNECT>Service Library>Service Info> 08 - Electrical / 8Q - Vehicle Theft Security / Module, Digital Key Control / Removal.
2. Are there holes drilled into the backside of the module [Fig. 1](#)?

Fig. 1
SPAAK Module (Damaged)

- YES>>> Proceed to [Step 3](#).
 - NO>>> This bulletin does not apply. Use Inspect LOP (08-19-2V-90). Perform further diagnostics.
3. Replace the SPAAK module. Refer to the detailed service procedures listed in DealerCONNECT>Service Library>Service Info> 08 - Electrical / 8Q - Vehicle Theft Security / Module, Digital Key Control / Installation.

4. Using wiTECH, run the DKCM Replacement Routine.
5. After running the Replacement Routine, clear all DTC's set in any module.
