Technical Service Bulletin

SUBJECT:		No: TSB-25-42-002	
DOOR AJAR WARNING LIGHT COMES ON WHEN REAR DOOR IS CLOSED		DATE: April 2025	
		MODEL: See below	
CIRCULATE TO:	<input type="checkbox"/> GENERAL MANAGER	<input checked="" type="checkbox"/> PARTS MANAGER	<input checked="" type="checkbox"/> TECHNICIAN
<input checked="" type="checkbox"/> SERVICE ADVISOR	<input checked="" type="checkbox"/> SERVICE MANAGER	<input checked="" type="checkbox"/> WARRANTY PROCESSOR	<input type="checkbox"/> SALES MANAGER

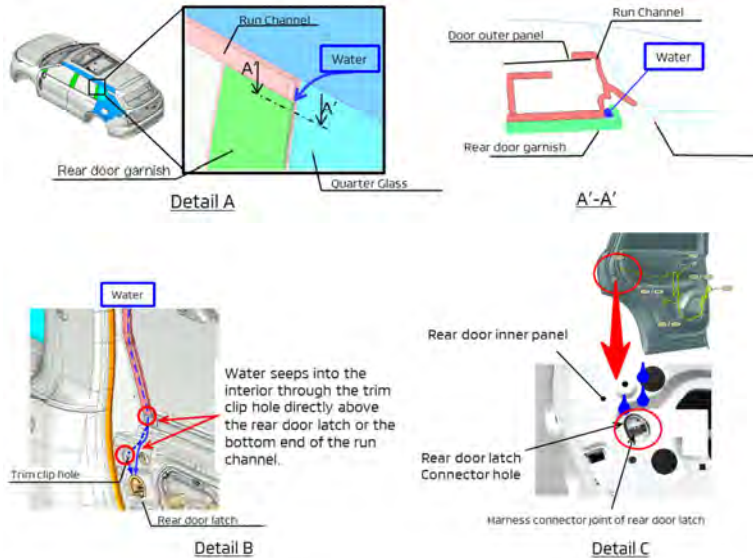
When it rains or when washing the car, water may seep in behind the top of the rear door garnish (see Detail A). If water runs down the back of the rear door run channel and enters the trim clip hole directly above the rear door latch or at the bottom end of the run channel on the interior side of the rear door panel (see Detail B) and makes contact with the connector joint between the rear door latch and the door harness (see Detail C), the door ajar detection signal circuit will connect and the door warning light will come on. To prevent water from seeping in to the rear door latch connector, a waterproof sponge has been added to the rear door trim clip and sealer has been added to the rear door latch channel.

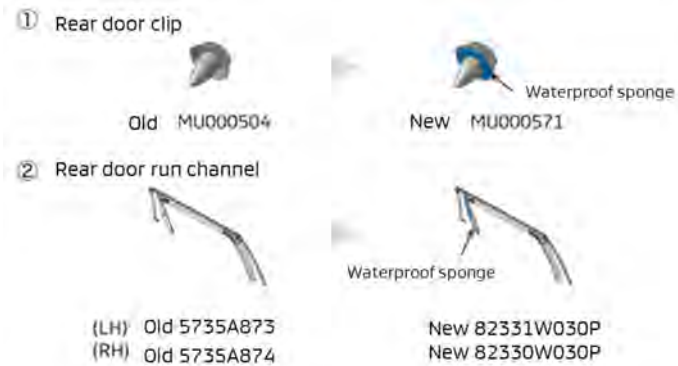
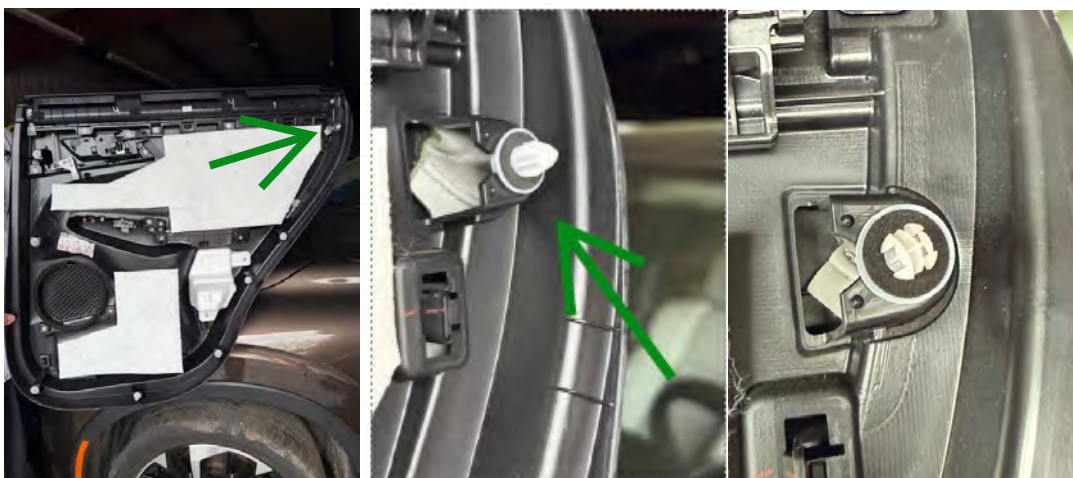
To prevent water from getting into the rear door latch connector, ① and ② have been added:

- ① A waterproof sponge has been added to the rear door trim clip.
- ② EPT sealer has been added to the rear door latch channel.

NEW Waterproof sponge

Note: If moisture is found around the latch connector hole on the rear door inner panel, dry the area using an air compressor/blow dryer.
