**Reduced Engine Power/Fault Memory Entry "P048E00" in the DME Control Unit: Check Electric Wire Harness for Exhaust Flap (Bank 1) Actuator (19/25)**

Model Line: **Cayenne (9YA/9YB)**

Model Year: **As of 2019 up to 2024**

Concerns: **Exhaust flap actuator (Bank 1)**

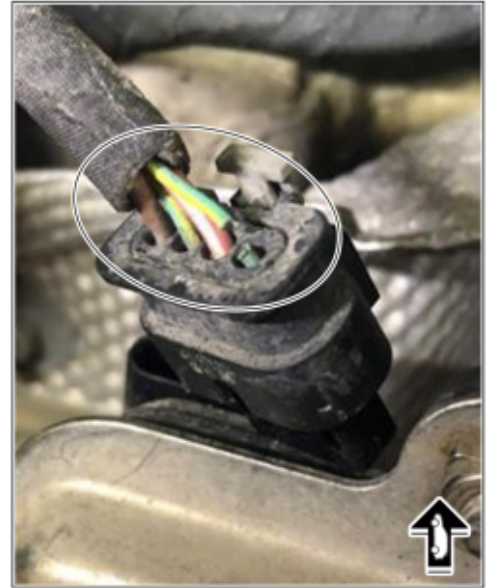
Cause: **The customer complains about a faulty working of the exhaust flap (bank 1), in combination with reduced engine performance of the internal combustion engine. Depending on the market, the malfunction indicator light may also be active.**

- **P048E00** - Exhaust pressure valve, short circuit to positive

- 2 Check electric wire harness for exhaust flap bank 1 (at right in direction of travel) for damage in the area of the electric plug connection. ⇒ *Electric wiring harness for exhaust flap actuator*

Assessment		Action
(✓)	Electric wire harness for exhaust flap actuator <b>is not damaged.</b>	Continue troubleshooting further. <b>End of action.</b>
(✗)	Electric wire harness for exhaust flap actuator <b>is damaged.</b>	Repair electric wire harness for exhaust flap actuator. Then continue with Step ⇒ 3.
