Replacement Requirement for Pressure Sensors for Refrigerant Circuit - Mixed Installation Not Permitted (70/24)

Vehicle Type: **Panamera 4 E-Hybrid (971)/Panamera 4S E-Hybrid (971)**

Model Year: **As of 2017 up to 2024**

Concerns: **Refrigerant circuit pressure sensors**

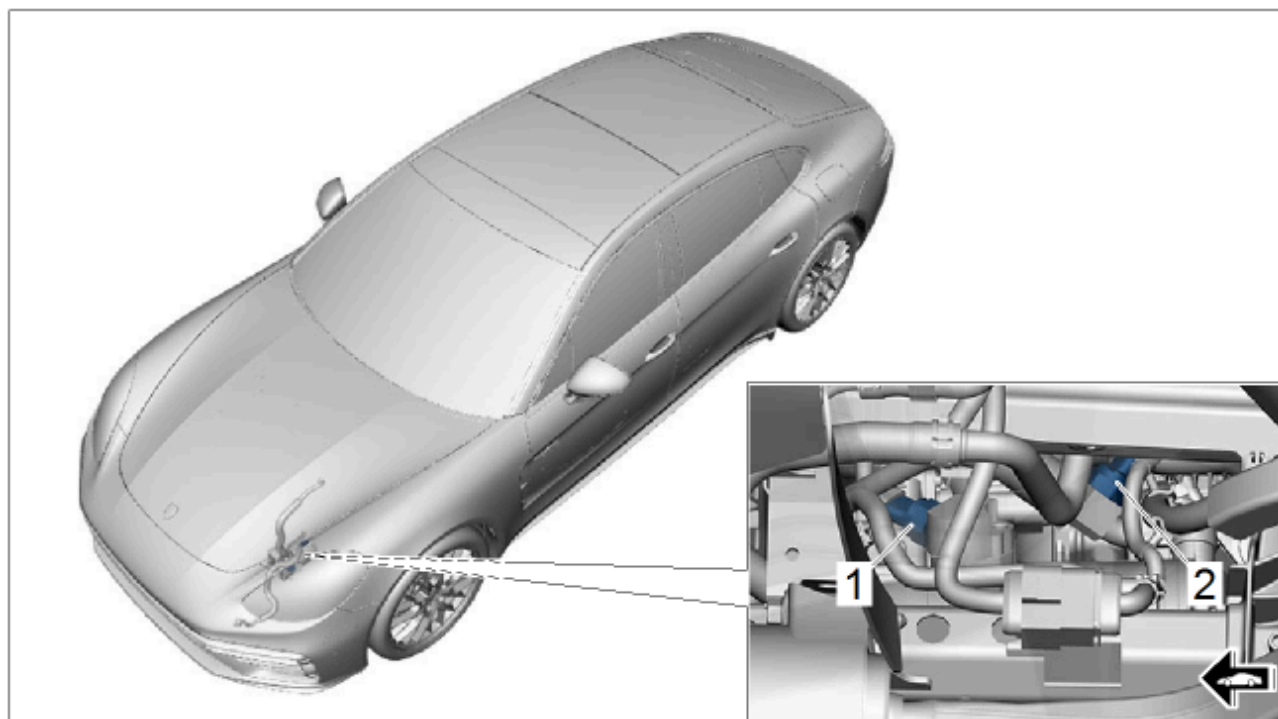
Installation position

- 1 – Pressure sensor (PT2) on low-pressure side
- 2 – Pressure sensor (PT1) on high-pressure side
