Replacement Requirement for Pressure Sensors for Refrigerant Circuit - Mixed Installation Not Permitted (70/24)

Vehicle Type: **Cayenne Turbo E-Hybrid (9YA/9YB)/ Cayenne Turbo S E-Hybrid (9YA/9YB)/ Cayenne Turbo E-Hybrid Coupé with GT Package (9YB)**

Concerns: **Refrigerant circuit pressure sensors**

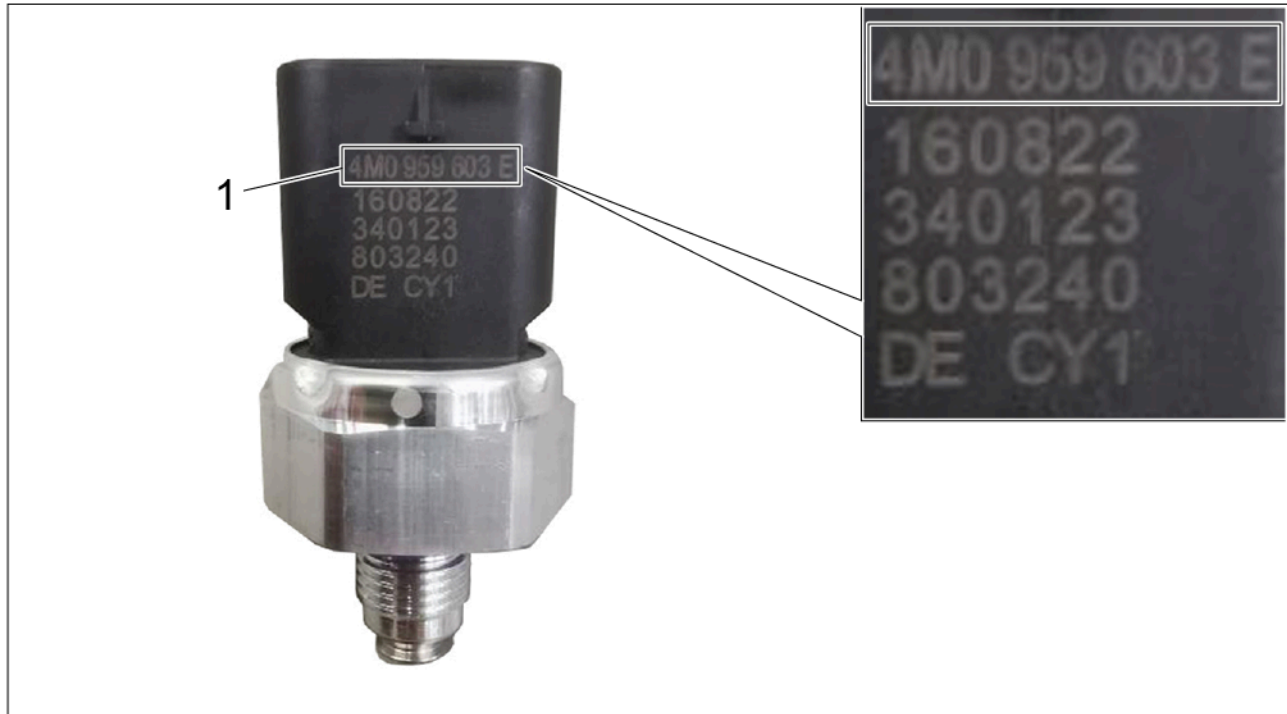
Pressure sensors that correspond to the changed component status are not compatible with the previous pressure sensors.

If a pressure sensor is required for replacement, it must therefore be ensured that both pressure sensors in the refrigerant circuit correspond to the changed component status (identical part number). If this is not the case, the respective other pressure sensor must also be replaced as a one-off. Mixed installation of pressure sensors with different component status (mixed installation) is not technically permissible and leads to faults in the refrigerant circuit and in the air conditioning.

- 1 – Pressure sensor part identifier

Action: If a pressure sensor must be replaced, ensure that both pressure sensors in the refrigerant circuit correspond to the changed component status with the part identifier 4M0959603J.

If this is not the case, **both** pressure sensors must be replaced.

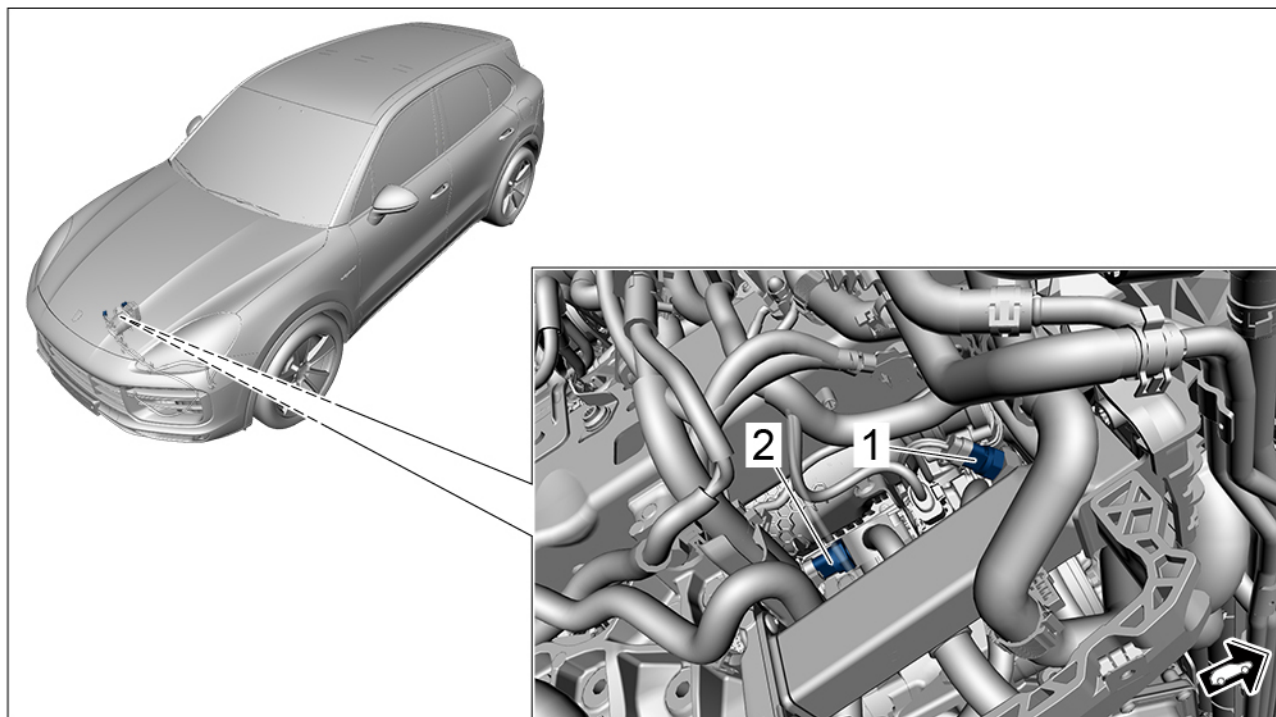
Installation position of pressure sensors

- 1 – Pressure sensor (PT1) on high-pressure side
- 2 – Pressure sensor (PT2) on low-pressure side
