Replacement Requirement for Pressure Sensors for Refrigerant Circuit - Mixed Installation Not Permitted (70/24)

Vehicle Type: **Panamera Turbo S E-Hybrid (971)**

Model Year: **As of 2017 up to 2024**

Concerns: **Refrigerant circuit pressure sensors**

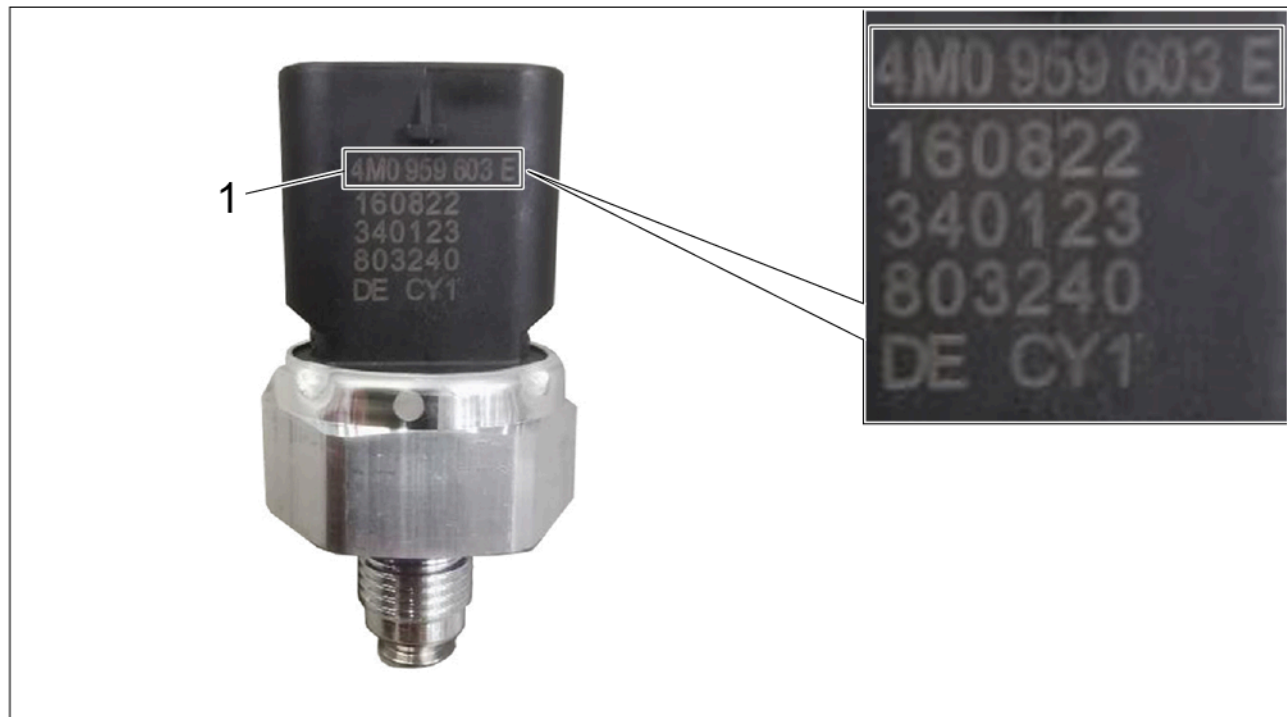
Cause: **Due to the discontinuation of an electronic component within the pressure sensor, the pressure sensors for the refrigerant circuit have been switched to a changed component status.**
 The changed component status can be identified by a changed part number.
 Pressure sensors that correspond to the changed component status are not compatible with the previous pressure sensors.
 If a pressure sensor is required for replacement, it must therefore be ensured that both pressure sensors in the refrigerant circuit correspond to the changed component status (identical part number). If this is not the case, the respective other pressure sensor must also be replaced as a one-off. Mixed installation of pressure sensors with different component status (mixed installation) is not technically permissible and leads to faults in the refrigerant circuit and in the air conditioning.

- 1 – Pressure sensor part identifier

Action: If a pressure sensor must be replaced, ensure that both pressure sensors in the refrigerant circuit correspond to the changed component status with the part identifier 4M0959603J.

If this is not the case, **both** pressure sensors must be replaced.

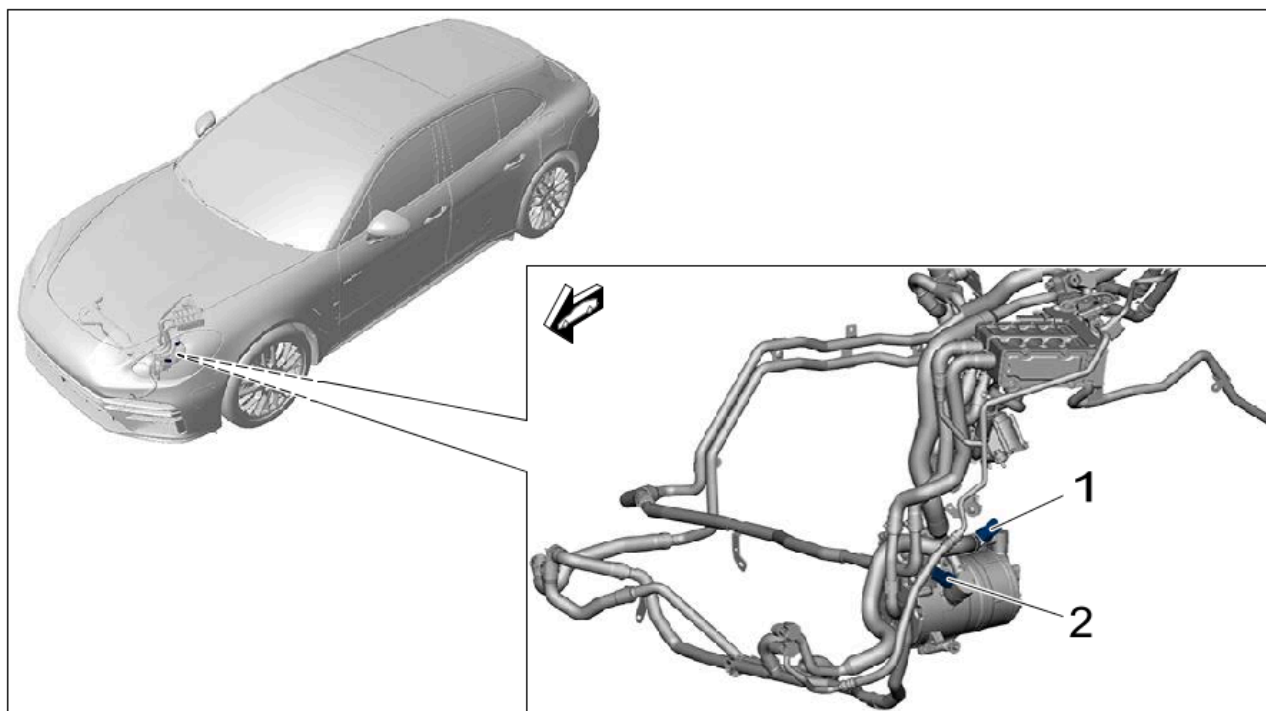
Installation position of pressure sensors

- 1 – Pressure sensor (PT1) on high-pressure side
- 2 – Pressure sensor (PT2) on low-pressure side
