REFERENCE:	TSB: 08-133-25 GROUP: 08 - Electrical	Date:	April 29, 2025	REVISION:	—
VEHICLES AFFECTED:	2025 (LB) Dodge Charger This bulletin applies to vehicles built on or before April 03, 2025 (MDH 0405XX) equipped with 400V G2500 FR/RR Elec Drive Motors (Sales Code ELD).	MARKET APPLICABILITY:			
		<input checked="" type="checkbox"/> NA		<input checked="" type="checkbox"/> MEA	
		<input checked="" type="checkbox"/> SA		<input checked="" type="checkbox"/> IAP	
		<input checked="" type="checkbox"/> EE		<input checked="" type="checkbox"/> CH	
CUSTOMER SYMPTOM:	Customers may comment on one or more of the following: <ul style="list-style-type: none"> 12 volt battery lamp on the Instrument Panel Cluster (IPC) illuminated due to depleted 12 volt battery. Unable to charge at High Voltage Charging station at Level-1, Level-2 or DC Fast Charge. 				
CAUSE:	IDCM software update

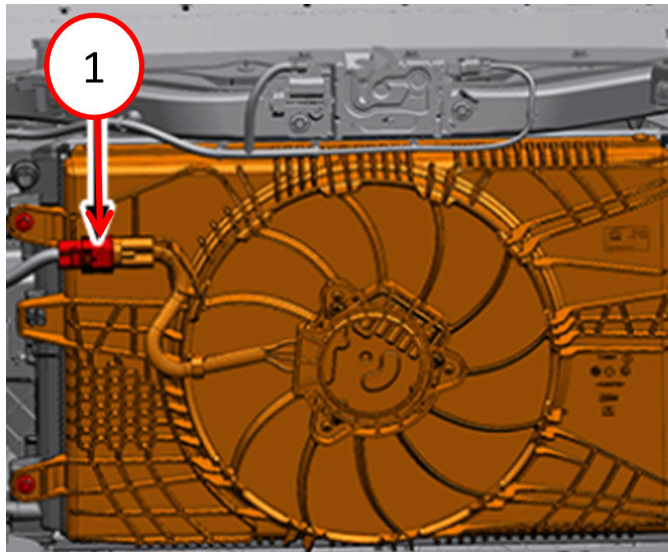
Fig. 1
Cooling Fan Assembly

1 - Wire Harness To Disconnect/Connect

4. Disconnect the cooling fan wire harness connector [Fig. 1](#).

26. Connect the cooling fan wire harness connector [Fig. 1](#).

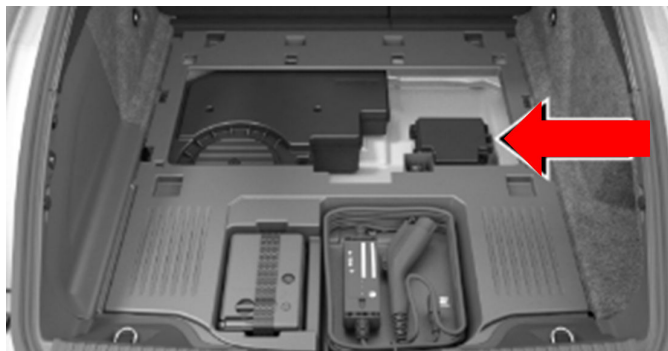
Fig. 2

Rear PDC Location

5. From the rear of the vehicle, pull back the carpet to access the rear Power Distribution Center (PDC) [Fig. 2](#).

24. Install the #38 AGSM fuse [Fig. 3](#) and the PDC cover [Fig. 2](#).

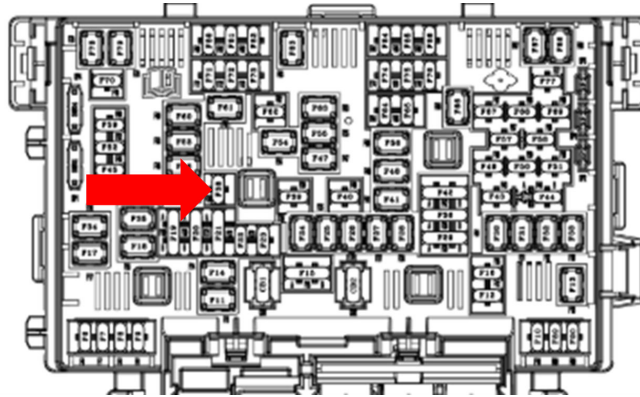
Fig. 3

#38 AGSM Fuse Location

6. Remove the PDC cover, locate and remove the #38 AGSM fuse [Fig. 3](#).
