## Technical Service Bulletin

<b>Topic</b>	Front door clash with the rear door brightware   Bentayga Series   21MY - 25MY
<b>Market area</b>	Bentley: worldwide (2WBE),China 723 Volkswagen (Anhui) Automotive CO (6723),China 796 VW Import Comp. Ltd (Vico), Beijing (6796)
<b>Brand</b>	Bentley
<b>Transaction No.</b>	2068064/4
<b>Level</b>	EH
<b>Status</b>	Released for publishing
<b>Release date</b>	Apr 7, 2025

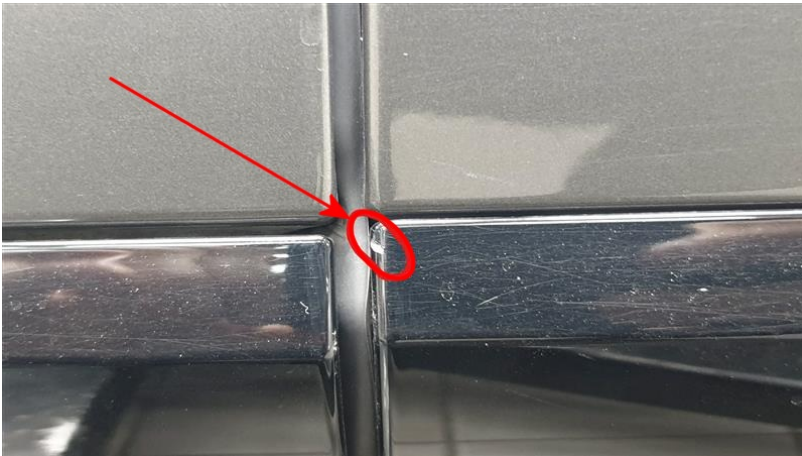
Figure 1

The front door inner panel hem is clashing with the rear door lower brightware (Figure 1) during the closing operation of the front door

1) With extreme care - Use a suitable "smooth cut hand file" to remove the raised inner door panel hem edge, until the hem edge is as shown in Figure 5

2) Once the protruding hem edge has been suitably reduced, close the front door to confirm the issue is resolved (No clash condition evident between the front door inner panel hem and the rear door lower brightware)

3) Conduct a paint repair to the applicable area **ensuring all approved paint repair guidelines are strictly followed to eliminate the risk of any paint and/or corrosion related issues**

4) Referring to Rep.Gr 66 - Replace the rear door lower brightware

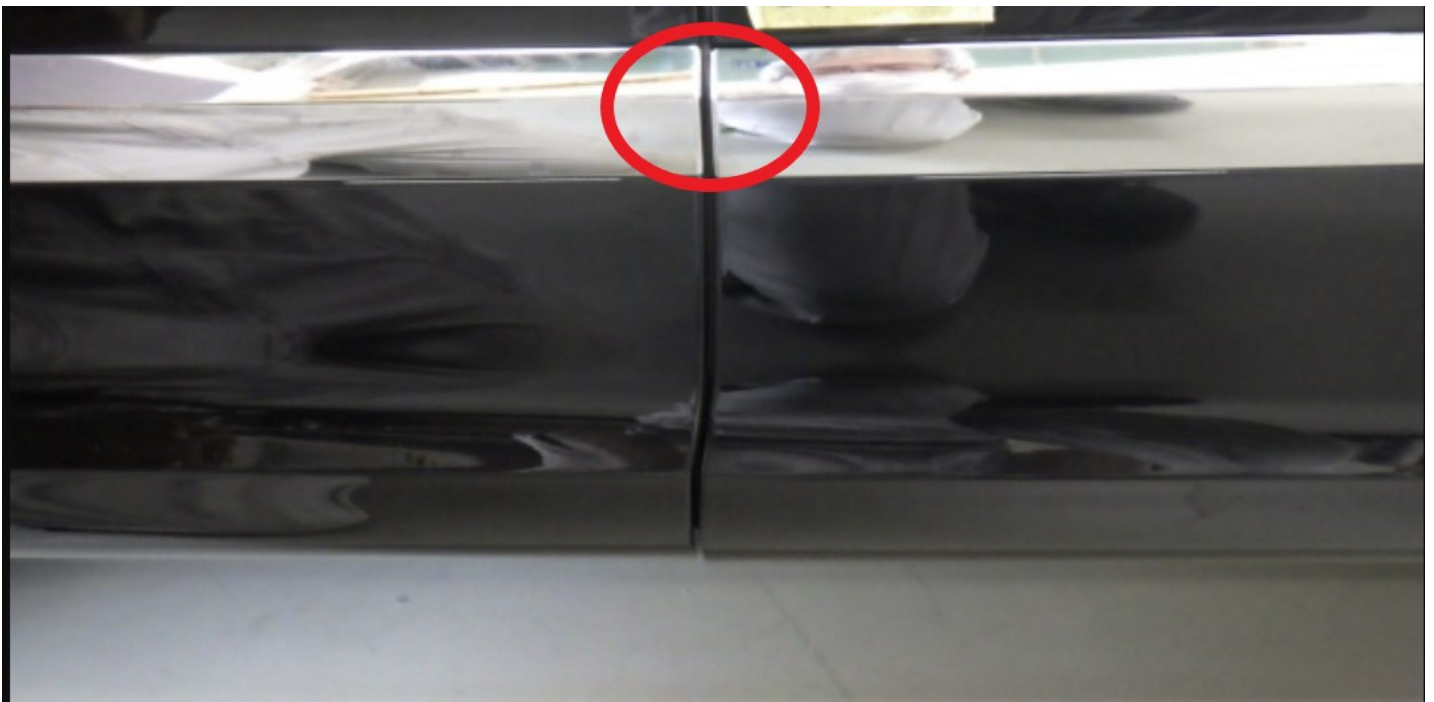
The rear door lower brightware is clashing with the front door brightware (Figure 2)

In the event the rear door lower brightware is clashing with the front door lower brightware as shown in Figure 2 the operative should conduct the instructions within the Measure section for (Scenario 2)

In the event the issue is as described and the clash condition is between the rear door lower brightware and the front door lower brightware the operative must refer to the instructions within Rep.Gr 66 - Door lower brightware – To remove and fit ensuring the following before refitting:

- 
- If you are re-using the old part, replace the adhesive strips with "3M automotive acrylic tape" or similar, locally sourced

- Clean the bonding surface of the door with Cleaning solution 3M VHB before refitting the lower brightware

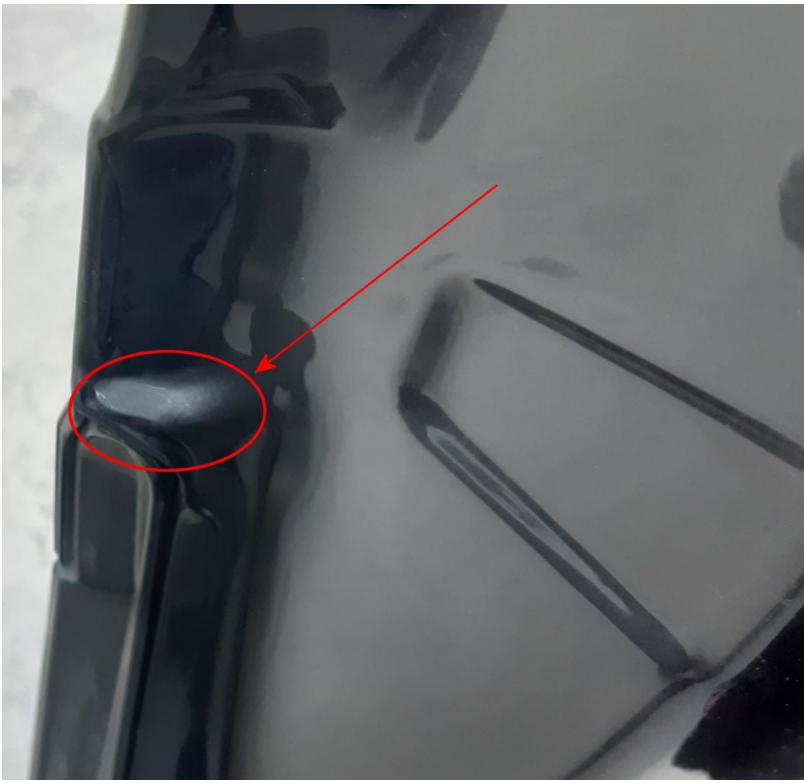
Figure 3

The issue is evident due to a clash condition between the front door inner panel hem (Figure 3) and the rear door lower brightware (Figure 4)

**TIP:** The operative should not attempt to adjust the gap and profile of the front and/or rear door to attempt to rectify the clash condition, for this issue only the operative should conduct the instructions within the Measure section of this TPI
