Vehicle has No Power Steering and Multiple Yellow Warning Messages (247/24)

Model Line: **Macan (XAB)**

Model Year: **As of 2024**

Concerns: **HCP4 body electronics main control unit**

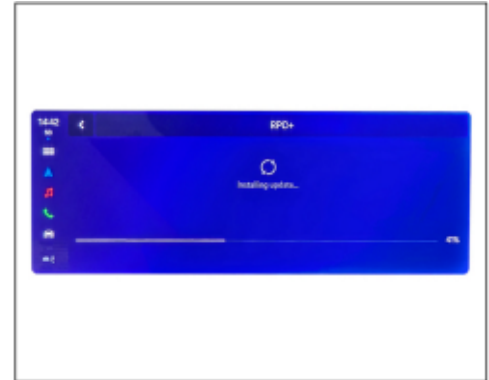
Update progress on central display
