Technical Service Bulletin (TSB)
RSU With Additional Sleep Cycles for HV Battery Integrity Check
- Flash: Integrated Dual Charging Module (IDCM) Updates 11A1

REFERENCE:	TSB: 08-130-25 GROUP: 08 - Electrical	Date:	April 29, 2025	REVISION:	—
VEHICLES AFFECTED:	2024 (LB) Dodge Charger This bulletin applies to vehicles equipped with 400V G2500 FR/RR Elec Drive Motors (Sales Code ELD).	MARKET APPLICABILITY:		<input checked="" type="checkbox"/> NA	<input checked="" type="checkbox"/> MEA
				<input checked="" type="checkbox"/> SA	<input checked="" type="checkbox"/> IAP
				<input checked="" type="checkbox"/> EE	<input checked="" type="checkbox"/> CH
CUSTOMER SYMPTOM:	Customers may comment on one or more of the following: <ul style="list-style-type: none"> 12 volt battery lamp on the Instrument Panel Cluster (IPC) illuminated due to depleted 12 volt battery. Unable to charge at High Voltage Charging station at Level-1, Level-2 or DC Fast Charge. 				
CAUSE:	IDCM software update

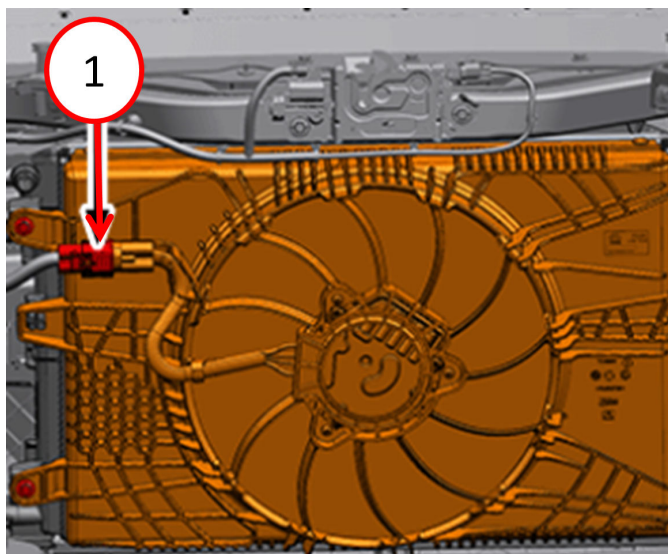
Fig. 1
Cooling Fan Assembly

4. Disconnect the cooling fan wire harness connector [Fig. 1](#).

1 - Wire Harness To Disconnect/Connect

24. Install the #38 AGSM fuse [Fig. 3](#) and the PDC cover [Fig. 2](#).
25. Position the rear carpet in place.
26. Connect the cooling fan wire harness connector [Fig. 1](#).

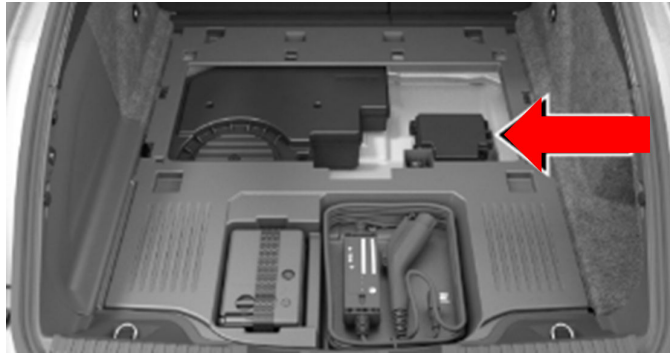
Fig. 2

5. From the rear of the vehicle, pull back the carpet to access the rear Power Distribution Center (PDC) [Fig. 2](#).

Rear PDC Location

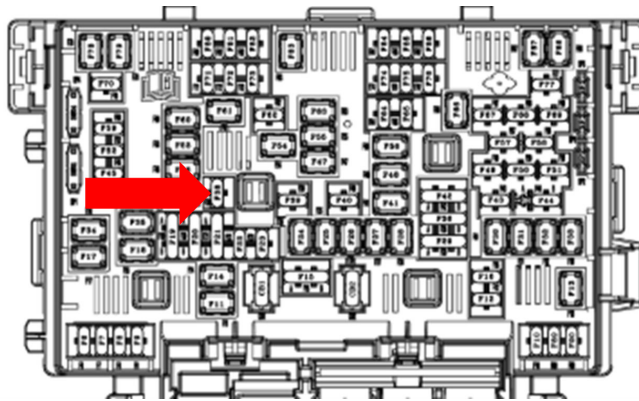
Fig. 3

Failure to remove the #38 AGSM fuse will result in damage to the shifter.

6. Remove the PDC cover, locate and remove the #38 AGSM fuse [Fig. 3](#).

#38 AGSM Fuse Location
