Technical Service Bulletin

Topic	Front or rear door(s) - Soft close function failure - DTC B122D29 Bentayga 22MY - 25MY
Market area	Australia E04 Bentley rest Asia and Australia (6E04),China 796 VW Import Comp. Ltd (Vico), Beijing (6796),Germany E02 Bentley rest Europe (6E02),Japan E03 Bentley Japan (6E03),Korea, (South) E08 Bentley South Korea (6E08),United Arab Emirates E06 Bentley Middle East and Africa (6E06),United Kingdom E01 Bentley UK (6E01),United States E05 Bentley USA and rest America (6E05)
Brand	Bentley
Transaction No.	2072938/3
Level	EH
Status	Released for publishing
Release date	Apr 7, 2025

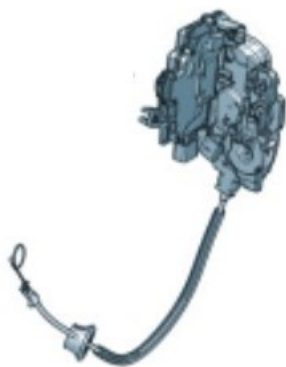
Note: For reference purposes Figure 1 shows an example of a door latch

- Request permission via DISS to replace the applicable door latch **IMPORTANT:** Attach a short video confirming the issue is still evident
- Referring to Rep.Gr 57 (front) or Rep.Gr 58 (rear) replace the applicable door latch

Take a clear photograph of the original door latch Tip: Ensure the photograph clearly shows the Part number / serial
