REFERENCE:	TSB: 08-128-25 GROUP: 08 - Electrical	Date:	April 29, 2025	REVISION:	—
VEHICLES AFFECTED:	2025 (KM) Jeep Wagoneer S This bulletin applies to vehicles built on or before April 05, 2025 (MDH 0405XX) equipped with 400V G2500 FR/RR Elec Drive Motors (Sales Code ELD).			MARKET APPLICABILITY:	
				<input checked="" type="checkbox"/> NA	<input checked="" type="checkbox"/> MEA
				<input checked="" type="checkbox"/> SA	<input checked="" type="checkbox"/> IAP
				<input checked="" type="checkbox"/> EE	<input checked="" type="checkbox"/> CH
CUSTOMER SYMPTOM:	<p>Customers may experience a Malfunction Indicator Lamp (MIL) illumination and the vehicle may exhibit/set one or more the following Diagnostic Trouble Codes (DTCs):</p> <ul style="list-style-type: none"> • P0DE6 - Hybrid/EV Battery Pack Cell Voltage Low. NOTE: Active or stored. • P1DAF - Incompatible Limp In Action Requested. NOTE: Active or stored. • P1CDE - Hybrid/EV Wakeup Control 2 Output Circuit Short to Ground. • P1CDA - Hybrid/EV Wakeup Control 1 Output Circuit/Open. • U00C6 - Lost Communication With AIR Pressure Sensor. • P0F00 - Hybrid/EV Battery Module 1 Performance. • P0F01 - Hybrid/EV Battery Module 2 Performance

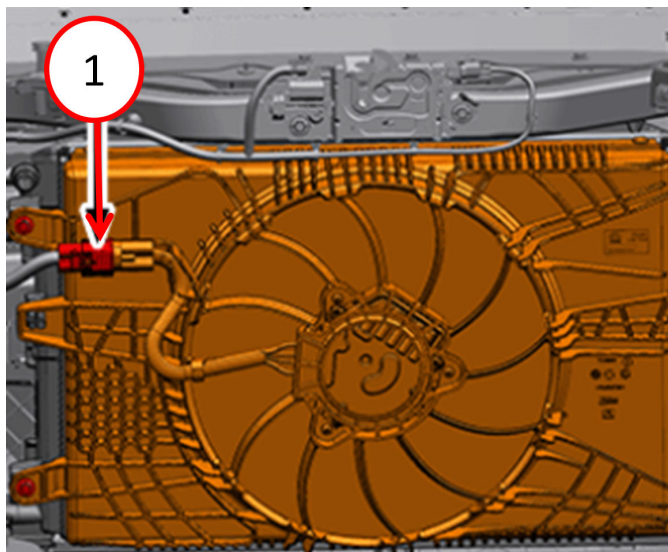
Fig. 1
Cooling Fan Assembly

1 - Wire Harness To Disconnect/Connect

4. Disconnect the cooling fan wire harness connector [Fig. 1](#).

20. Connect the cooling fan wire harness connector [Fig. 1](#).
