Surround Camera Intermittent Operation

Vehicles Affected

Models	Model Year	Model Type	VIN Range	Vehicle-Specific Equipment
Cayenne	As of 2019 up to 2025	9YA, 9YB	N/A	KA6

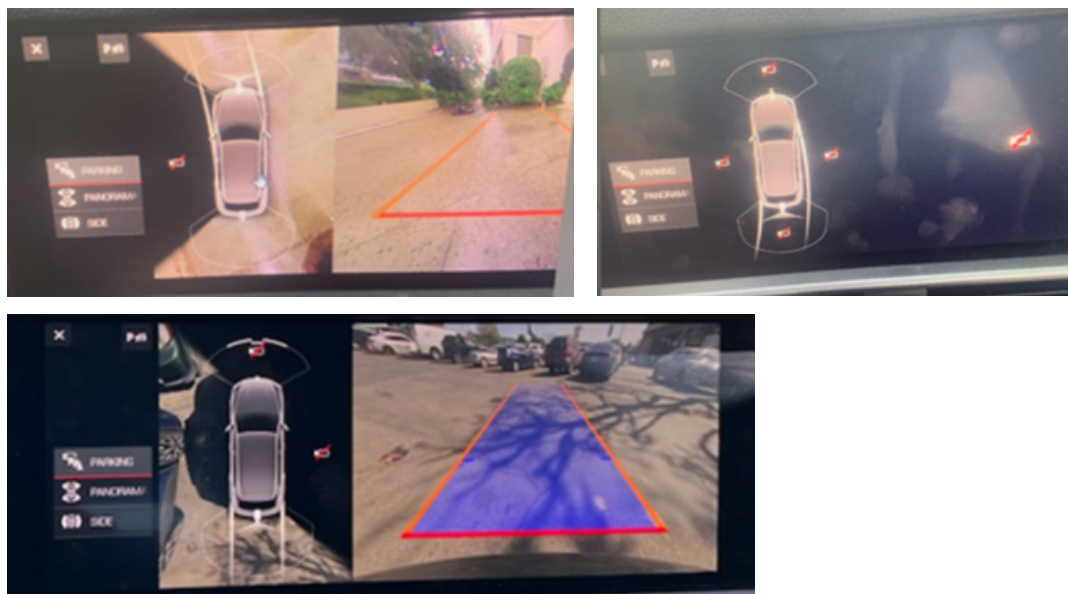
Customer complains of intermittent operation for one or multiple surround view cameras while appearing blank with a crossed-out camera icon for each failed camera.

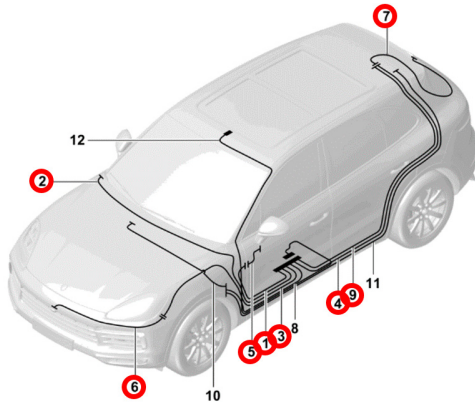
Figure 1 - Antenna cable lines

Any component failure of the surround view system can lead to a single or a combination of surround camera images being blank within the PCM display.

3. Replace the components listed below:
 - a. All four surround cameras
 - b. All antenna cable lines including:
 - Lines to each camera located at:
 - front bumper (**Figure 1 - #6**)

- tailgate (**Figure 1 - #7**)
 - both side view mirrors (**Figure 1 - #5**)
 - Lines to the zFAS control unit:
 - zFAS to driver side A-pillar (**Figure 1 - #1**)

- zFAS to passenger side A-pillar (**Figure 1 - #2**)
 - zFAS to front bumper connection (**Figure 1 - #3**)
 - zFAS to tailgate connection (**Figure 1 - #4 & #9**)
