Technical Service Bulletin

Topic	HVAC distribution/operational issues - HVAC Motor defect DTC's logged Continental GT/GTC & Bentayga Series
Market area	Australia E04 Bentley rest Asia and Australia (6E04),China 723 Volkswagen (Anhui) Automotive CO (6723),China 796 VW Import Comp. Ltd (Vico), Beijing (6796),Germany E02 Bentley rest Europe (6E02),Japan E03 Bentley Japan (6E03),Korea, (South) E08 Bentley South Korea (6E08),United Arab Emirates E06 Bentley Middle East and Africa (6E06),United Kingdom E01 Bentley UK (6E01),United States E05 Bentley USA and rest America (6E05)
Brand	Bentley
Transaction No.	2051519/14
Level	EH
Status	Released for publishing
Release date	Apr 7, 2025

- HVAC distribution/operational issues
- HVAC motor defect (DTC's) evident within address 08 - Climatronic control unit, the DTC's can be static or Intermittent

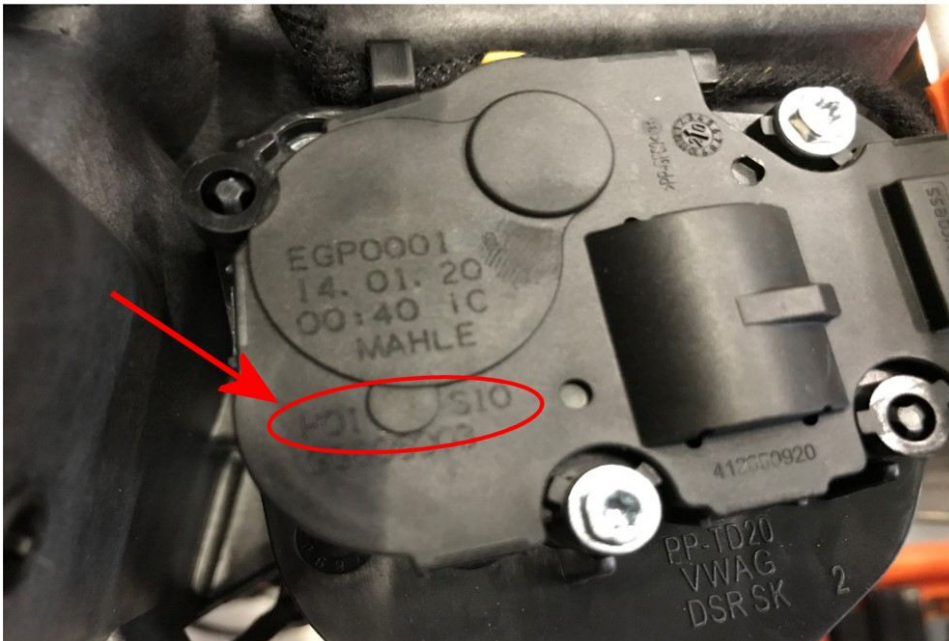
Note: Figure 1 shows a Bentayga motor and Figure 2 shows a New Continental GT/GTC and New Flying Spur motor

Scenario 1- Motors identified as PRIOR/BEFORE Hardware H01 and Software S10

- Replace all motors ensuring the latest specification parts are ordered and fitted

Scenario 2 - Motors identified as Hardware H01 and Software S10

- Motors **MUST NOT** be replaced unless diagnosed **and** proven to be faulty

Scenario 3 - Motors identified as POST/AFTER Hardware H01 and Software S10

For **example**: Motors with H07 / S11 should not be replaced unless faulty
