# Technical Service Bulletin

<b>Topic</b>	HVAC failing to cool   DTC B16A1F0 in diagnostic address 00C5   Bentayga Series (Hybrid)   23MY - 25MY
<b>Market area</b>	Australia E04 Bentley rest Asia and Australia (6E04),China 723 Volkswagen (Anhui) Automotive CO (6723),China 796 VW Import Comp. Ltd (Vico), Beijing (6796),Germany E02 Bentley rest Europe (6E02),Japan E03 Bentley Japan (6E03),Korea, (South) E08 Bentley South Korea (6E08),United Arab Emirates E06 Bentley Middle East and Africa (6E06),United Kingdom E01 Bentley UK (6E01),United States E05 Bentley USA and rest America (6E05)
<b>Brand</b>	Bentley
<b>Transaction No.</b>	2071190/2
<b>Level</b>	EH
<b>Status</b>	Released for publishing
<b>Release date</b>	Apr 7, 2025

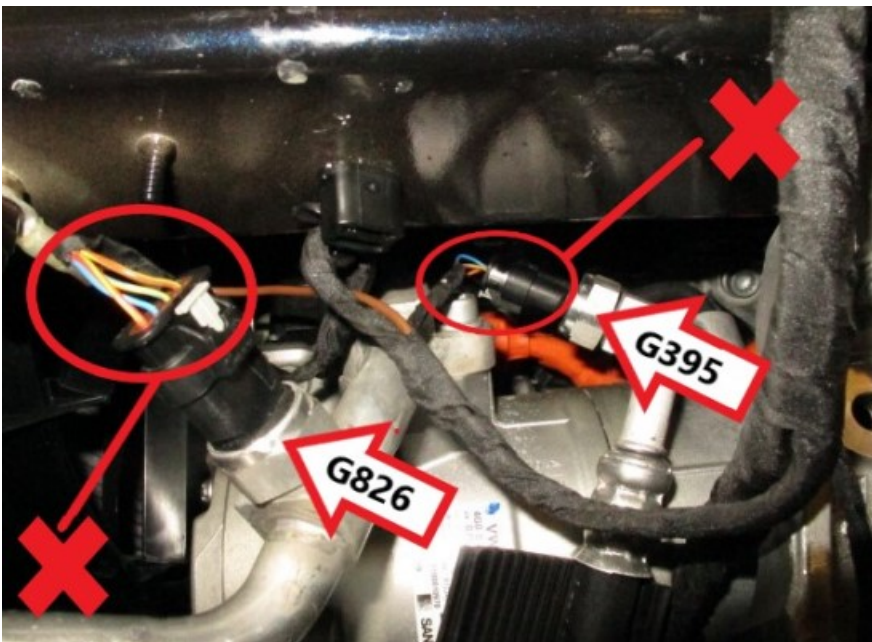
- 1) Referring to Rep.Gr 44 - Remove the left hand front wheel
- 2) Referring to Rep.Gr 66 - Remove the left hand front foremost wheel arch liner
- 3) Remove (x3) speaker box fixings (5Nm)
  - Disconnect the speaker box electrical connector
  - Remove the speaker box
- 4) Access can now be gained to the required connector plugs - Figure 1 shows G826 and G395 with the connector plugs fitted incorrectly
  - Low pressure sender G826 connector plug with 4 wires (**Incorrect**)
  - High pressure sender G395 connector plug with 3 wires (**Incorrect**)

In the event the pressure sender connector plugs are fitted incorrectly the plugs should be disconnected and refitted correctly as shown in Figures 2 and 3

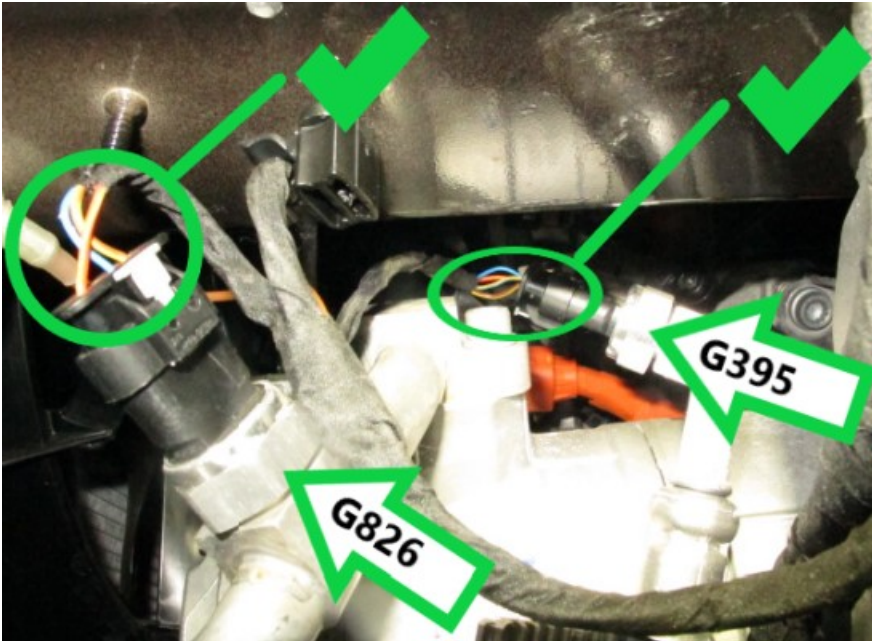
- Figure 2 shows G826 and G395 connector plugs fitted correctly
- Low pressure sender G826 connector plug with 3 wires (**Correct**)
- High pressure sender G395 connector plug with 4 wires (**Correct**)

5) Once the orientation of the connector plugs is correct - Refit all previously components

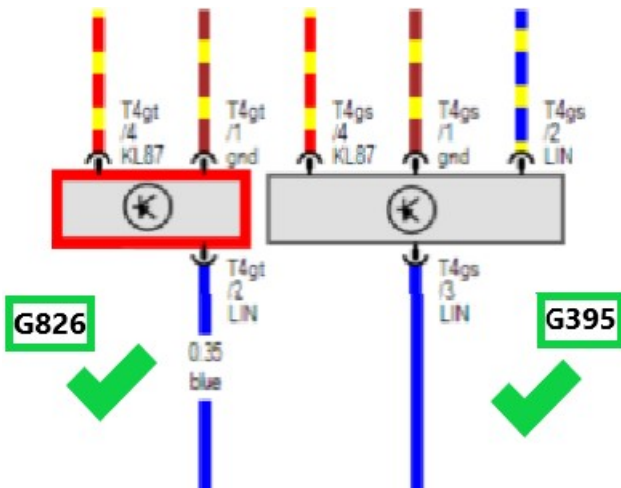
Hint: Figure 3 shows G826 and G395 as per the applicable Current Flow Diagram (Correct)
