Service Bulletin

Bulletin No.: 24-NA-180

Subject: Malfunction Indicator Lamp (MIL) Illuminated, Knock Sensor Service Calibration DTCs P0326 and/or P0331 Set

Brand:	Model:	Model Year:		VIN:		Engine:	Transmission :
		from	to	from	to		
Chevrolet	Colorado	2024	2024			L3B	
						L2R	
GMC	Canyon	2024	2024			L3B

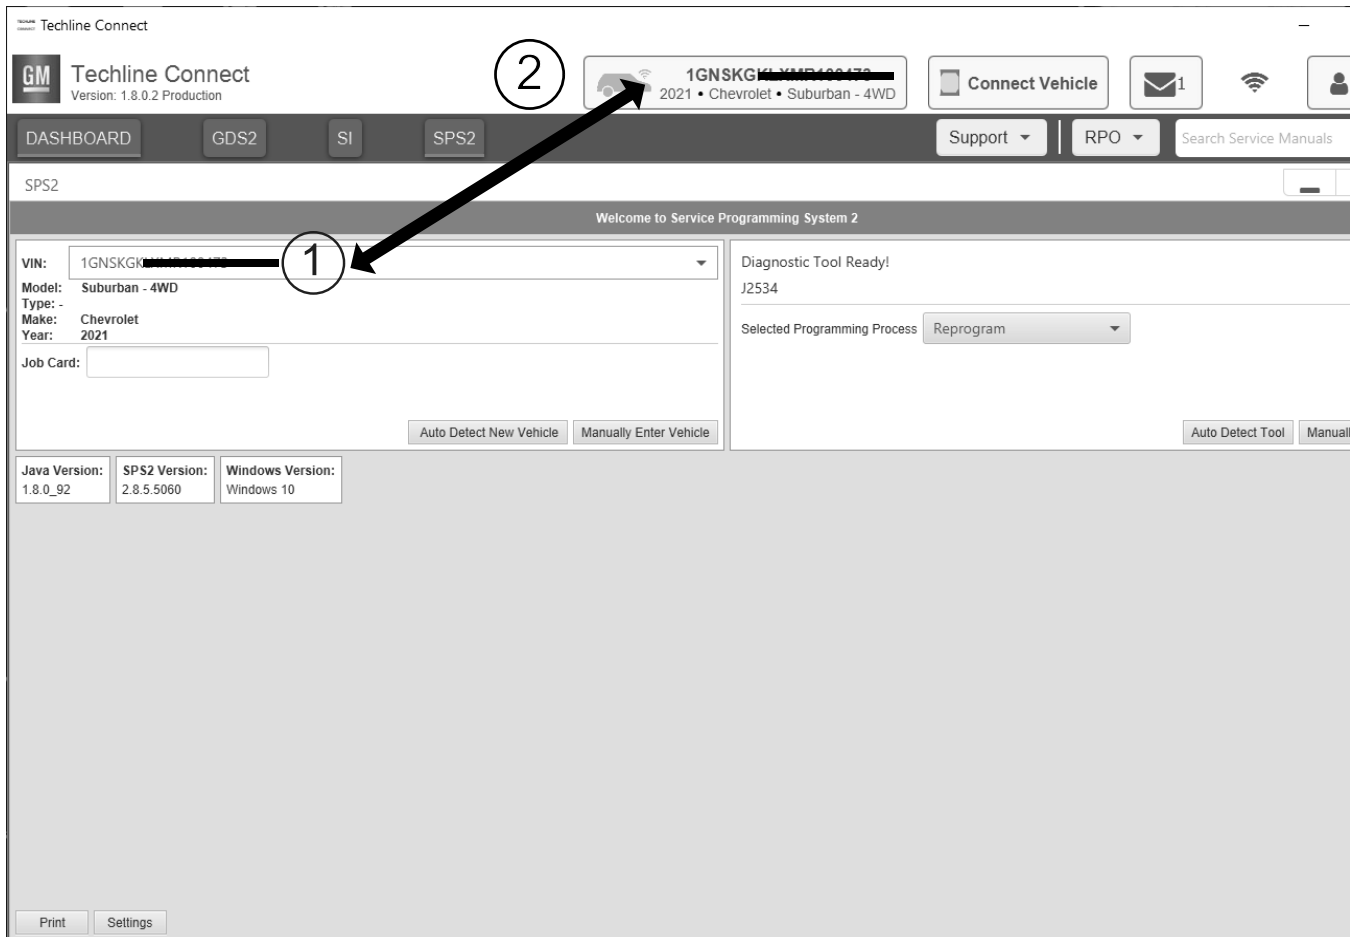
5743643

Caution: Be sure the VIN selected in the drop-down menu (1) is the same as the vehicle connected (2) before beginning programming.
