Technical Service Bulletin

Topic	Noises from Panoramic sun roof Bentayga Series 17MY - 25MY
Market area	Bentley: worldwide (2WBE)
Brand	Bentley
Transaction No.	2054210/5
Level	EH
Status	Released for publishing
Release date	Apr 7, 2025

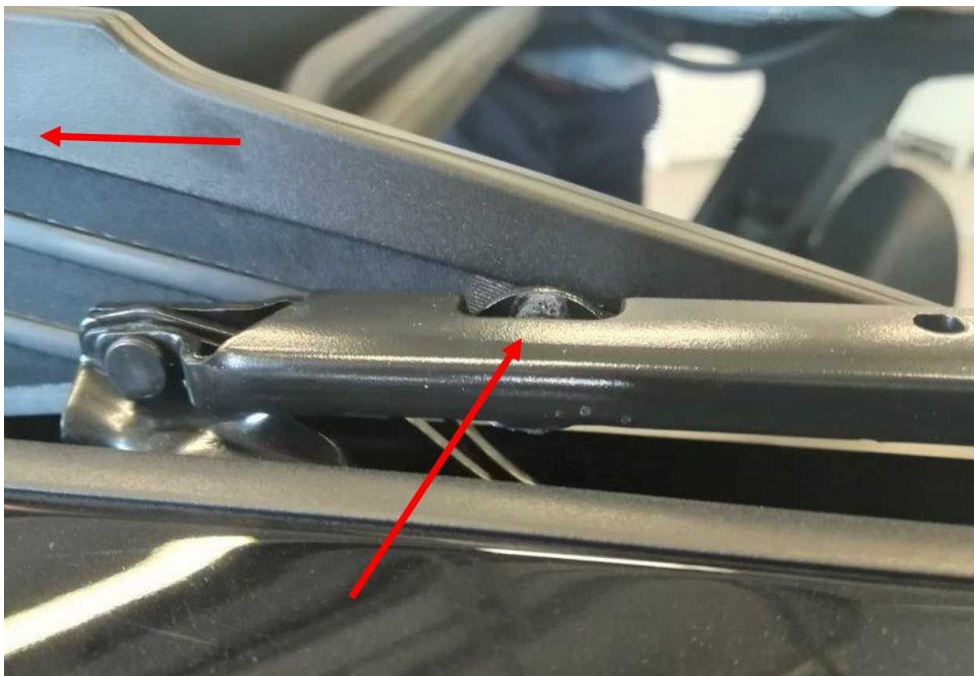
2) The above illustration shows the left mechanical system. The upper left arrow points to the driving direction. The lower arrow points to the first mounting point of the glass panel.

- For a better access to the points to be greased move the mechanical system (slightly) rearwards
- Apply grease spray G 060 567 A2 to the points shown within the onward instructions
