| REFERENCE: | TSB: 08-071-25 REV. B<br>GROUP: 08 - Electrical | Date: | April 30, 2025 | REVISION: | 08-071-25 REV. A |
| VEHICLES AFFECTED: | 2024 (LB) Dodge Charger<br>This bulletin applies to vehicles equipped with 400V G2500 FR/RR Elec Drive Motors (Sales Code ELD). | | | MARKET APPLICABILITY:<br><div><div><input type="checkbox"/> NA<input type="checkbox"/> MEA</div><div><input type="checkbox"/> SA<input type="checkbox"/> IAP</div><div><input type="checkbox"/> EE<input type="checkbox"/> CH</div></div> | |

| <b>CAUSE:</b> | <b>BPCM software update</b> |

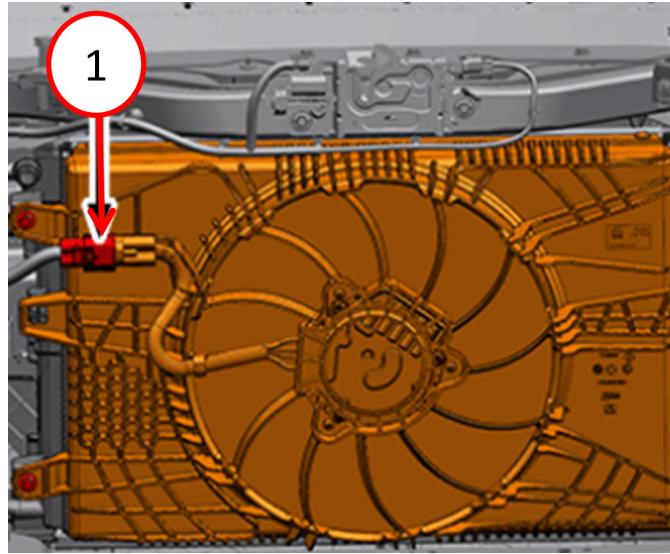
**Fig. 1**  
Cooling Fan Assembly

4. Disconnect the cooling fan wire harness connector [Fig. 1](#).

1 - Wire Harness To Disconnect/Connect

26. Connect the cooling fan wire harness connector [Fig. 1](#).

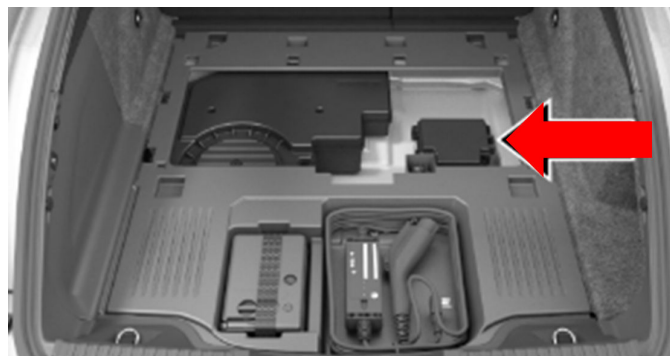
**Fig. 2**  
Rear PDC Location

5. From the rear of the vehicle, pull back the carpet to access the rear Power Distribution Center (PDC) [Fig. 2](#).

24. Install the #38 AGSM fuse [Fig. 3](#) and the PDC cover [Fig. 2](#).

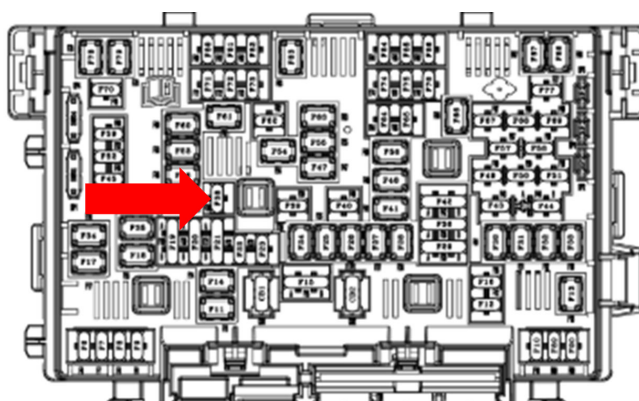
**Fig. 3**  
#38 AGSM Fuse Location

**Failure to remove the #38 AGSM fuse will result in damage to the shifter.**

6. Remove the PDC cover, locate and remove the #38 AGSM fuse [Fig. 3](#).
